## SPYDER Pressurized Crankcase On 1330 Engines - 137963

The engine crankcase might be pressurized because of blocked breather hose.

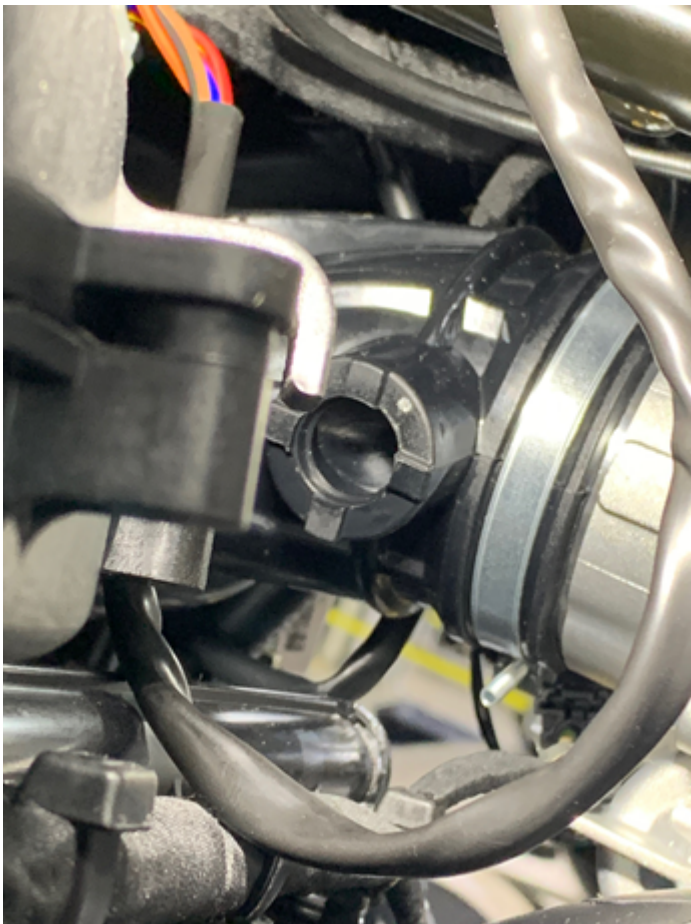
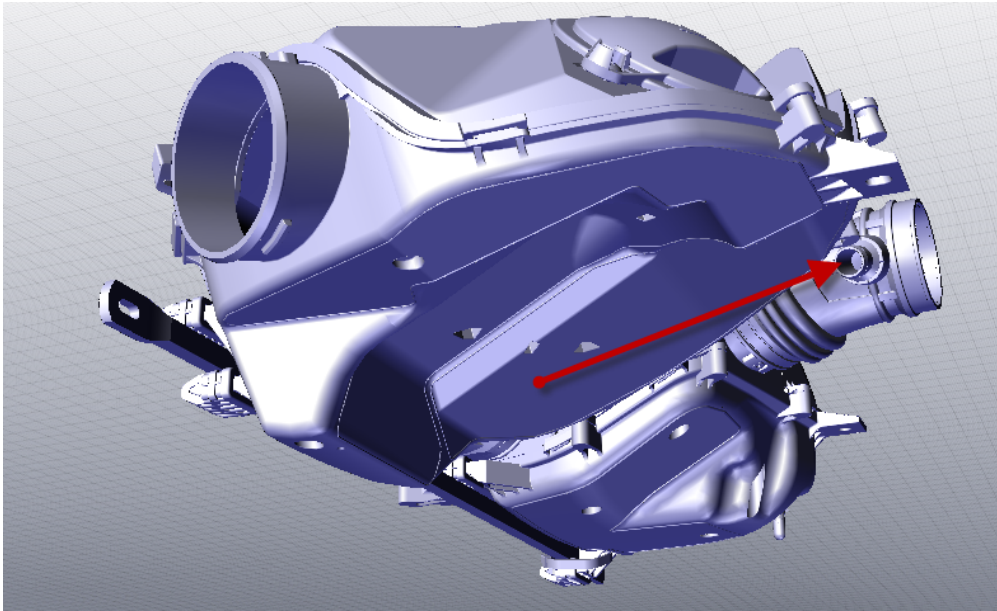
Inspect the intake inlet at the throttle body. The breather hose inlet might be blocked not allowing crankcase to breathe and creating internal engine pressure.

If the hole is blocked, simply open it by using a small blade.
