HYUNDAI Technical Service Bulletin

GROUP STEERING	NUMBER 20-ST-002H-1
DATE AUGUST, 2020	MODEL(S) ELANTRA (ADa)

SUBJECT: C-MDPS WORM SHAFT ASSEMBLY BEARING NOISE

THIS TSB SUPERSEDES 20-ST-002H TO REPLACE THE WORM SHAFT ASSEMBLY INSTEAD OF THE COLUMN & HOUSING ASSEMBLY FOR C-MDPS BEARING NOISE.

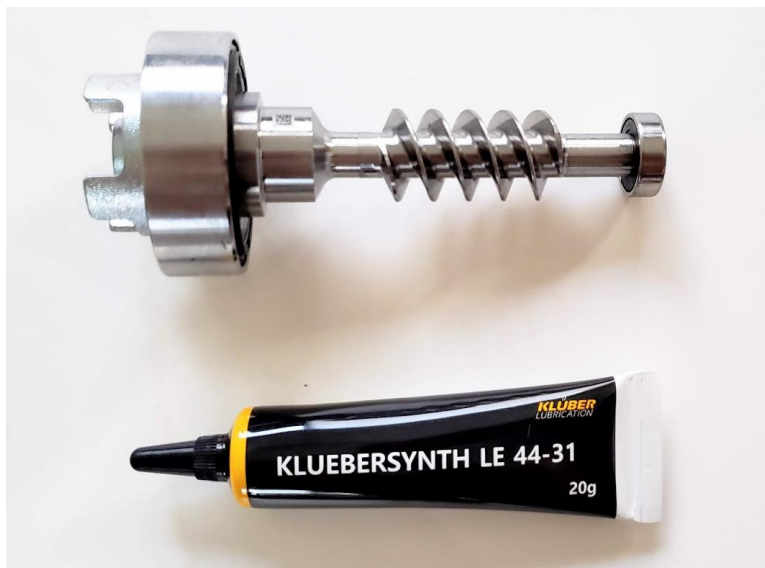
Description: Certain vehicles may develop a bearing noise within the Motor Driven Power Steering (MDPS) column worm shaft assembly. If bearing noise is heard, follow the procedure in this bulletin to replace the worm shaft assembly.

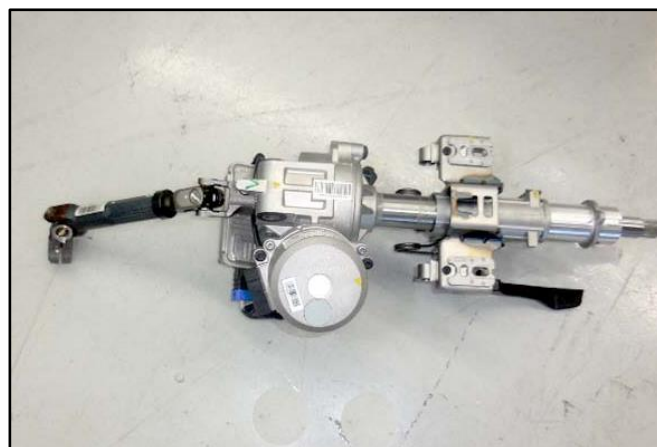
3. Remove the C-MPDS assembly and universal joint according to the applicable vehicle shop manual.

Before removing the C-MDPS assembly, ensure the wheels are straight and the steering wheel is level.

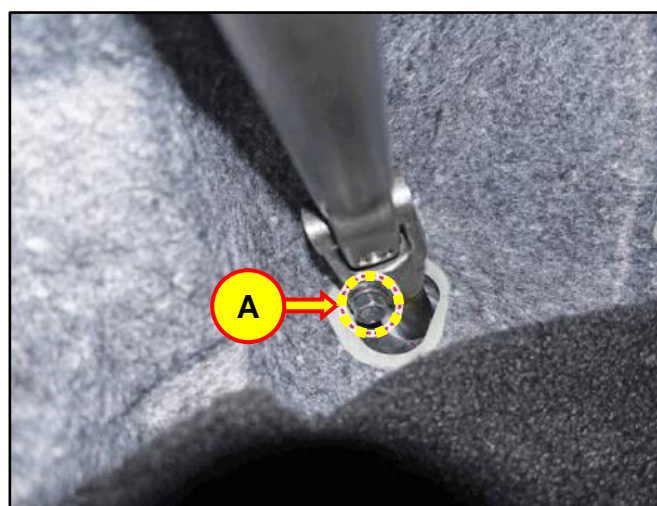
4. Only remove the lower pinch bolt (A) on the steering universal joint assembly to remove the C-MDPS assembly.

Pinch Bolt Torque

lb-ft	• 23.9-27.5
kgf.m	• 3.3-3.8
N.m	• 32.4-37.3

If the pinch bolts on either end of the steering universal joint assembly are removed, the bolts **cannot** be reused during reassembly.

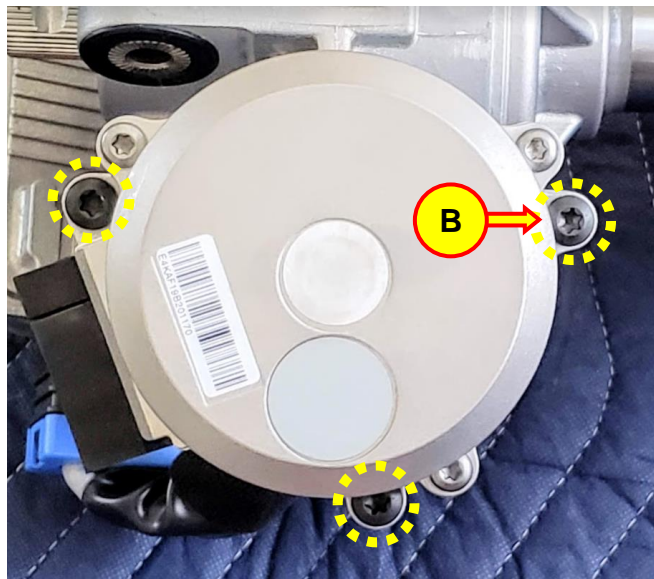
5. Loosen the motor mounting bolts (B).

Motor Mount Tightening Torque

lb-ft	• 5.8-8.7
-------	-----------

kgf.m	• 0.8-1.2
-------	-----------

N.m	• 7.8-11.8
-----	------------

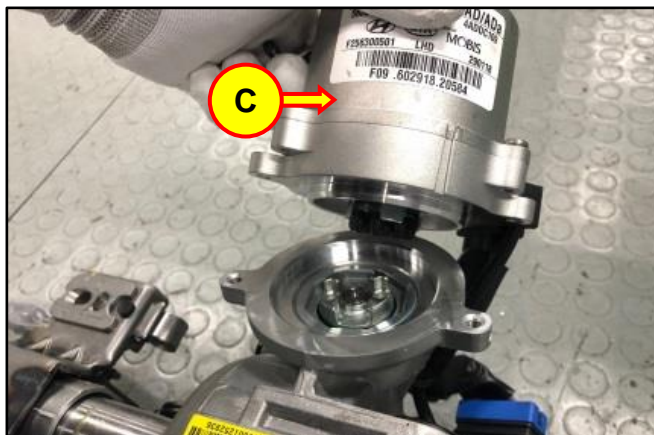
6. Remove the motor assembly (C).

Reuse the flexible coupling.

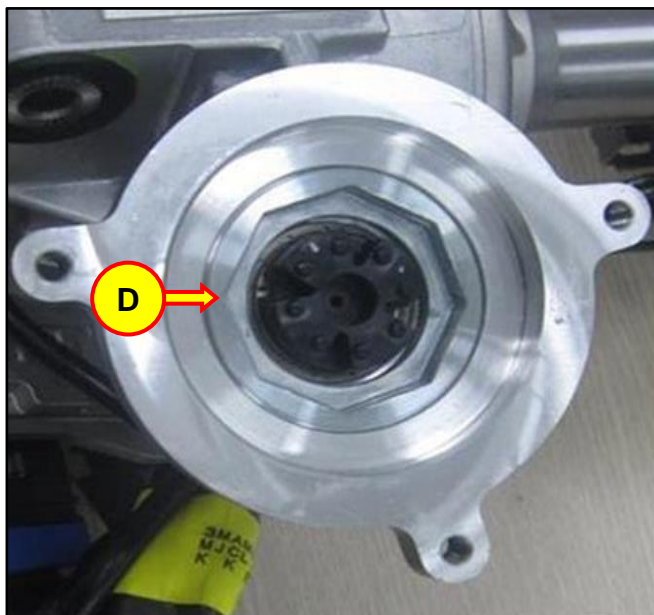
7. Remove the worm shaft plug (D) using the worm shaft assembly plug tool.

Worm Shaft Plug Tightening Torque

lb-ft	• 51.4-59.3
-------	-------------

kgf.m	• 7.1-8.2
-------	-----------

N.m	• 69.7-80.4
-----	-------------

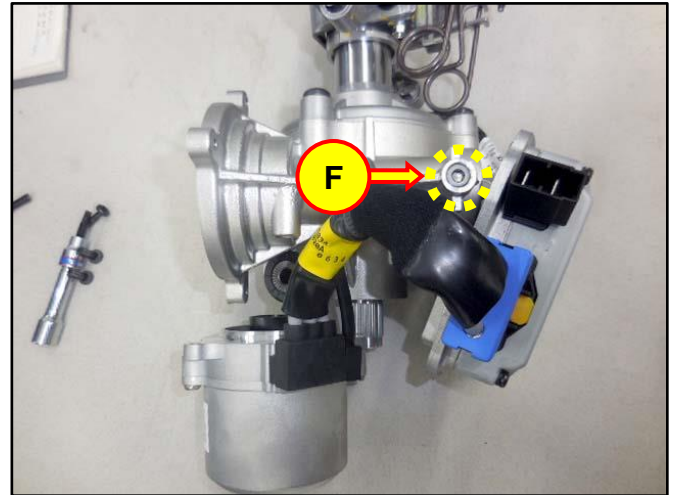
8. Remove the anti-rattle plug (F).

Anti-Rattle Plug Tightening Torque

lb-ft	• 7.2-9.4
kgf.m	• 1.0-1.3
N.m	• 9.8-12.8

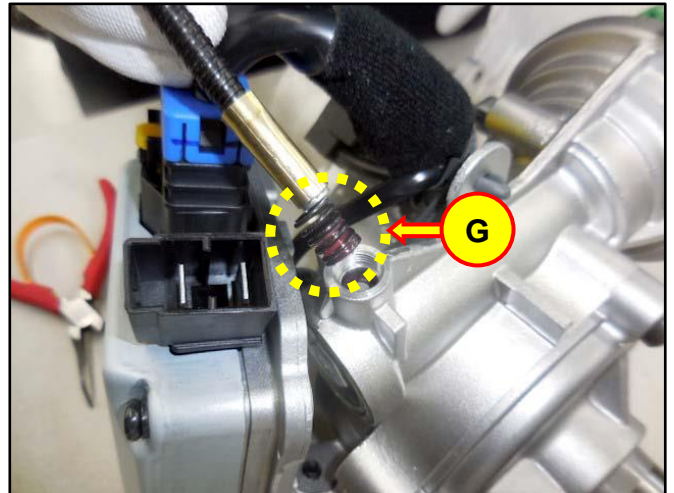
9. Remove the anti-rattle spring (G).

Keep the anti-rattle spring free of debris after removal. Reuse the spring during reassembly.

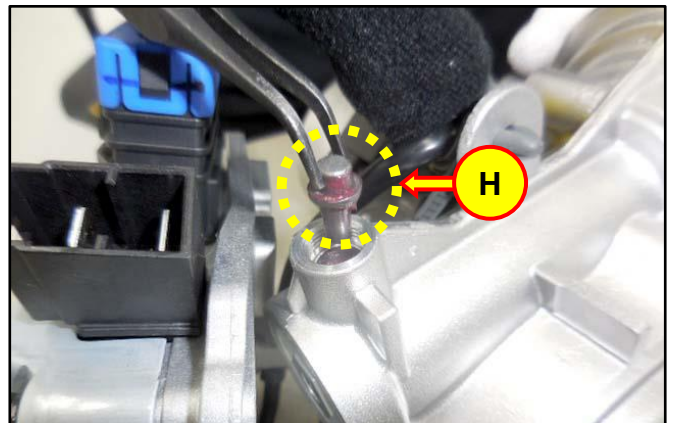
10. Remove the slide pin (H).

Keep the slide pin free of debris after removal. Reuse the slide pin during reassembly.

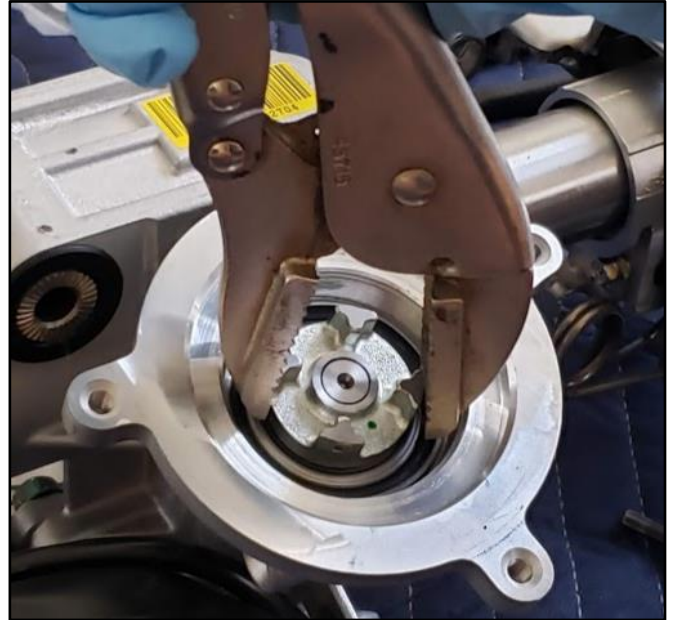
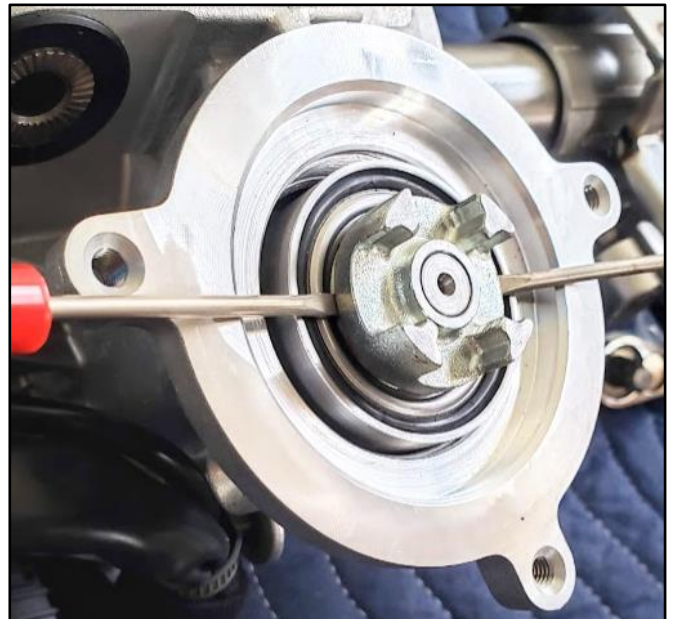
11. There are a few methods to remove the worm shaft assembly.
- Use locking pliers or similar tool to grip the coupler and pull out the assembly.
After the worm shaft assembly is freed, move to step 12. (Page 10)

- Place two flat-head screwdrivers under the coupler, 180 degrees apart, to pry out the assembly.
After the worm shaft assembly is freed, move to step 12. (Page 10)

- If either of the above methods are unsuccessful, move to step 11c (Page 8) for an alternate method of removal.

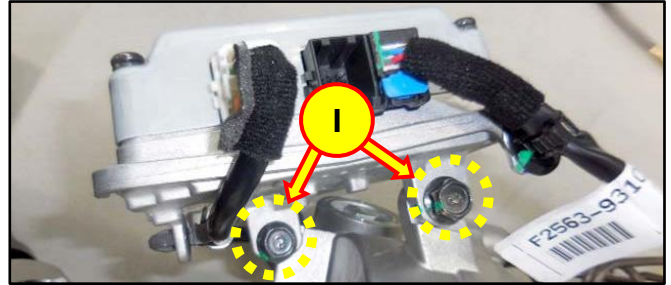
11c-1. Remove the ECU mounting bolts (I) and set aside the ECU assembly.

ECU Mounting Bolts Tightening Torque

lb-ft	• 14.5-17.4
kgf.m	• 2.0-2.4
N.m	• 19.6-23.5

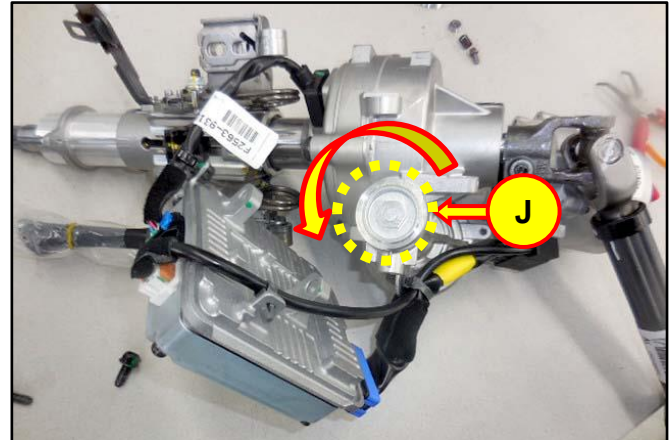
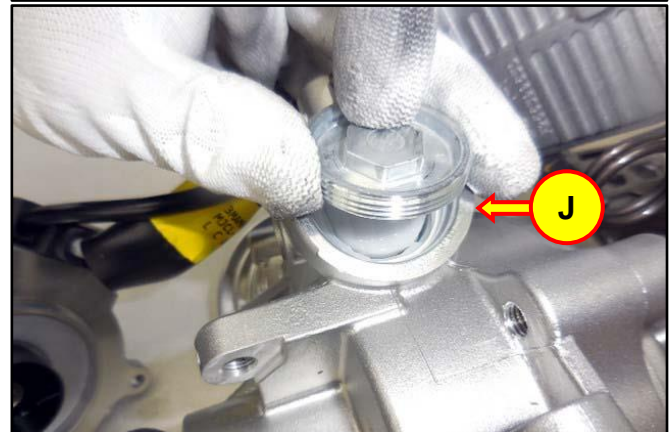
11c-2. Remove the plug (J).

Plug Tightening Torque

lb-ft	• 28.2-35.5
kgf.m	• 3.9-4.9
N.m	• 38.3-48.1

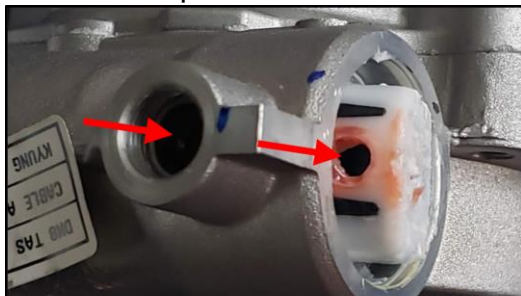
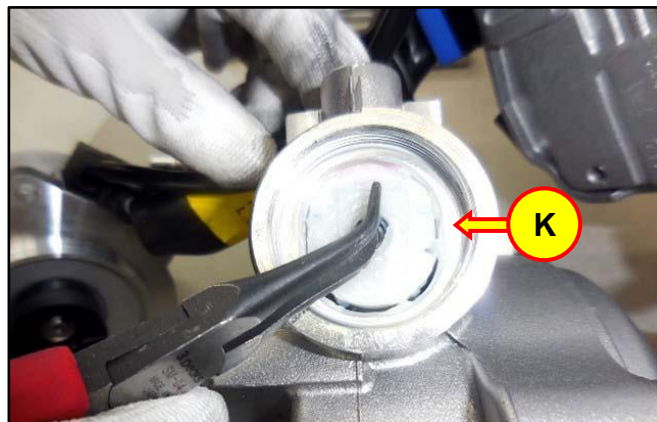
11c-3. Remove the grease plug (K).

During reassembly, align the hole on the side of the grease plug with the boss to insert the slide pin.

Keep the grease plug free of debris after removal. Reuse the plug during reassembly.

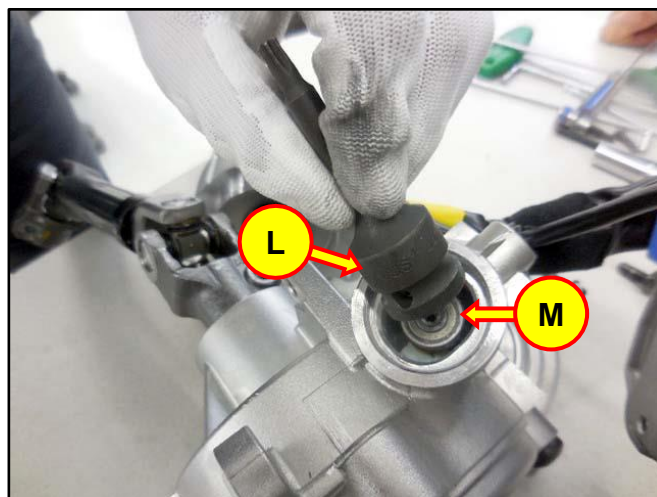
11c-4. Place a short 3/8-inch socket extension or similar tool (L) onto the small bearing (M) as shown.

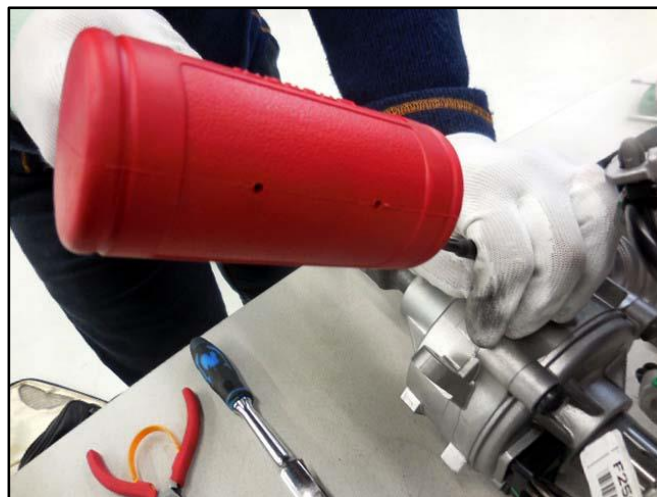
11c-5. Using a plastic hammer or rubber mallet, lightly tap the extension to free the worm shaft assembly.

After the worm shaft assembly is freed, move to step 12. (Page 10)

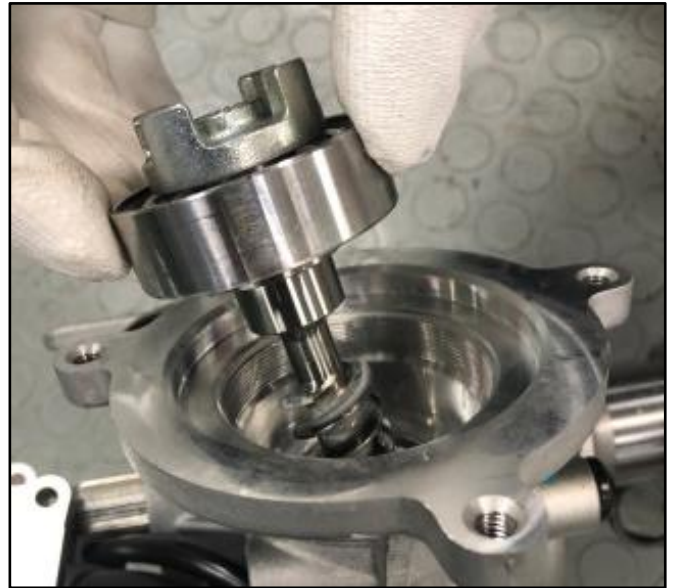
12. Pull the worm shaft assembly out of the MDPS column and discard the assembly.

Keep the housing opening free and clear of debris.

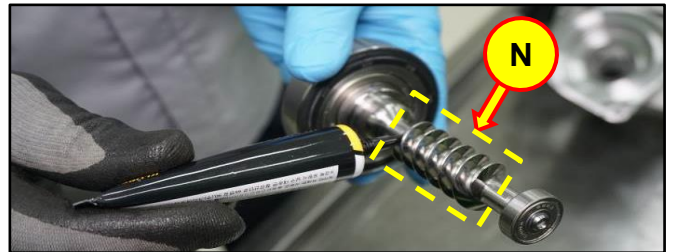
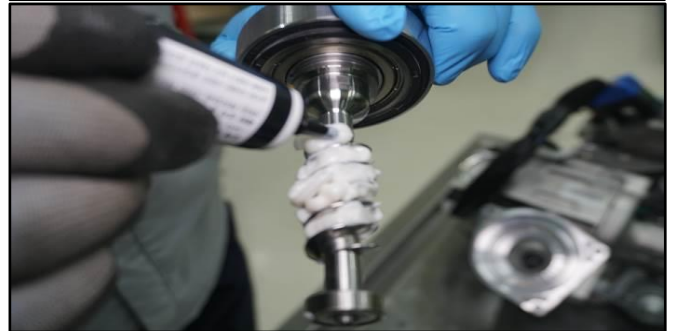
13. Apply the entire contents of the supplied grease evenly onto the new worm gear (N).

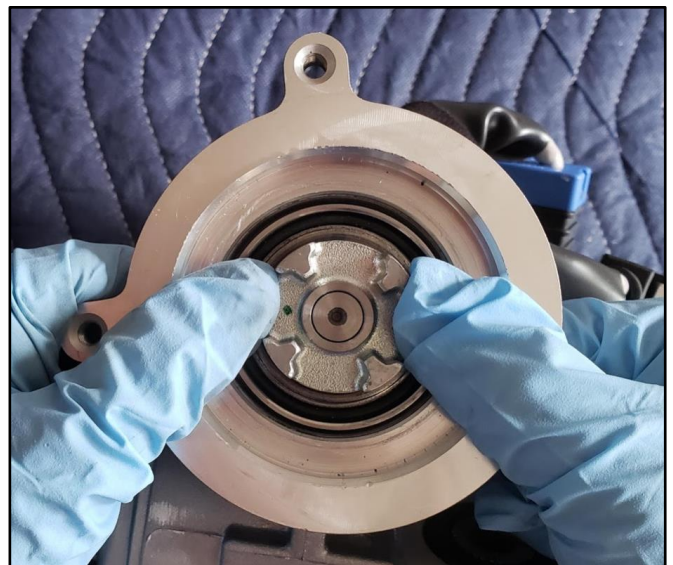
14. Carefully reinstall the new worm shaft assembly.

Slide the assembly straight into the housing. Light thumb pressure on either side of the large bearing/coupler should be sufficient to seat the assembly. If the assembly does not slide into place, remove the assembly and try again.

Do not force or tap the worm shaft assembly into the housing.
