Emissions Recall

Code: 24GB

Subject	Engine and Transmission Control Module (ECM/TCM)															
Release Date	September 16, 2020															
Affected Vehicles

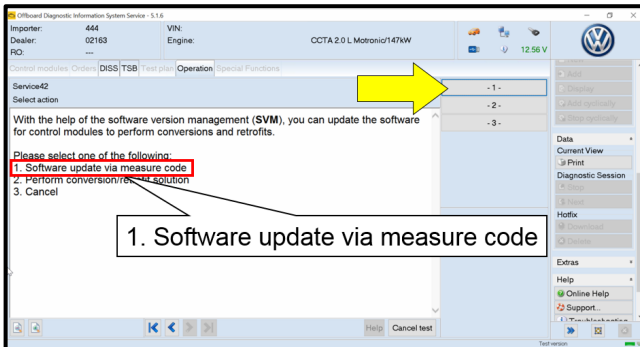
- Select the correct option to “Update software via action code” OR “Software update via measured code”.

NOTE
The different options to perform the SVM operation may vary based on model.
