# Emissions Service Action

## Code: 24GA

<b>Subject</b>	Engine Control Module (ECM) Software																									
<b>Release Date</b>	September 11, 2020																									
<b>REVISION SUMMARY</b>	<b>Problem description updated.</b>																									
<b>Affected Vehicles</b>

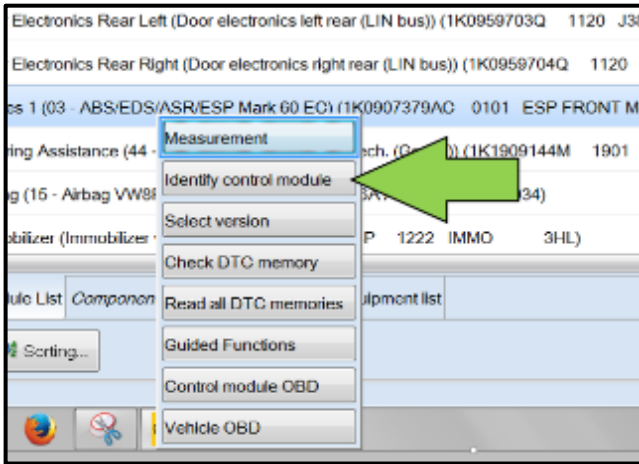
- After the software update is completed and before sending the GFF Log Online:
  - Select the "Control Module" tab.
  - Scroll down and right click on the module that was updated (0001).
  - Select "Identify Control Module" <arrow>.
