STAR ONLINE PUBLICATION

Case Number: S2008000122

Symptom/Vehicle Issue: Blind Spot LED Stays ON. DTC B285F-15 Blind Spot Warning Light Control-Circuit Short To Battery Or Open

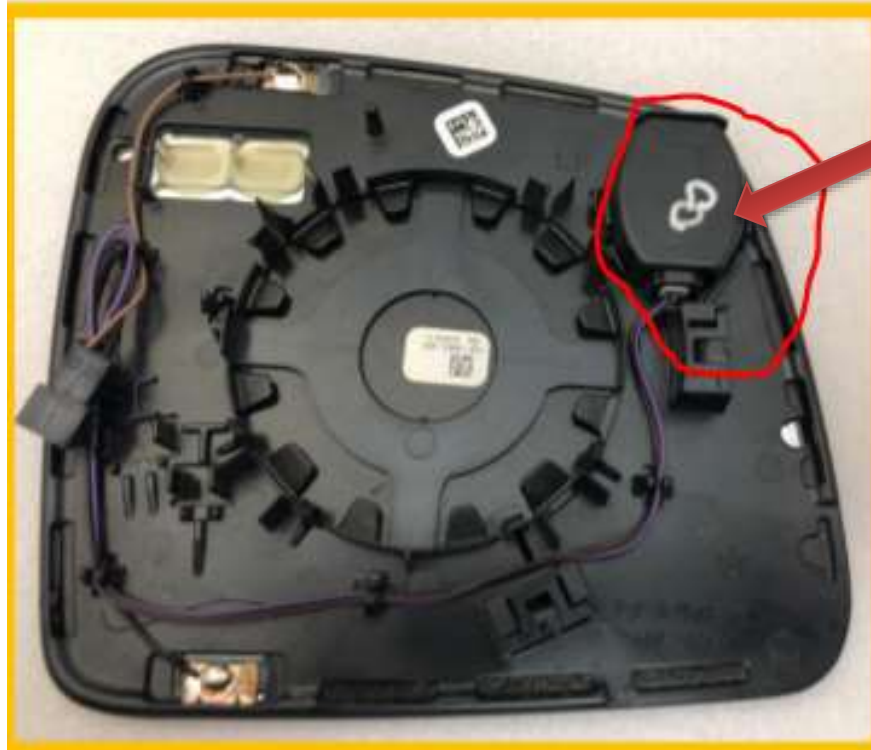
Discussion: Intermittently the customer may find that either the left or right blind spot indicators remains on. Upon scanning the vehicle for DTC's B285F-15 Blind Spot Warning Light Control-Circuit Short To Battery Or Open set in either the DDM or PDM. A spread terminal for the blind spot LED indicator located on the back of the mirror glass could create an open and cause this concern.

Using WiTech, command the Blind Spot Indicators on in the DDM or PDM. Tilt the mirror in order to gain access to the LED indicator wiring harness. Wiggle test the wiring near the LED indicator connector. Watch the corresponding LED indicator. If the light turns on and off as the wiring is moved, that mirror has a spread terminal.

Blind Spot
LED Indicator
Housing and
Connector

Back of Exterior Mirror

Repair: If the concern is isolated when performing the wiggle test. The Mirror glass should be replaced. The replacement mirror will have a new wiring harness for the LED indicator. The replacement mirror will eliminate the loose terminal fitment concern.

Verification: After replacing the mirror glass clear the DTC's. Using WiTech, again turn on the Blind Spot indicators. Wiggle test the wiring to confirm a loose connection is no longer present.
