STAR ONLINE PUBLICATION

Case Number: S2008000133

Symptom/Vehicle Issue: ABS And Cluster Warning Lights Intermittently Illuminate.

Multiple CAN B Faults

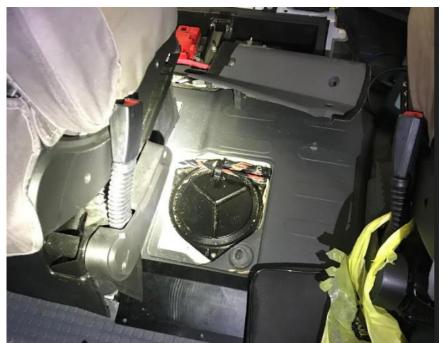
Discussion: The CAN B circuits may become pinched and damaged from the locking tab on the small access panel between the driver and passenger front seat. This concern can be caused by a person repeatedly walking on the access panel.

Diagnosis: Remove the access panel and inspect for damaged wiring. Commonly the CAN B circuits are damaged.

Repair: Repair the wiring as necessary using standard procedures. Reroute the harness away from the access panel lock tab. Be sure it is routed in a way that the circuits can no longer be damaged.
