# Service Bulletin

Bulletin No.: 20-NA-020

**Subject: Brake Squealing Noise**

Brand:	Model:	Model Year:		Date Breakpoint:		Engine:	Transmission:
		from	to	from	to		
Chevrolet	Silverado 2500HD/ 3500HD	2020	2020	SOP	September 01, 2019	-	-
GMC	Sierra 2500HD/ 3500HD

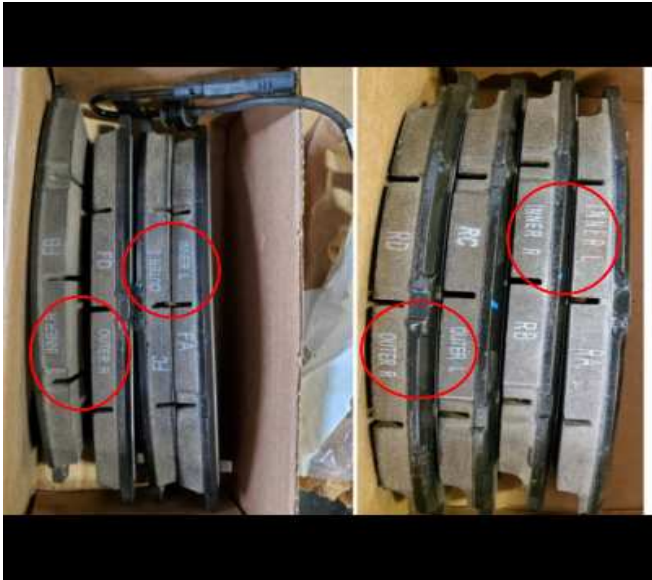
<b>Involved Region or Country</b>	United States, Canada, Mexico, Middle East, Israel
<b>Condition</b>	Some customers may comment that the brakes are squealing.
<b>Cause</b>	This condition may be caused by a low scorch friction material was used on the original brake pads.
<b>Correction</b>	<p>Replace the front and rear brake pads.</p>

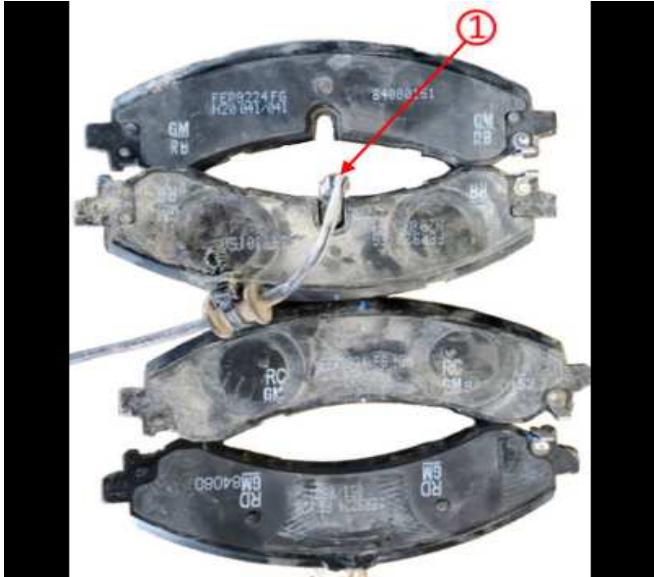
5638987

**Important:** Only the left side of the truck has the wear sensors (1) and is mounted on the inner pad.  
 Refer to *Front and Rear Disc Brake Pads Replacement* in SI.
