TECHNICAL SERVICE BULLETIN

Crew Cab - Folding Rear Seat Backrest Assembly Excessive Latching Effort When Returning To The Upright Position

20-2218
08 September
2020

Ford 2019-2020 Ranger

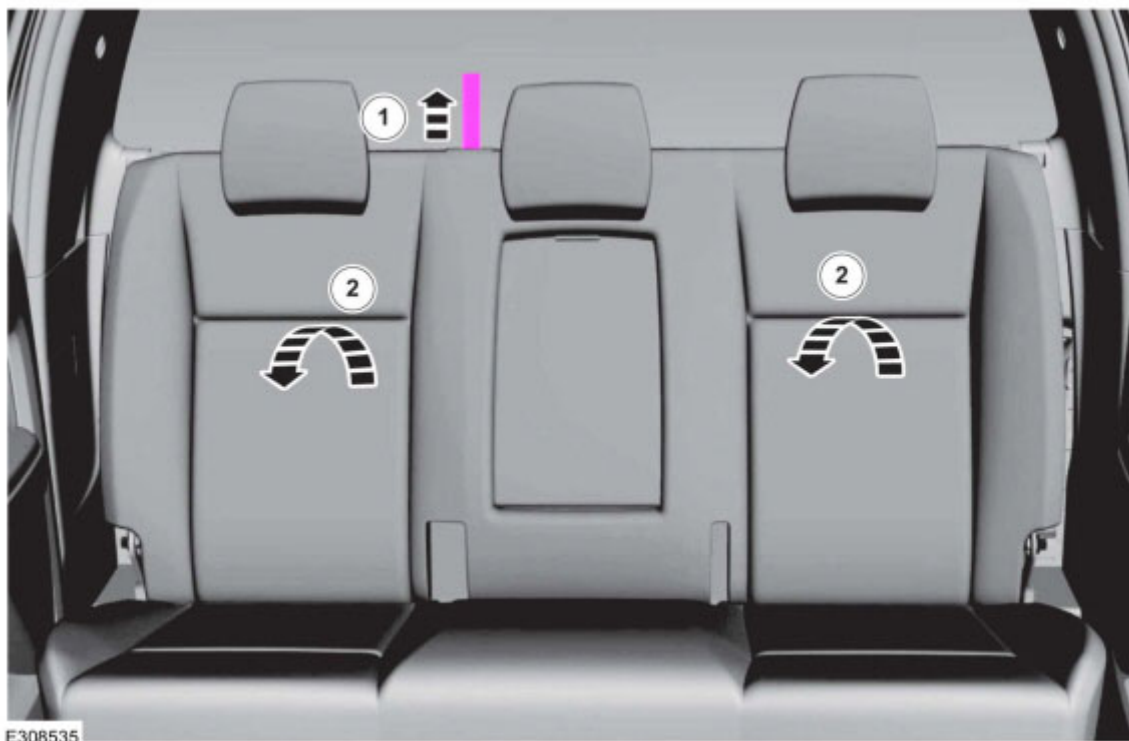
Figure 1

1. Check the vehicle build date. Was the vehicle built on or before 04-Feb-2019?
 - (1). Yes – proceed to Step 2.
 - (2). No – proceed to Step 14.
2. Release the rear seat backrest latch (Figure 1 Callout 1) and lower to the fold flat position. (Figure 1 Callout 2)

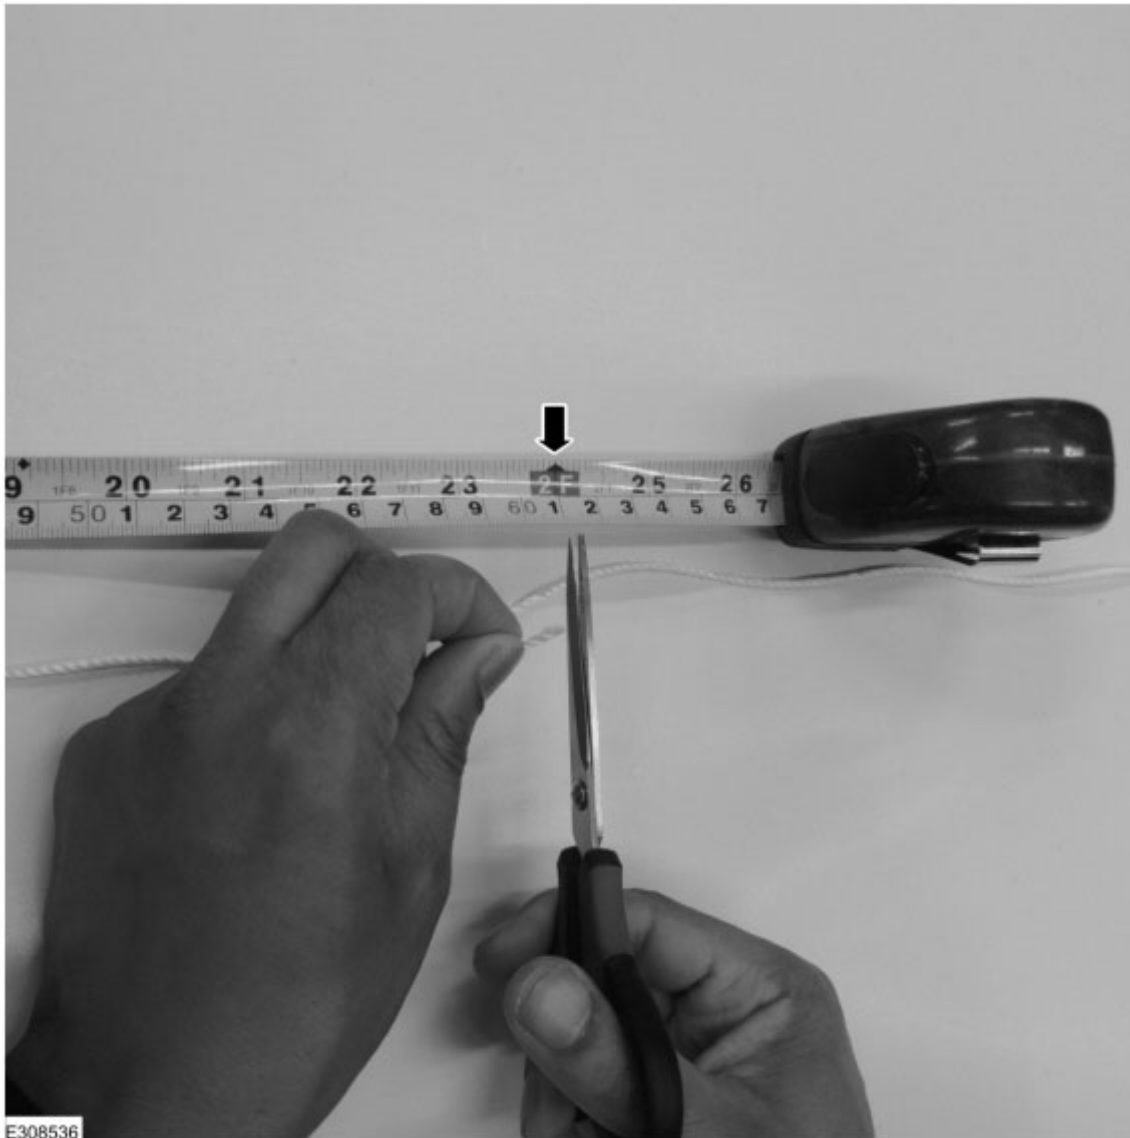
Figure 2

3. Measure and cut a 60 cm (2-foot) piece of string. (Figure 2)

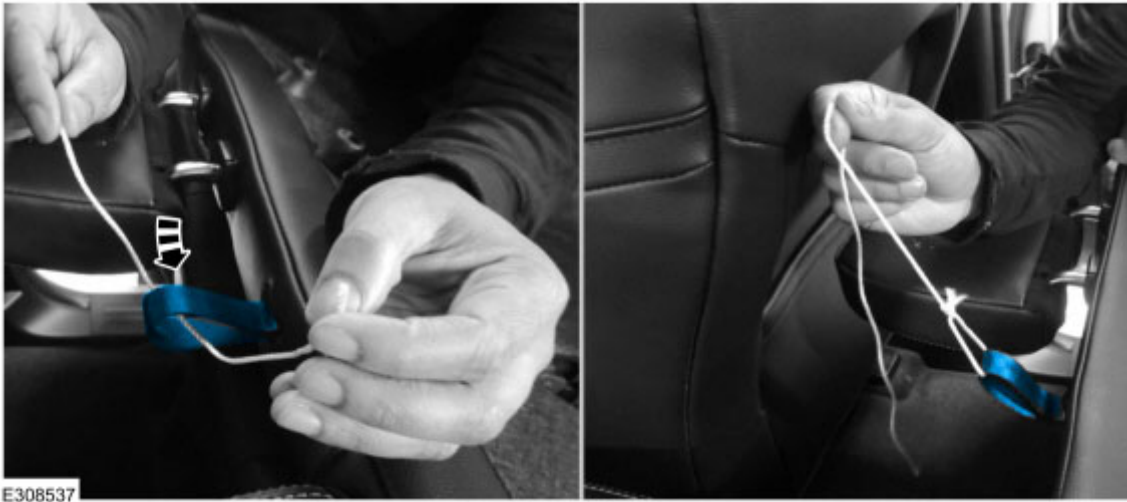
Figure 3

4. Guide the string through the rear seat backrest release strap and double knot a loose loop. (Figure 3)

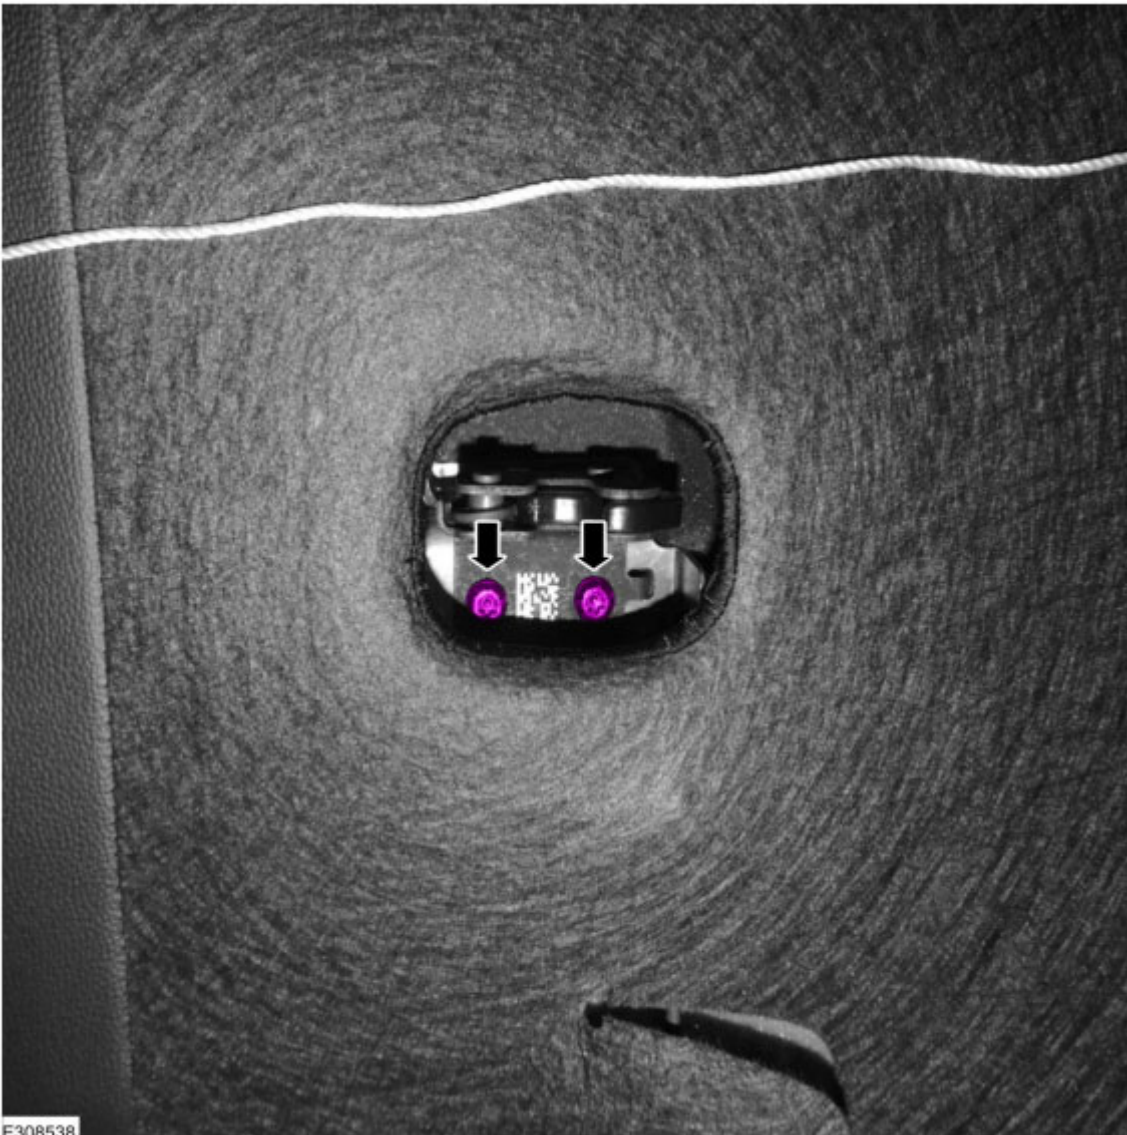
Figure 4

5. Remove the rear seat backrest latch retainers. (Figure 4)

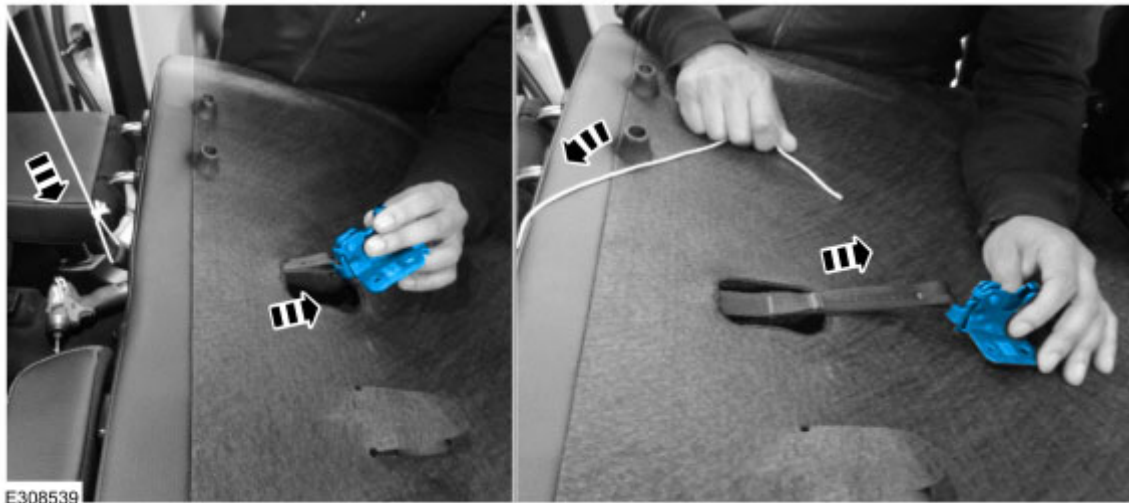
Figure 5

6. Holding the string, guide the rear seat backrest latch up and out of the rear seat backrest assembly just enough to access and remove the rear seat backrest latch release strap. (Figure 5)

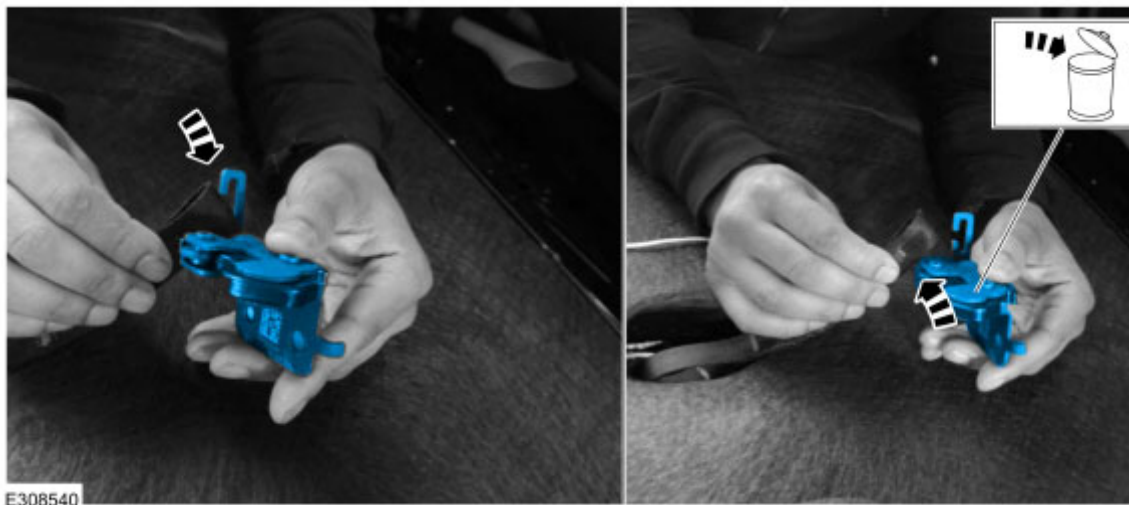
Figure 6

7. Remove and discard the rear seat backrest latch from the rear seat backrest release strap. (Figure 6)

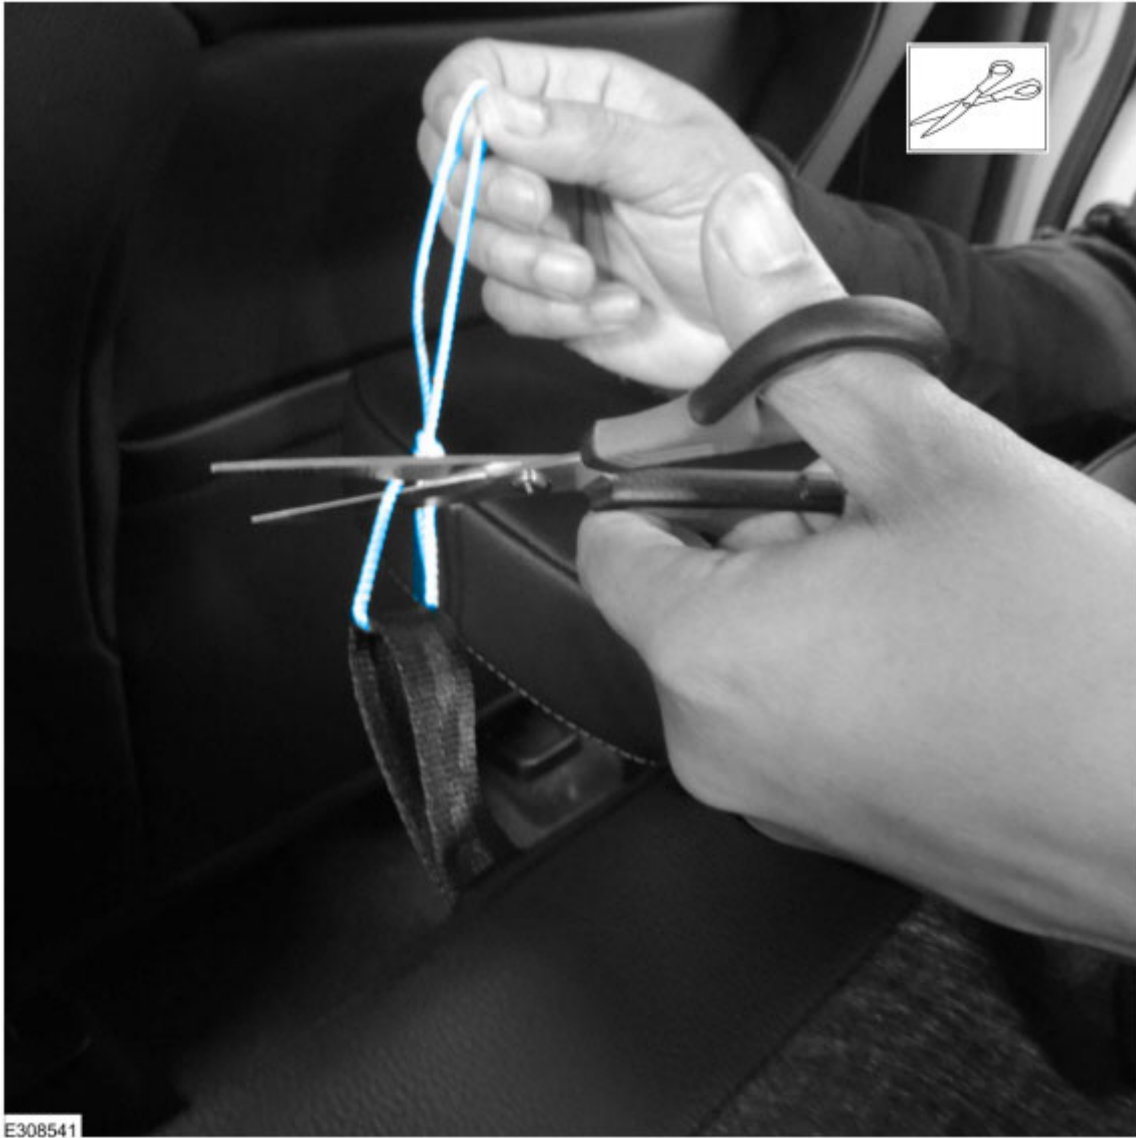
Figure 7

8. Install the rear seat backrest release strap onto the new rear seat backrest latch.
9. Install the new rear seat backrest latch by pulling the string attached to the rear seat backrest release strap back through the seat backrest cover and guiding the rear seat backrest latch back into the rear seat backrest assembly. (Figure 5)
10. Install the rear seat backrest latch retainers. (Figure 4)
 - (1). Tighten both retainers to 1.2 Nm (10.6 in-lb).
11. Remove the string attached to the rear seat backrest release strap. (Figure 7) Make sure to cut the string as far away from the rear seat backrest release strap as possible or damage to the release strap may occur.

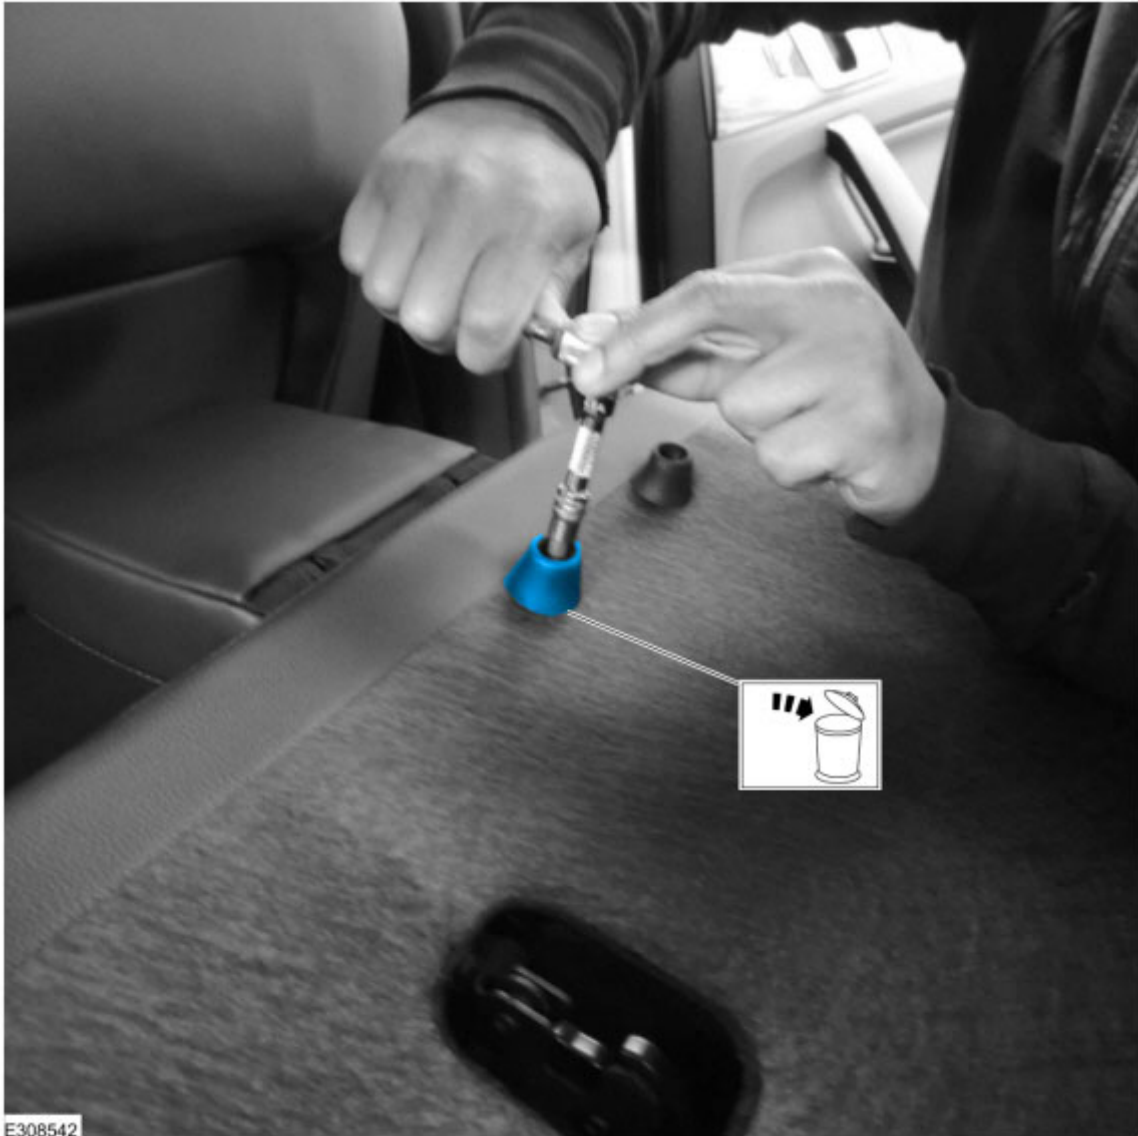
Figure 8

12. Remove and discard the passenger side inboard rear seat backrest bumper on the backside of the rear seat backrest assembly. (Figure 8)

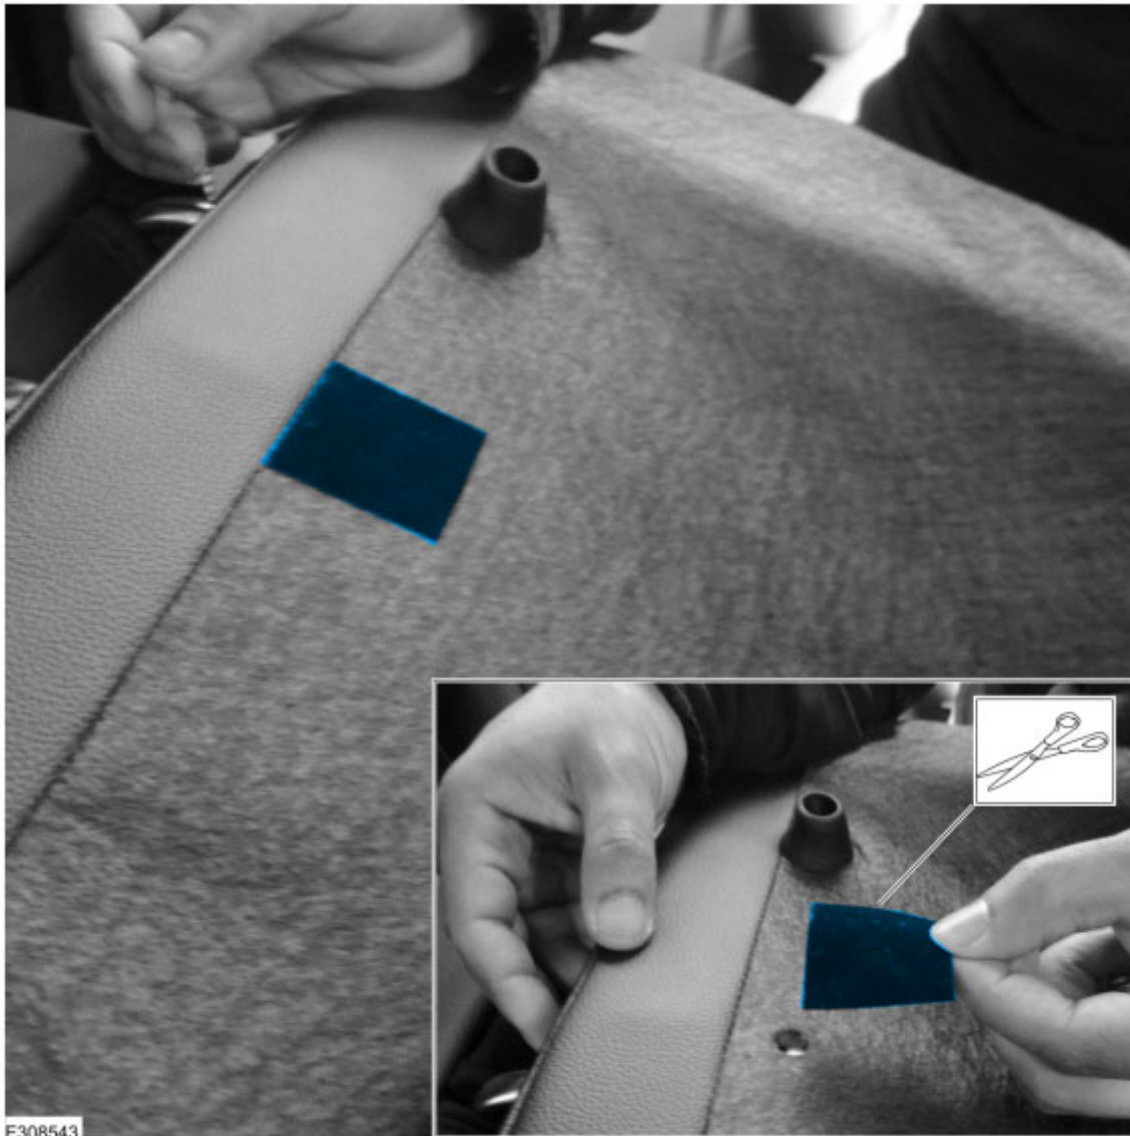
Figure 9

13. Cut a 40 mm by 40 mm (1.5 inch by 1.5 inch) piece of flock tape and install it over the rear seat backrest bumper retainer hole. (Figure 9)

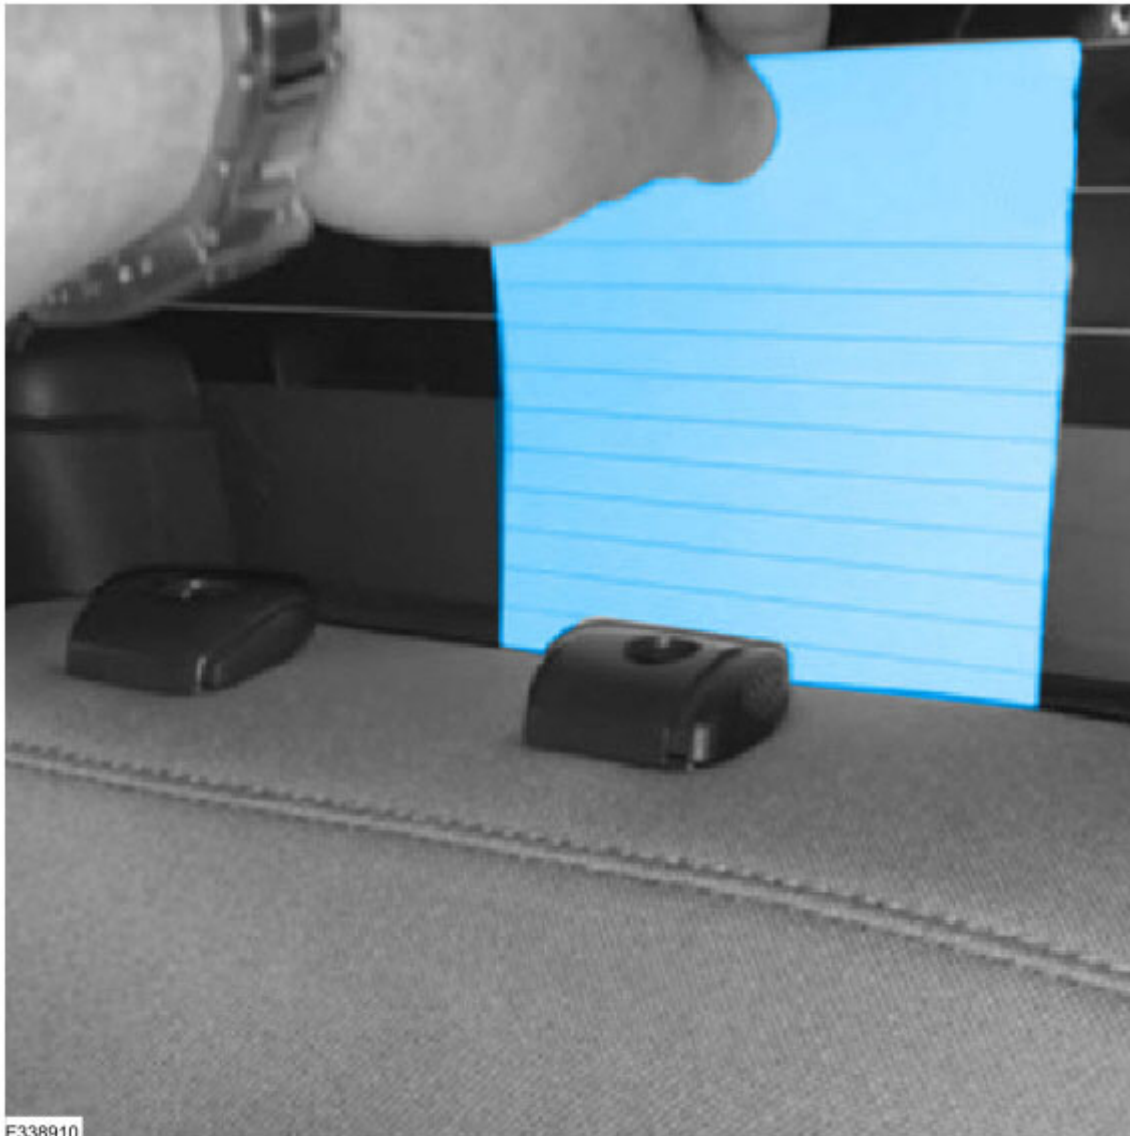
Figure 10

14. Remove only the rear seat outermost head restraints.
 - (1). Press inward on the head restraint locks.
 - (2). Lift upward on the head restraint.
15. Replace all 3 rear seat backrest bumpers and fasteners. Tighten to 1.6 Nm (14 In-lb)
16. Perform a drag test using a sheet of paper to determine which of the 3 rear seat backrest bumpers contacts the back of the cab first.
 - (1). While covering one rear seat backrest bumper with a sheet of paper, raise the rear seat backrest so it is in the upright position, but not latched, and lightly tug on the paper to determine if that bumper is contacting the rear of the cab. Repeat this test on all 3 bumpers.
 - (2). The rear seat backrest bumper that holds the paper will be considered rear seat backrest bumper 'X'. Remember the location of rear seat backrest bumper 'X', as it will be used later in the procedure. (Figure 10)

NOTE: If more than one seat backrest bumper is found to be contacting the rear of the cab, the bumper closest to the latch should be considered rear seat backrest bumper 'X'.

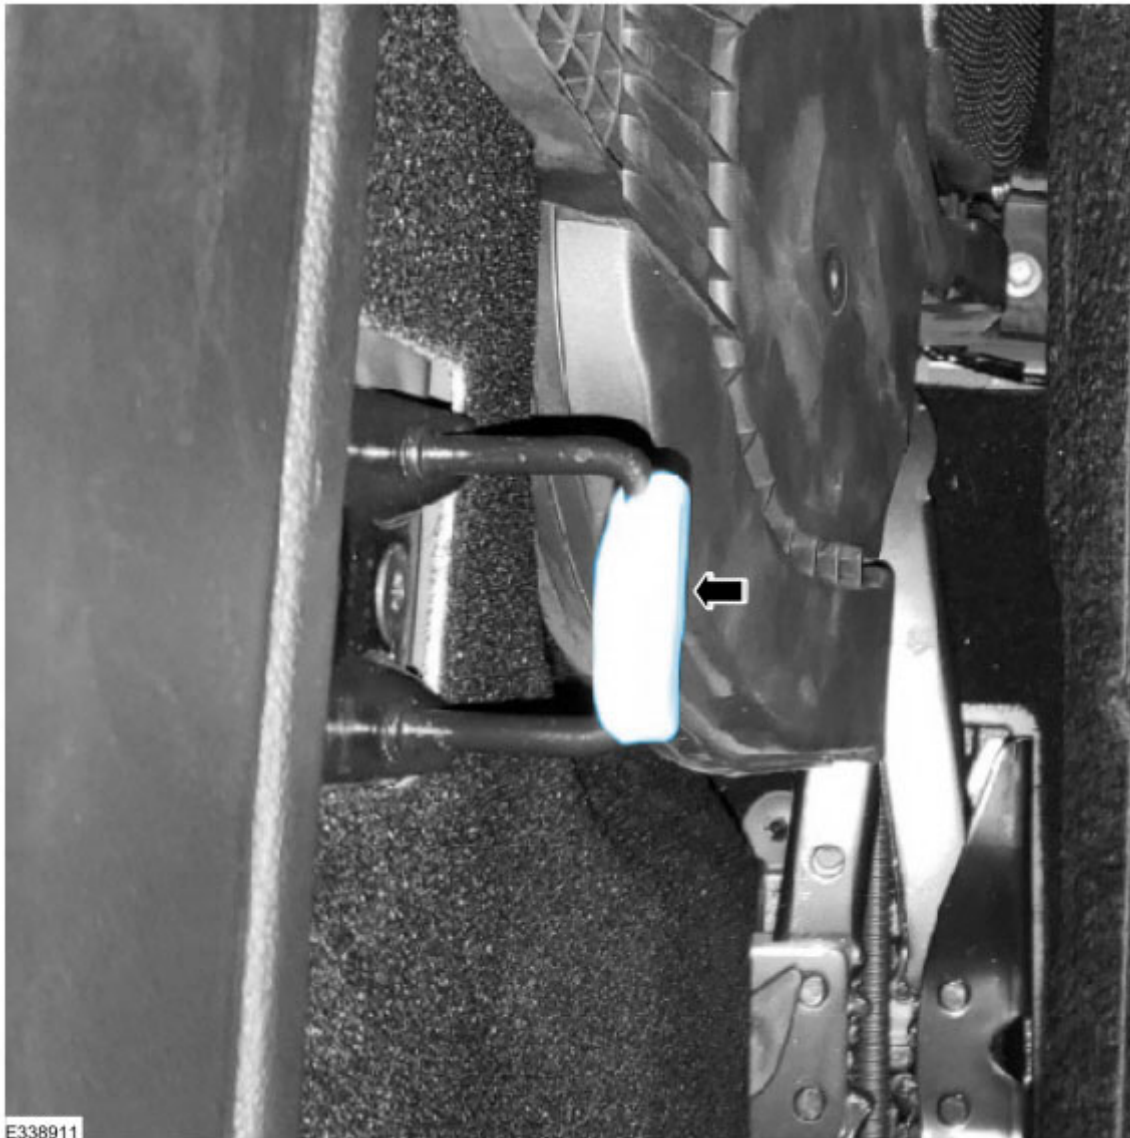
Figure 11

- 17.** Use modeling clay to measure the position of the rear seat back rest latch relative to the striker.
- (1). With the rear seat backrest assembly folded to the flat position, apply modeling clay to the width of the striker. The modeling clay should be no more than 5mm thick on the forward side of the striker. (Figure 11)
 - (2). While holding a sheet of paper over rear seat backrest bumper 'X', raise the rear seat backrest assembly until vertical.
 - (3). Allow gravity to pull the rear seat backrest assembly the rest of the way against the modeling clay while lightly tugging on the paper to confirm when the rear seat backrest bumper 'X' is against the cab. If the paper is not being held, apply very light pressure near rear seat backrest bumper 'X' until resistance can be felt when tugging on the paper.

NOTE: Applying too much pressure against the rear seat backrest may compress the rear seat backrest bumpers and give a false impression in the modeling clay.

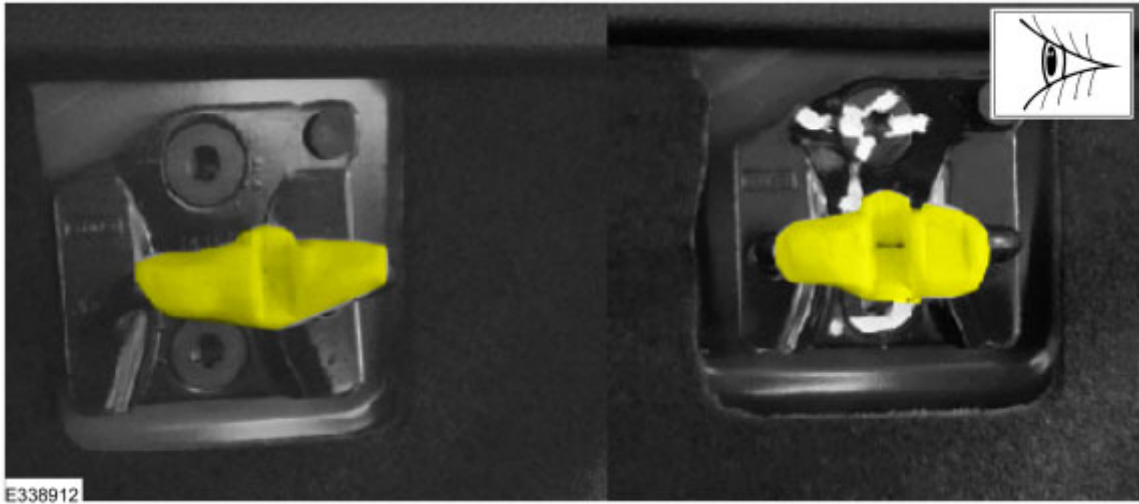
Figure 12

18. Lower the rear seat backrest assembly to the fold flat position and inspect the impression in the modeling clay left by the rear seat backrest latch. Is the striker visible through the modeling clay? (Figure 12)

(1). Yes – no adjustments to the rear seat backrest bumpers are necessary, however, material may be removed from the rubber bumpers to reduce seat latching efforts for customer preference, but removing too much material may result in rear seat backrest noise, vibration, and harshness (NVH) concerns.

(2). No – proceed to Step 19.

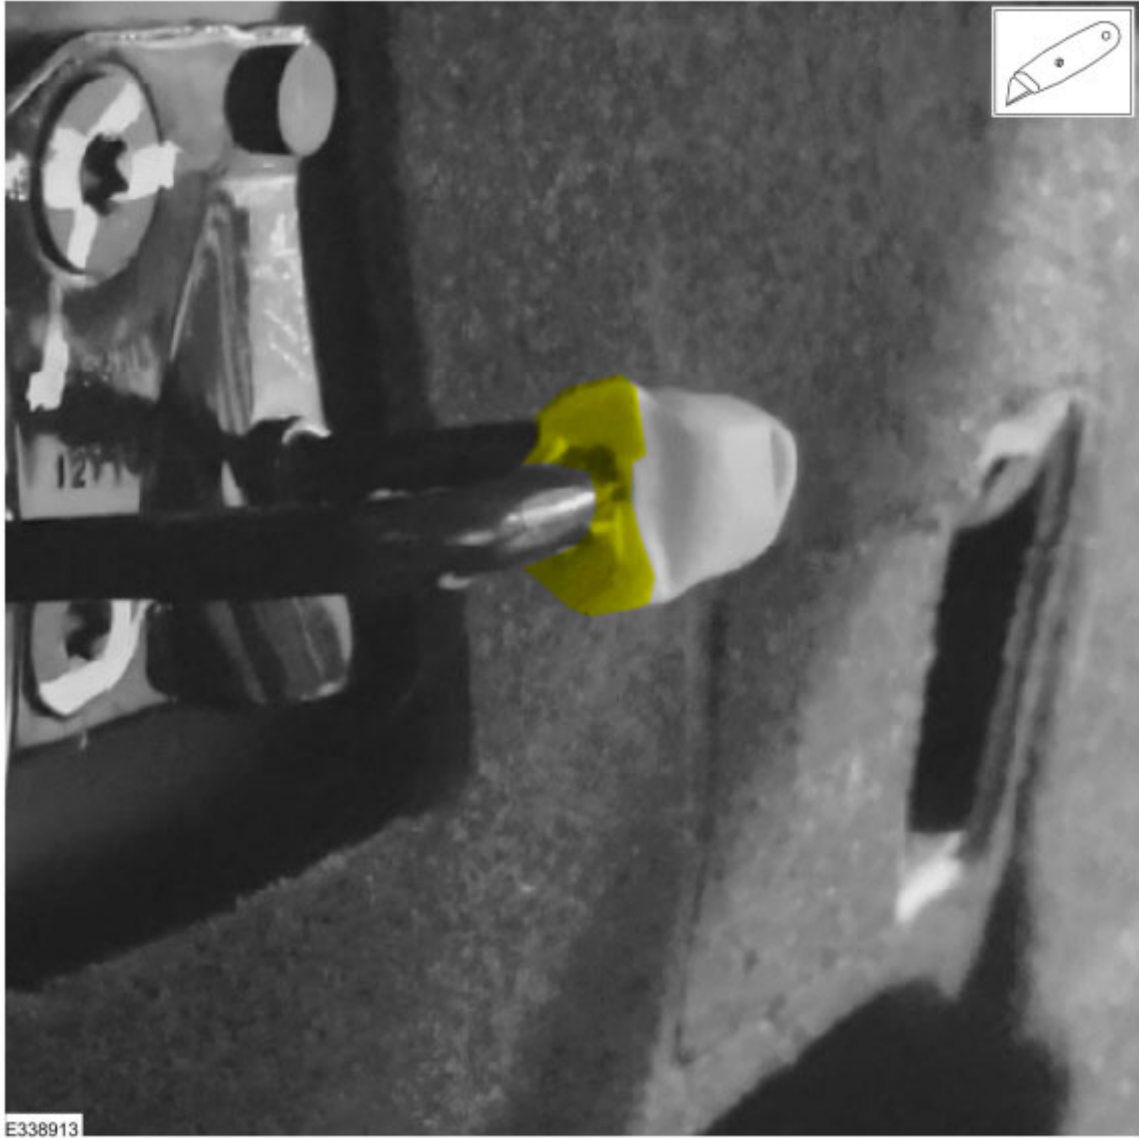
Figure 13

19. Using a knife or blade, cut away half of the modeling clay through the center of the impression to show a cross section of the impression left by the rear seat backrest latch. (Figure 13)

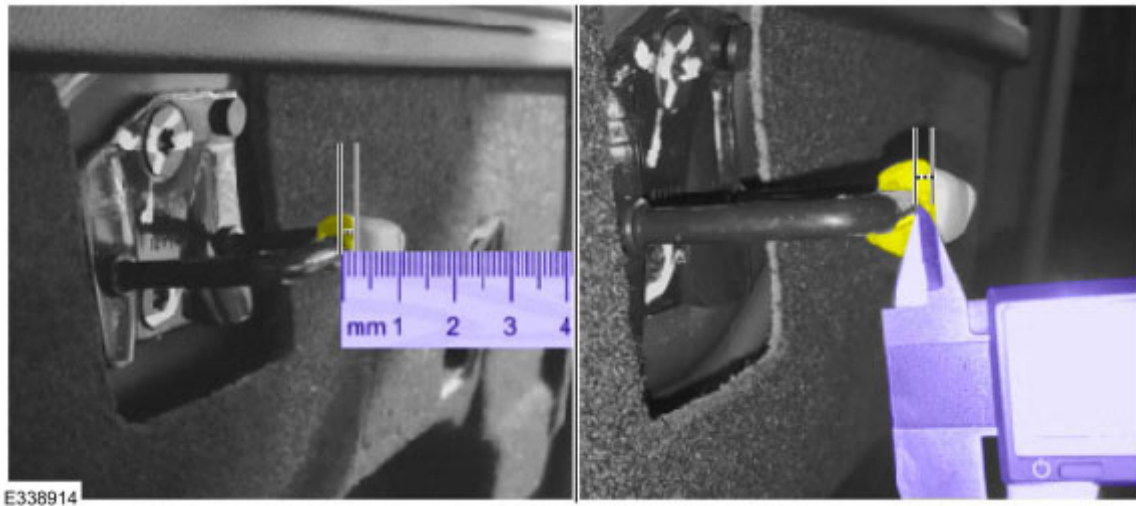
Figure 14

20. Using a ruler or dial caliper, measure the distance between the striker and the deepest part of the impression left in the modeling clay by the rear seat backrest latch. This measurement will be how much material is to be removed from each rear seat backrest bumper. (Figure 14)

21. Per the modeling clay measurement, mark the top of each rear seat backrest bumper in 4 places, 90° apart, to indicate the amount of material to be removed.

22. Using sand paper or sanding block (80 grit is preferred), remove the measured amount of material from each rear seat backrest bumper. Make sure that any shavings are cleaned prior to returning the vehicle to the customer.
