Technical Service Bulletin

PSS 90 Instrument cluster: The center display is black

90 20 72 2057082/3 September 30, 2020. Supersedes Technical Service Bulletin Group 90 number 20-60 dated July 15, 2020 for reasons listed below.

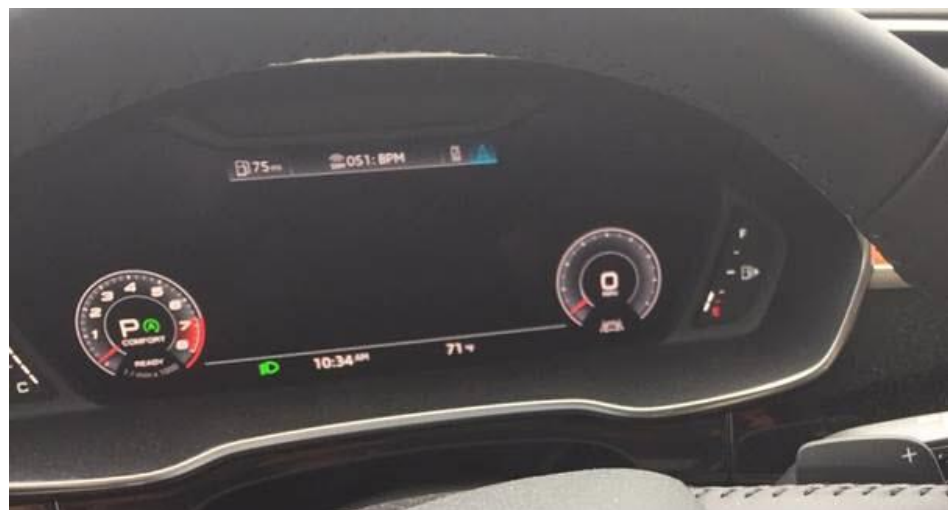
- The central display area in the Audi virtual cockpit is black and does not show the expected tab, no matter which tab is currently selected (Figure 1).
- The tachometer and speedometer remain visible and operational.

Figure 1. Central display area is blank.

A software malfunction can cause the center display to blank out.

1. Explain to the customer that a solution is forthcoming for the 4th quarter of 2020 and that no repairs are necessary at this point. Do not replace any components for this condition since this will not resolve the customer's concern.
2. Create a PSS record in the PSS application through the Pending Service Solutions (PSS) link in AccessAudi (under *Related Links >> Service*), or through the Technical Assistance page in Elsa.
