Complaint - Creases on Seat Surface/Side Bolster of Front Seat and Ridge Formation on Seat Surface of Rear Seat: Replacing Cover and Padding (119/20)

Model Line: **Cayenne (9YA/9YB)**

Model Year: **As of 2018 up to 2020**

Subject: **Front and rear seat**

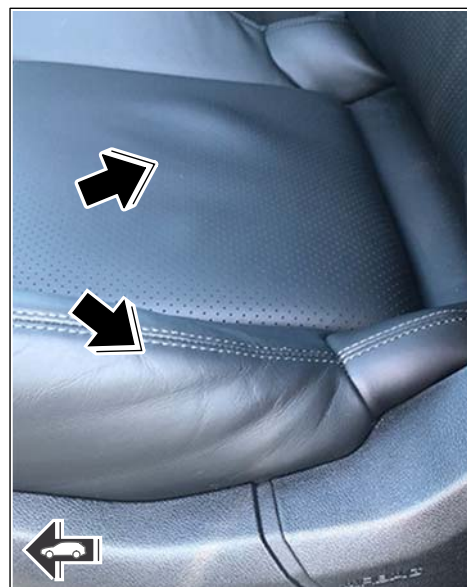
Wrinkling on front seat

Information: Leather stretching and compression in conjunction with an entry height typical for SUVs results in permanent creases in the seat covers and side bolsters of the front seats ⇒ *Wrinkling on front seat -Arrows-*.

In the event of a customer complaint and on vehicles produced before the date of introduction specified below, replace padding and seat cover, see

- ⇒ Workshop Manual '741319 Removing and installing cover for front seat'
- ⇒ Workshop Manual '741055 Replacing padding for front seat'
- ⇒ Workshop Manual '74501901 Replacing cover for rear seat (2/3-split folding rear seat)'
- ⇒ Workshop Manual '74495501 Replacing padding for rear seat surface (2/3-split folding rear seat)'
- ⇒ Workshop Manual '74501902 Removing and installing cover for rear seat (1/3-split folding rear seat)'
- ⇒ Workshop Manual '74495502 Replacing padding for rear seat surface (1/3-split folding rear seat)'
