TECHNICAL TOPICS

BODY/CHASSIS

Brake Cyclical Noise / Judder 19" Brakes Only	20MY Defender
<p>Customer Voice:</p> <ul style="list-style-type: none"> Customers may report a thumping or judder type noise while braking. <p>Technical Description:</p> <ul style="list-style-type: none"> Brake disc are being supplied with a finish is coarser than design intent. This coarse finish when accompanied with the NAO pad designed for this vehicle creates an uneven pad film build-up on the disc braking surface under heavy braking before the brake pads are fully bedded in. This does not affect braking performance but does create a noise / vibration concern. <p>Status:</p> <ul style="list-style-type: none"> SSM 74874 has been published to address this concern providing procedures to clean and dress the disc surface along with a specific bed-in. The brake disc supplier Brembo, has corrected a tooling issue that has led to the concern in production. Vehicles in plant built before the revised disc finish introduction are having the disc finish reworked in plant.

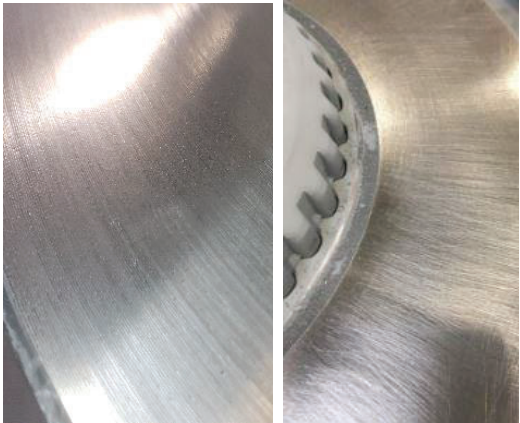
<p style="text-align: center;"> Before After </p>

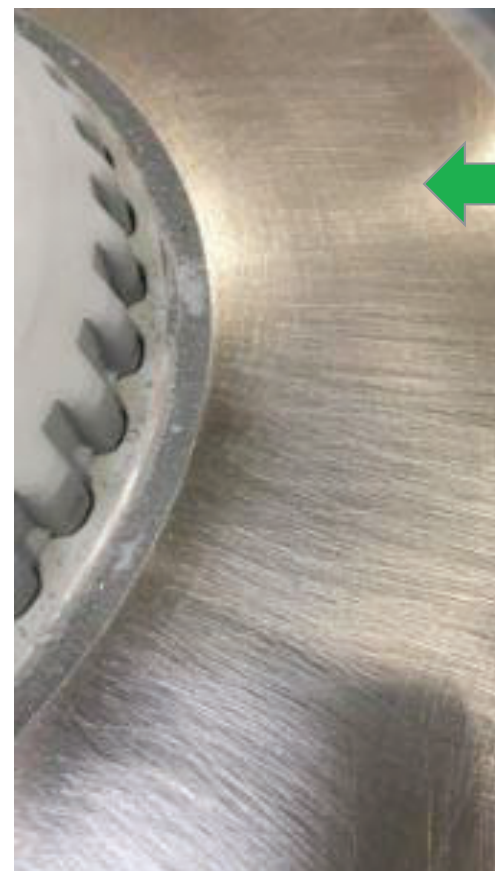
Correct
Disc
Finish

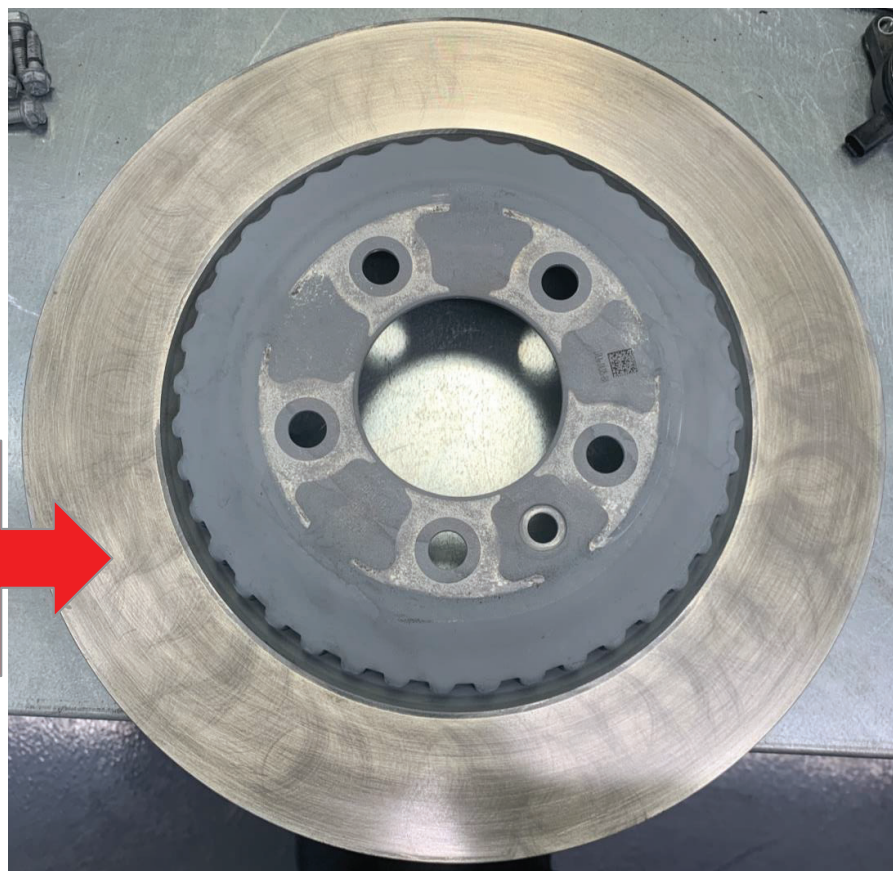
Incorrect
Disc
Refinish
Attempt
