SIB 51 24 20

SERVICE ACTION: RENEW INTERIOR MIRROR HOLDER

E-Series	Model Description	Production Date
I01	i3	July 8, 2020-August 6, 2020

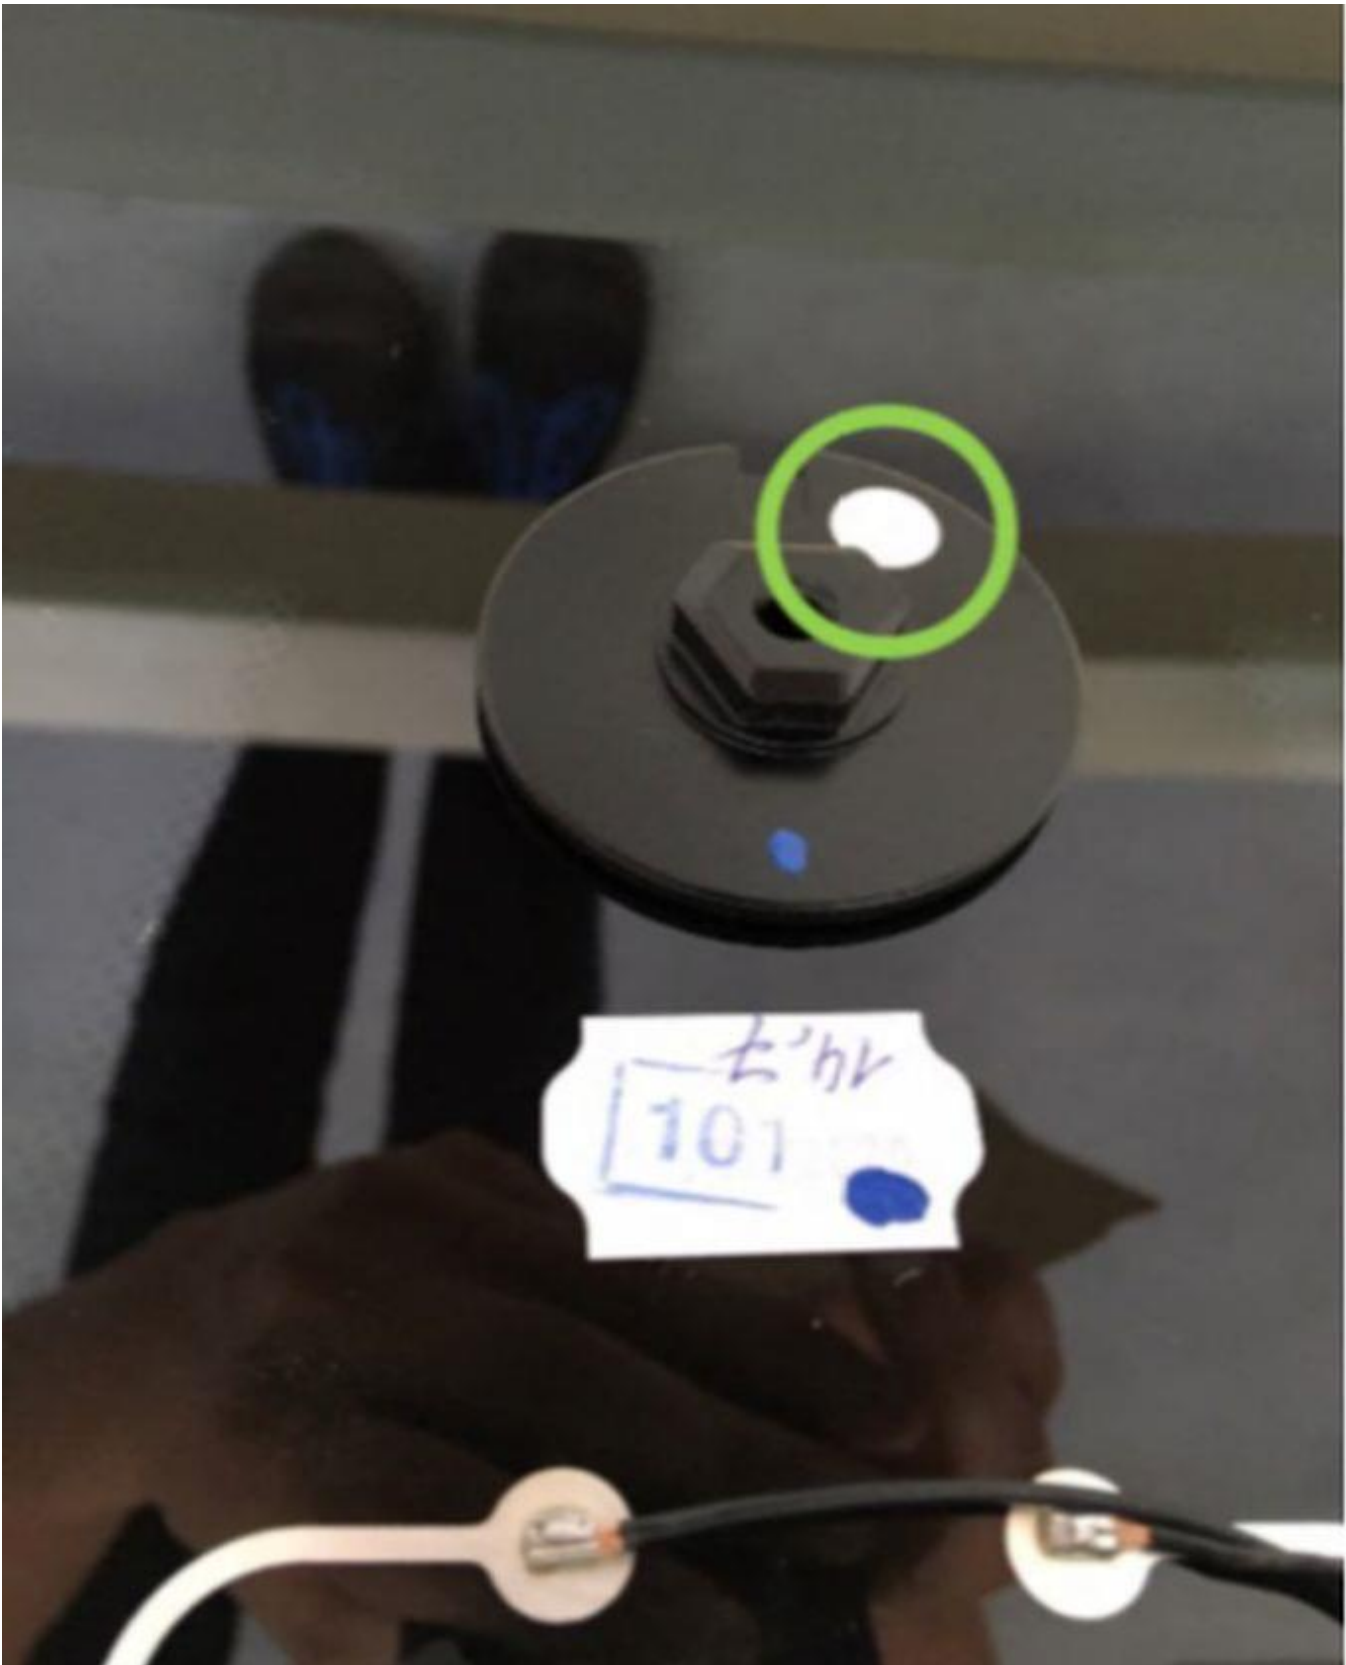
Check whether the mirror base is marked with a white dot as shown below:

2. Is the white dot present?

Yes: No further correction required. The mirror holder was correctly installed. Reassemble vehicle.

No: The vehicle will require additional repair. This bulletin will be updated when repair parts are available.
