SIB 61 02 20

SERVICE ACTION: WIRING HARNESS ABRASION PROTECTION

2020-09-09

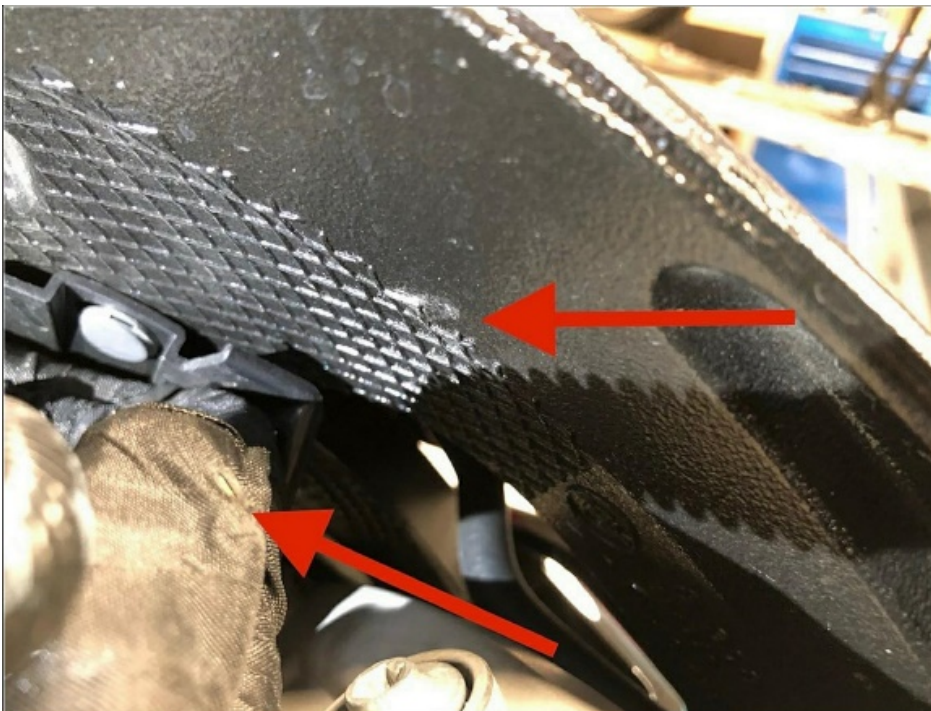
The engine wiring harness may chafe on the honeycomb structure of the frame. In case of damage to the wiring harness, the wake-up line of the instrument cluster will be damaged. The instrument cluster will no longer be activated with "Ignition ON".

Inspect the wiring harness for damage and install wiring protection as detailed in the enclosed Repair Instruction "00 60 358 - Retrofitting abrasion protection for wiring harness".
