STAR ONLINE PUBLICATION

Case Number: S1823000056 Rev D

Symptom/Vehicle Issue: Tailgate Ajar Indicator Light Is On And Or High Effort Required To Close And Latch The Tailgate

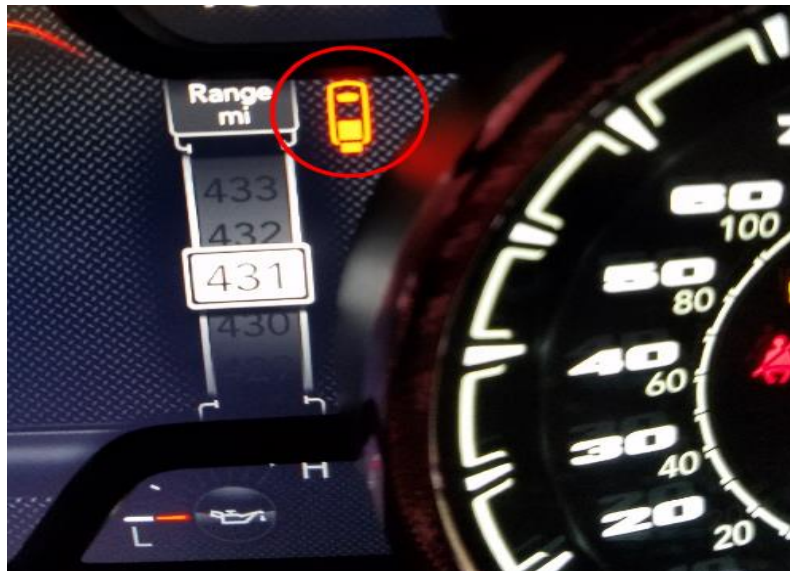
Closing effort can be caused by a striker setting or flush mismatch between the Tailgate and the Tailgate opening of the pickup box when the striker / latch is improperly adjusted. The striker / latch may require adjustment to optimize flush appearance and closing effort. Improperly adjusted latches may cause one latch to not

fully engage unless the Tailgate is slammed shut. The ajar switch is on the right side tail gate latch only. Verify the customers concern by using the following procedure:

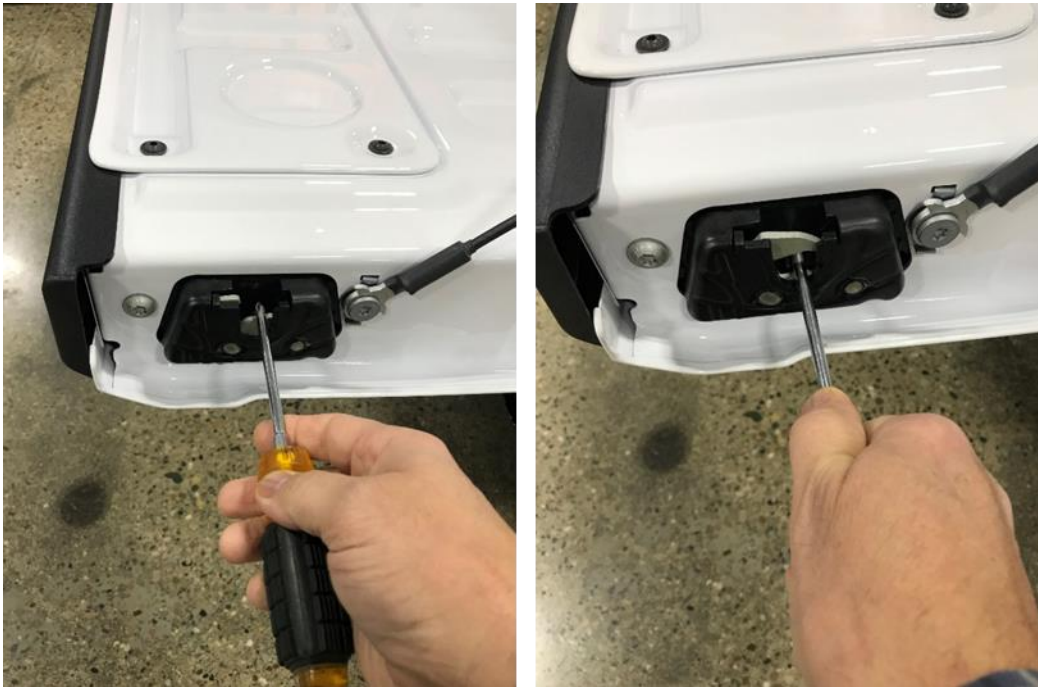
Fig 2 closing latch

1 - Confirm latch function -

- With tailgate open, using screwdriver actuate the latch(s) (Figures 2).
- If tail gate ajar light on dash turns off DO NOT replace latch.
- If the ajar light does not turn off check electrical connection and re-test.
- If electrical connection is good and latch ajar still does not turn off, then replace right side latch.

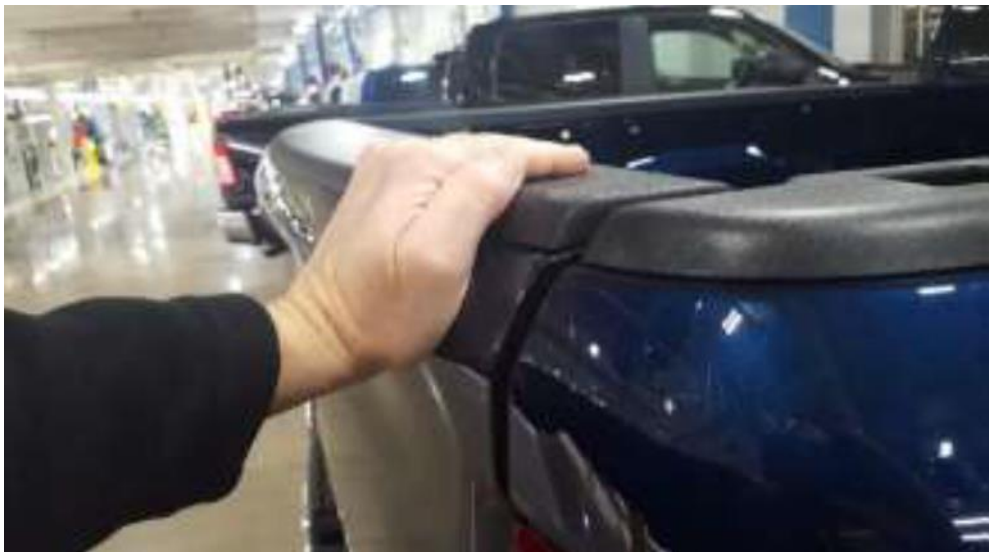
Fig 4. Over flush tail gate

- Assess flush condition of tailgate to box on both sides. (Figure 4)
- Make sure up / down position of both strikers hits the center of the latch opening. This can be seen visually by bringing the tailgate up to the striker on each side. A striker binding on the top or bottom latch opening can bind and prevent it from opening. Adjust each striker up/down if required to center it to the latch.
- With a China marker or grease pen mark striker location.
- Adjust right side striker aft such that both latches engage when pushing on tailgate from the center.
- If the latches are not latching simultaneously then the left side striker may need to be moved forward to reduce the closing effort.
- Secure the striker to the torque specified in Tech Connect. 35NM 26FtLbs.

Please note: The goal of this repair is to minimize the force required to fully latch the tailgate. One side of the tailgate may be slightly under flush relative to the other side but within specification.
