Service Bulletin

Bulletin No.: 19-NA-157

Subject: Brake Fluid Leak at Caliper, Cracking, Reduced Brake Performance, Rub or Grind Noise, Caliper Paint Appearance

Brand:	Model:	Model Year:		VIN:		Engine:	Transmission:
		from	to	from	to		
Chevrolet	Camaro	2016	2021	—	—	All	All

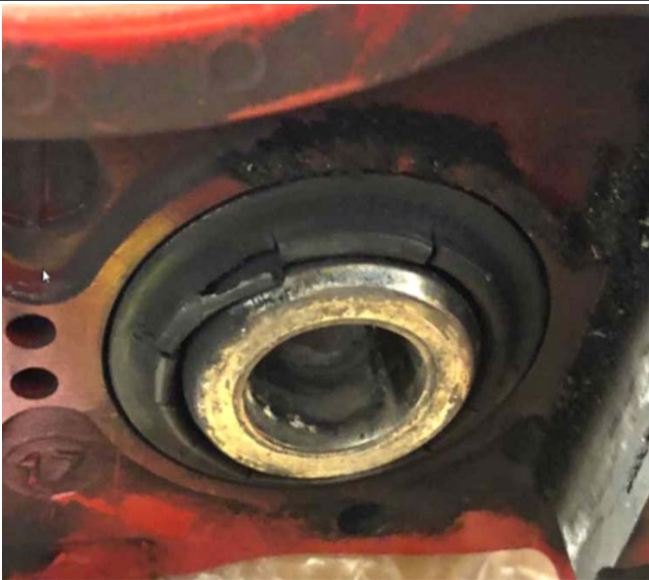
<p>5338372</p> <p>Note: For vehicles that are frequently used for track events, changing the caliper boots should be part of maintaining the vehicle.</p> <p>The cause of the condition may be the caliper boots are heat checked/cracked, allowing brake fluid to leak. Heat checking will occur when the caliper has been exposed to intense heat created while braking. An example of this damage is shown in the graphic above.</p>
Correction	<p>Important: Caliper boot kits are available through CCA service parts and should be used to service the calipers. DO NOT replace calipers for this concern.</p> <p>Inspect the caliper boots for cracking, and replace as necessary. Refer to the appropriate <i>Front or Rear Brake Caliper Overhaul</i> in SI.</p>
