October 23, 2020

Version 1

2018 Civic: Bluetooth® HandsFreeLink® Freezes After Calls: Voice Tags Are Missing at Startup

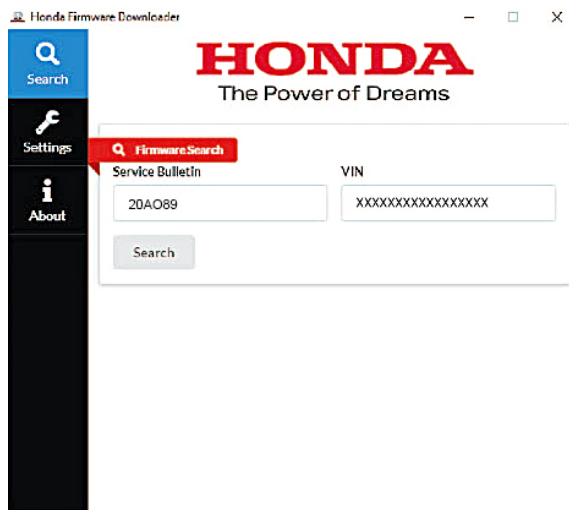
For 2018 Civic **4-Door**, enter **20A089** in the Service Bulletin field.

For 2018 Civic **2-Door**, enter **20B089** in the Service Bulletin field.

For 2018 Civic **5-Door**, enter **20C089** in the Service Bulletin field.

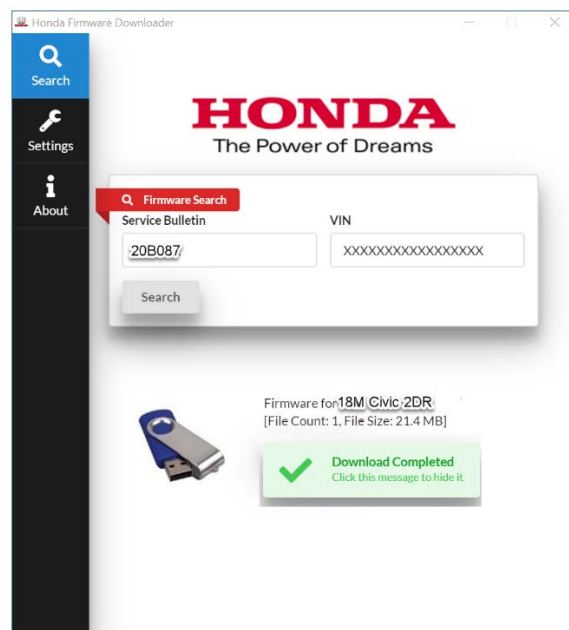
The software download may take up to **10-15 minutes**, depending on the size of the file.

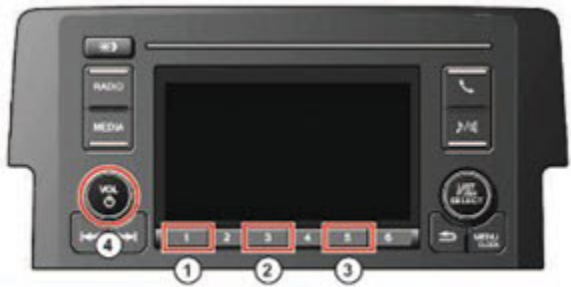
6. With the audio unit OFF, press and hold the buttons in sequential order as shown.

This will let you view the **Version display** screen.

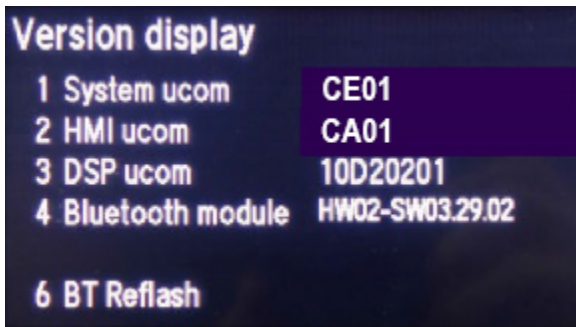
The image below is an example.

If any of the software versions do not match the ones listed in the table below, do not update the audio unit because you can damage it.

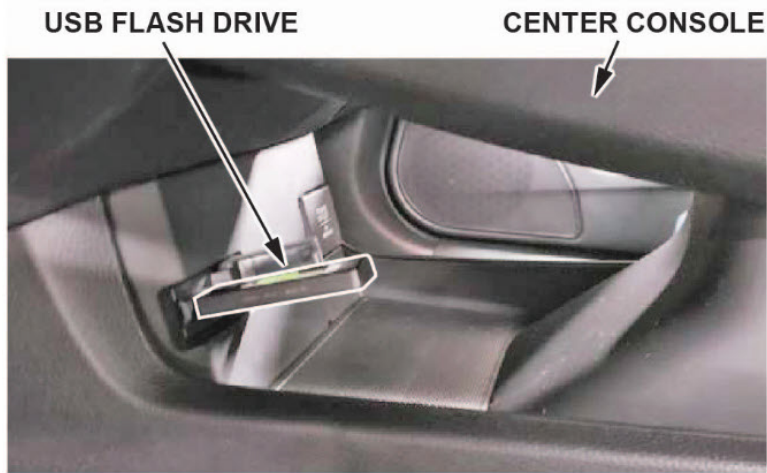
9. Plug the USB flash drive into the USB port to start updating the audio unit.

The audio unit will automatically detect the USB flash drive and start the update process.

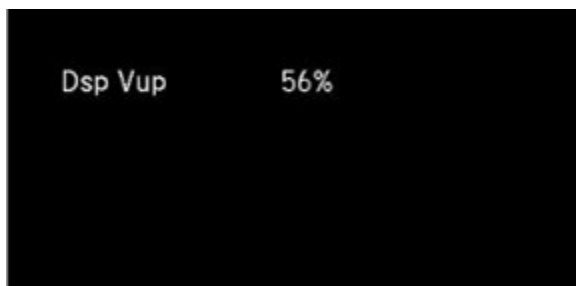
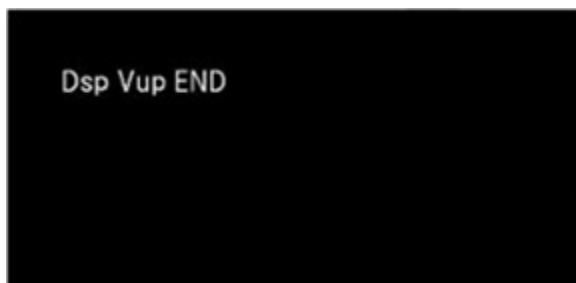
- Dsp Vup

You will see the following screens as the update runs.

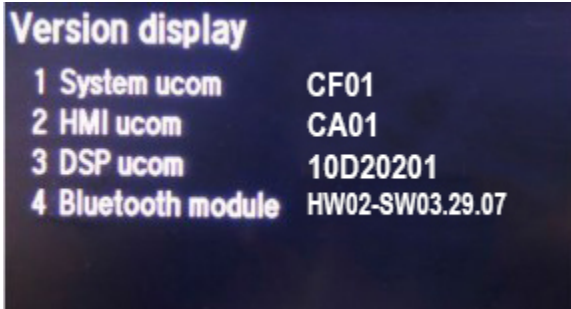
1. With the audio unit turned OFF, press and hold the buttons in sequential order as shown. This will let you view the **Version display** screen and verify the software version was updated.

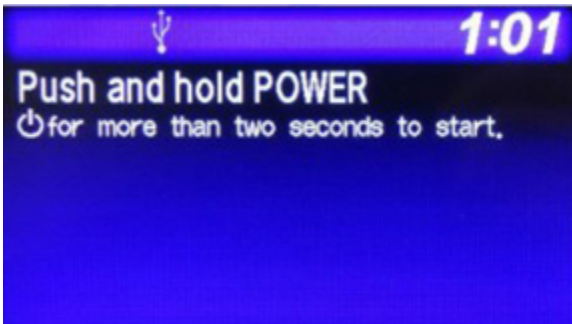
2. Press the VOL/Power button to exit the **Version display** screen.
3. Remove the USB flash drive.
4. Press and hold the VOL/Power button to sync the security code.
