A-Frame Additional Support

Bulletin Type:	Technical Service Bulletin TSB	Publication Date:	10/30/2020
Bulletin #:	20-026	Make(s):	Jayco TT
Job Code:	9801522	Model(s):	Eagle HT
Flat Rate:	1 Hour	Model Year(s):	2021

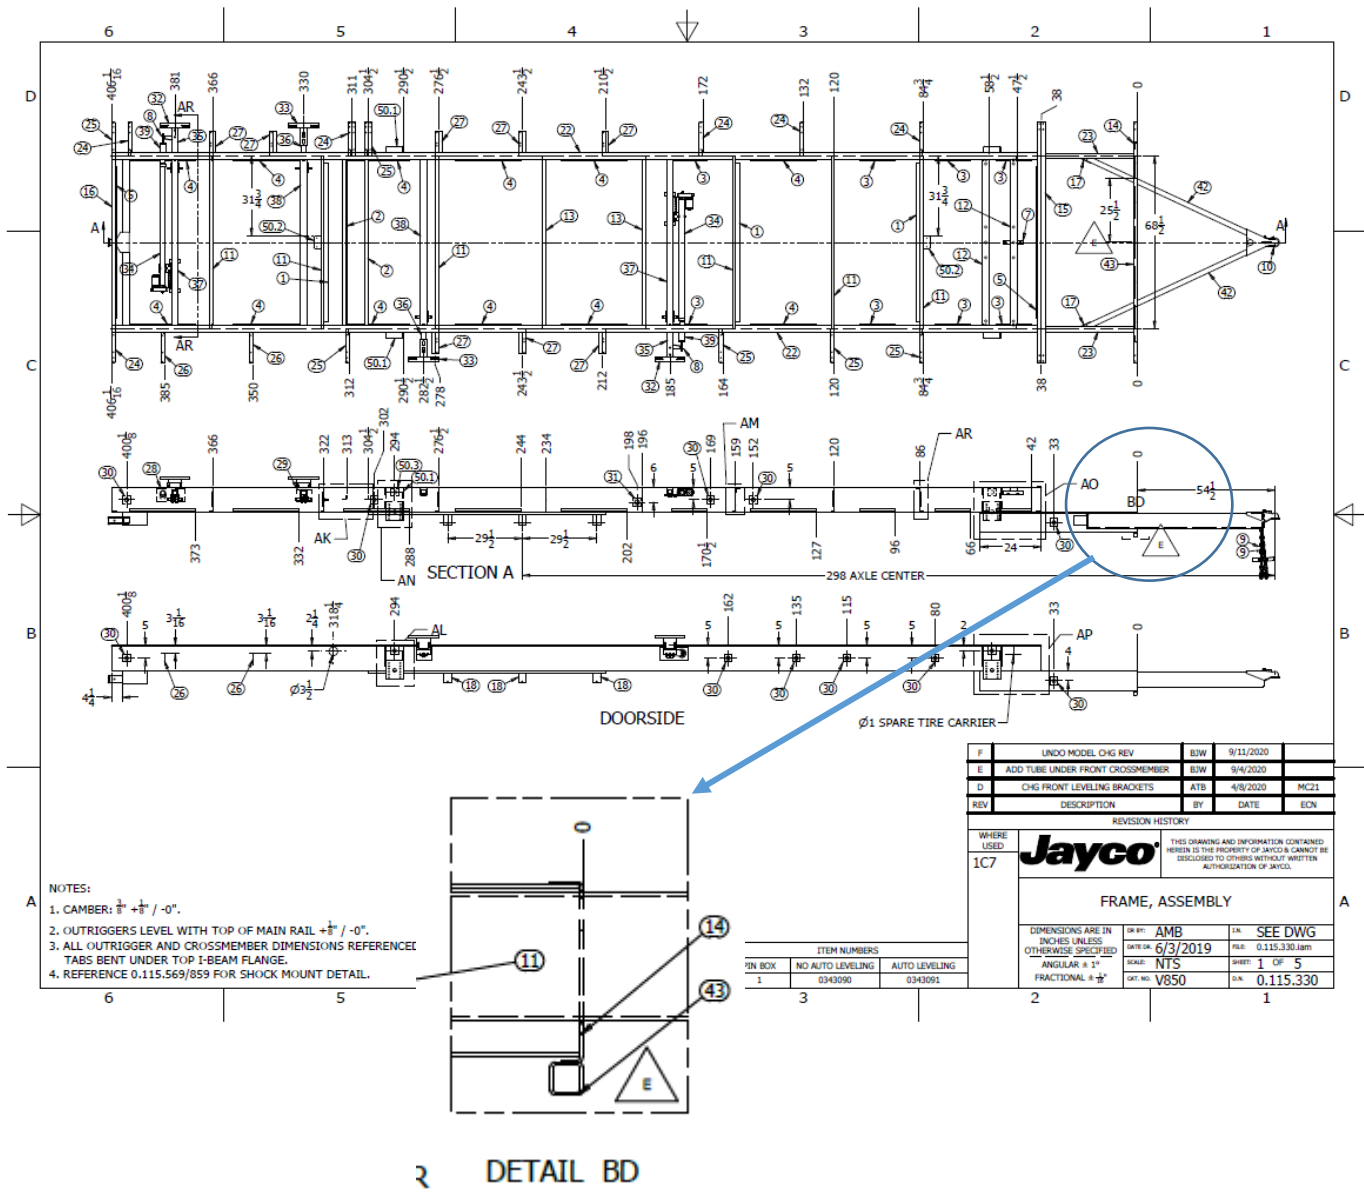
Incident:	When towing the trailer, the A-Frame may flex causing some distortion on the front cross-member.
Affected Units:	M1C2 0051-0074 M1C4 0051-0068 M1C7 0051-0074 M1C8 0051-0063
Parts:	Kit #: 20-026JT Contents: 1 ½" x 1 ½" x 51" square steel tube (11-12gauge) Supplier notes 1-3 day lead-time.
Misc. Tools & Supplies:	C-Clamps & Tape Measure Metal Saw & Steel Welder Wire Brush & Spray Paint (Black Rustoleum or Equivalent)

- Step 1: Center the 1 ½" Sq. Tube x 51" long (Item 47) below the front cross member (Item 15) and clamp into position as shown in Detail BD as shown in the attached frame drawings.
- Step 2: Weld Tube in position with 3" of weld spaced at 8" on center. Once one side is complete, weld the opposite side. See detail BD shown in the attached drawings.
- Step 3: Remove clamps and brush welded surfaces to remove any slag.
- Step 4: Touch up Paint with Rustoleum (or Equivalent).
