TECHNICAL TOPICS

Idle Surge with PCM Software Up to Date

19/20 MY Range Rover, RR Sport, Defender equipped with AJ20P6

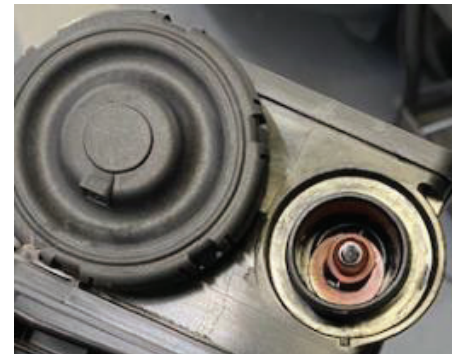
- Throttle and MAF PIDs show a metered air leak.

- Confirm the complaint and check the DIDs for Mass Air Flow and Throttle angle.
- If the engine is idling and the throttle angle is 0 degrees, this is a good indication that there is an air leak.
- Confirmation of elevated MAF readings show the air leak is metered.
- Remove the PCV tube from the intake tube and block the fitting.
- If values return to normal, inspect the PCV oil separator housing.
- Should a non-sealing gasket be identified, replace the PCV housing and raise an EPQR so the part can be returned for analysis.
