# Preliminary Information

## PIP5684C GE-52250 Power Smoke Diagnostic Leak Detector Turbocharger Charge Air And Induction System Tester MIL Reduced Engine Power

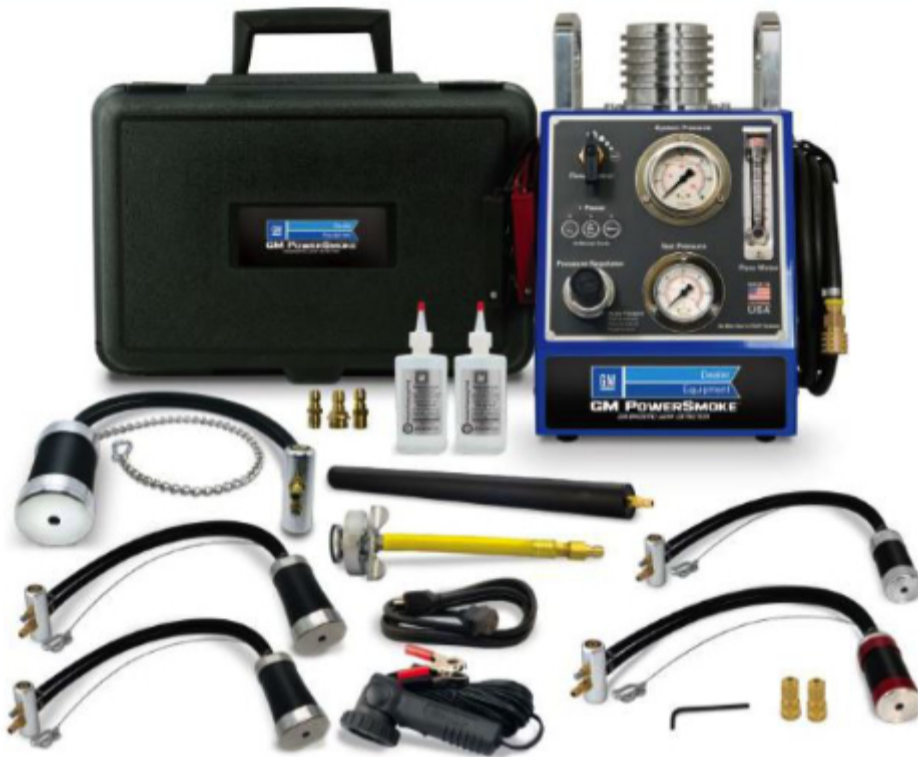
GE-52250 is shown below.

Note: The adapters may vary as the tool evolves.

The technician should follow SI diagnostics. If no cause for the concern is found or during diagnosis a leak check is required, power smoke diagnostic leak detector GE-52250 can be very helpful in locating leaks.

**NOTE: Do not use GE-52250 to diagnose EVAP system leaks due to the high pressure output this tool produces.**
