## STAR ONLINE PUBLICATION

**Case Number:** S2008000163

**Symptom/Vehicle Issue:** CEL (Check Engine Light) Came On After Start-Up

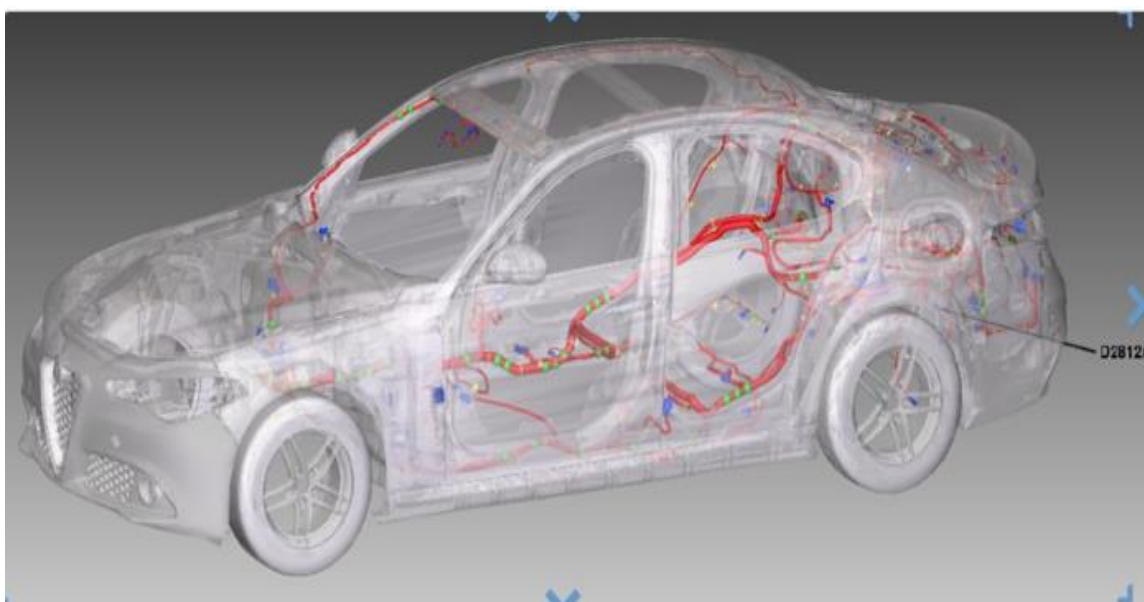
Fig 1

**Customer Complaint/ Technician Observation:** Owners complains that the check engine lamp came on after starting the vehicle. Technician observed the vehicle had been in for recent repair service and or was a low mileage vehicle, DTC P0440 Evaporative Emission System and/or P0456 EVAP Small Leak Detection as stored as active.

**Discussion:** Inspect the location of the ESIM connector D2812A at the ESIM to ensure all component connectors are fastened securely Fig 1, 2.
