Service Bulletin

Bulletin No.: 19-NA-007

Subject: Water Rush or Gurgle Noise from Heater Core

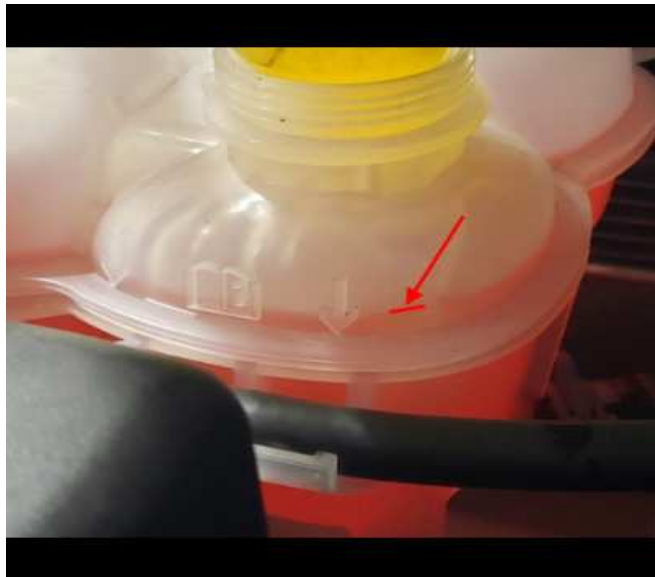
5660996

Note: When filling coolant after tank replacement or if noise is heard with new tank, it is necessary to fill 150 ml over factory fill. New coolant level is indicated by the red arrow as shown in the graphic above.

Refer to Radiator Surge Tank Replacement in SI.
