# Service Bulletin

Bulletin No.: 19-NA-126

**Subject: Emergency Trunk Release Key Will Not Turn, Unable to Open Trunk from Lock Cylinder Behind Rear Seat Back, Information on Convertible Key Extender**

Brand:	Model:	Model Year:		VIN:		Engine:	Transmission:
		from	to	from	to		
Chevrolet	Camaro - Convertible	2016	2021	—	—	All	All

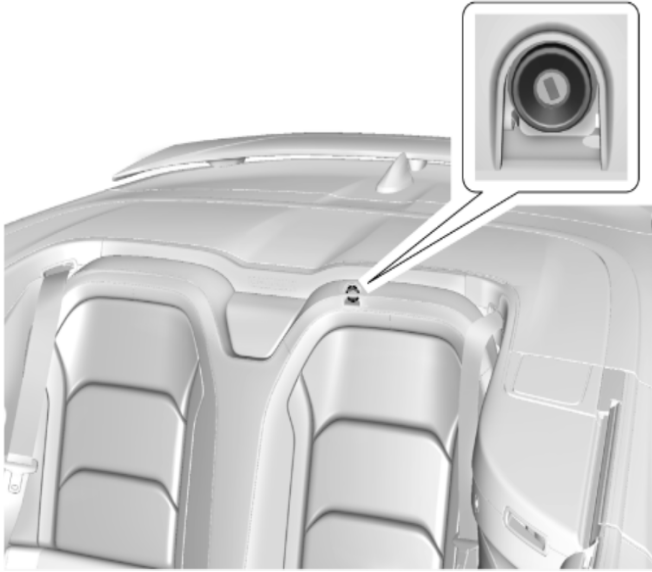
<p style="text-align: right; font-size: small;">5338393</p> <p>Some customers may comment that they have difficulty turning the key in the emergency trunk release cylinder, located behind the upper, center of the rear seatback cushion.</p>

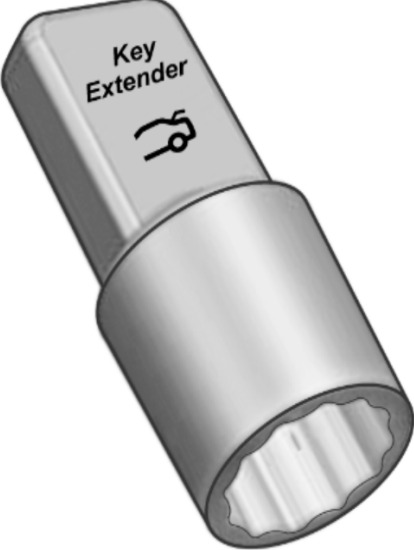
<p style="text-align: right;">5338396</p> <p>All convertibles come with a key extender packaged in with the loose shipped items from the assembly plant. The key extender should be placed in the glove box at the time of Pre-Delivery Inspection (PDI).</p>
<p><b>Correction</b></p>	<p><b>Caution:</b> Failure to use the key extender could cause the key to twist and break in the cylinder.</p> <p>The key extender should be used when opening the trunk, from the lock cylinder located behind the rear seat back cushion.</p> <p>Additional information regarding the proper usage of the key extender can be found in the <b>Emergency Trunk Release (Convertible Only)</b> section of <i>Trunk</i> in the Owner Manual.</p>
