GROUP <b>General</b>	MODEL ~2020MY Telluride (ON) 2021MY Sorento (MQ4a, MQ4 KH)
	NUMBER <b>PS656 (Rev 1, 11/20/2020)</b>	DATE <b>March 2020</b>

# REAR OCCUPANT ALERT (ROA) WITH ULTRASONIC OPERATION

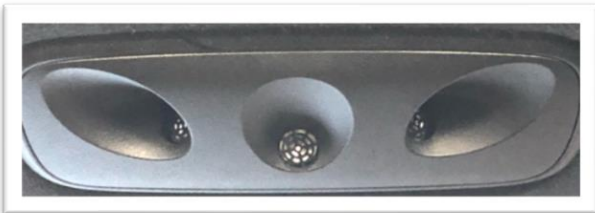
To deactivate or activate the ROA from the 'User Settings Mode' in the instrument cluster or in the Navigation Audio Head Unit.

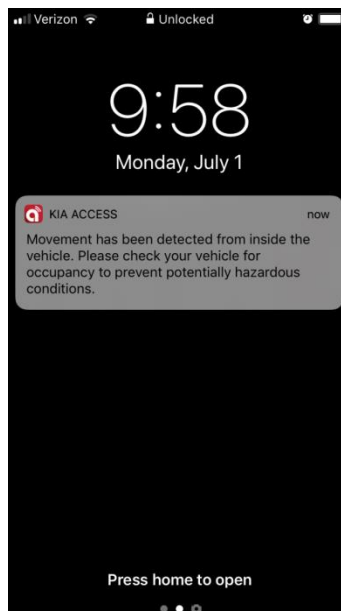
If the customer's Kia Access with UVO Link account is activated and notifications are enabled, they will receive the following phone notification when ROA is triggered.
