# PREVOST PRODUCT CHANGE NOTICE

## MP-1000 OBSOLESCENCE

ECN :2019152 rev:

**DESCRIPTION:** Replacement of the MP-1000 Safety Messaging player from REI with the new MP-1200HD

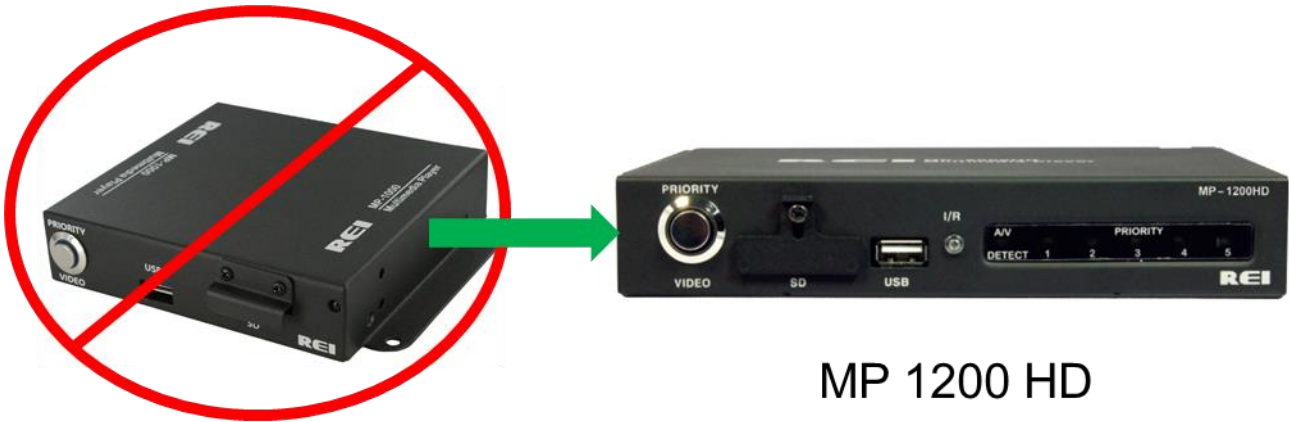
- New part number #901809 , The MP-1200 can be mounted in the same holes as the MP-1000 by installing the brackets from the interior.  
The MP-1200 is wider and use a different cable.
