Subarunet Announcement

New STOP SALE/Safety Recall: WRG-20 Continental Tire Recall 20T-018

WRG-20 SERVICE PROCEDURE

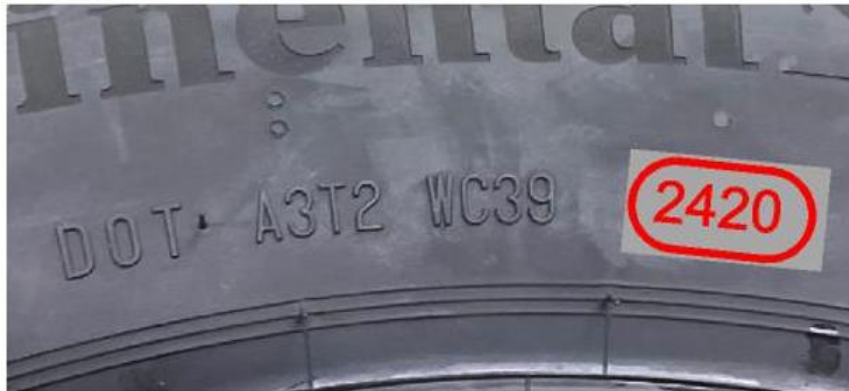
Tires made for use in the United States are required to have the **DOT Serial Number** with production week and year on **ONE** sidewall of the tire near the wheel. The photo below shows **2420** meaning the tire was manufactured during the 24th week of 2020.

- The **DOT Serial Number** for tires affected by WRG-20 is **2420**. If the DOT Serial Number is not found, check the opposite side of the tire as they are only found on **ONE** sidewall.

VERY IMPORTANT: When performing these inspections, **BOTH** the DOT Serial Number and the Mold Number (circled in **RED, Highlighted and In Parentheses**) must match those provided above. If only one of the 2 numbers match, the tire(s) is not affected.
