# Technical Service Bulletin

## 46 Brake pad wear indicator is on in the instrument cluster

46 20 18 2061403/1 November 17, 2020.

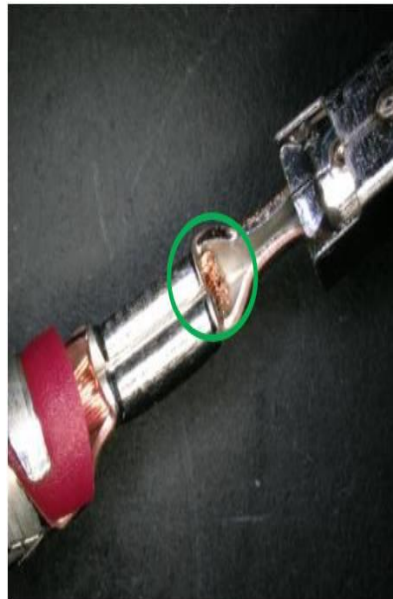
2. Ensure the strands of the wire are protruding past the crimp sleeve (Figure 1).

*Figure 1. Properly crimped wire.*

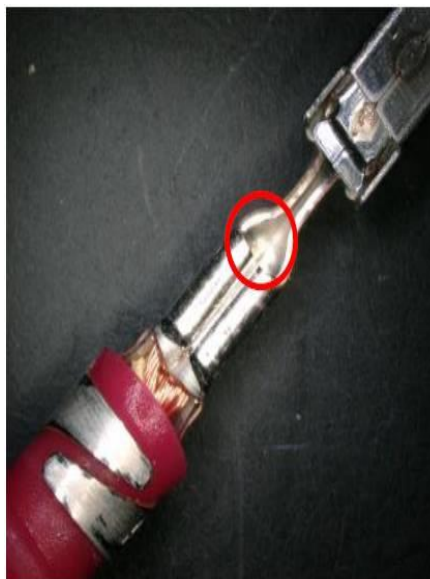
The brake pad wear sensor wire may not be properly crimped to the pin of the sensor connector.

**Figure 2.** Improperly crimped wire.

3. If the wire is found to be improperly crimped, then replace the affected harness for the front speed sensor and brake pad wear indicator (Figure 2).

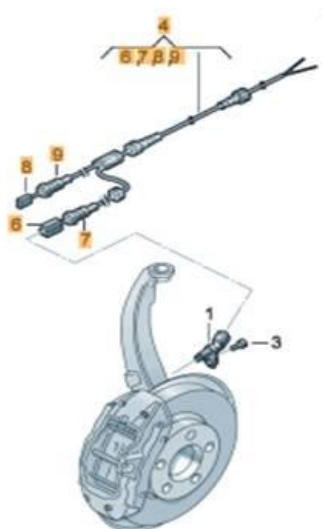
4. ETKA illustration 927-010 can be used to determine the harness needed (Figure 3).

**Figure 3.** ETKA image of harness.
