WLA5 - Replacing Rear Axle Differential (Workshop campaign)

Vehicle type: **Cayenne (9YAAE1)/Cayenne S (9YAAM1)/Cayenne Turbo (9YACF1)**

Subject: **Rear axle differential**

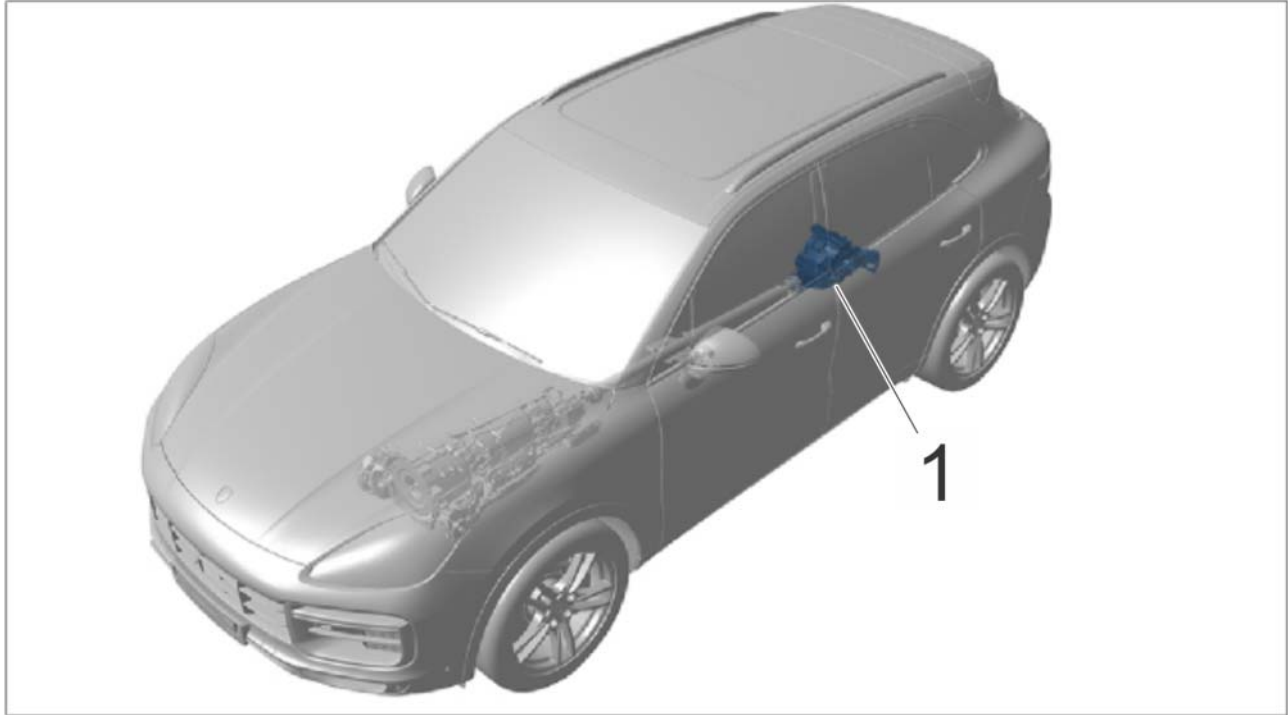
Installation position of rear axle differential

1 – Rear axle differential (**replace**)

Remedial Action: Replace rear axle differential.
