Technical Service Bulletin

SUBJECT:			No: TSB-20-15-002
ABNORMAL NOISE FROM EXHAUST HANGER			DATE: November 2020
			MODEL: 2014-20 Mirage, Mirage G4,
CIRCULATE TO:	<input type="checkbox"/> GENERAL MANAGER	<input checked="" type="checkbox"/> PARTS MANAGER	<input checked="" type="checkbox"/> TECHNICIAN
<input checked="" type="checkbox"/> SERVICE ADVISOR	<input checked="" type="checkbox"/> SERVICE MANAGER	<input checked="" type="checkbox"/> WARRANTY PROCESSOR	<input type="checkbox"/> SALES MANAGER

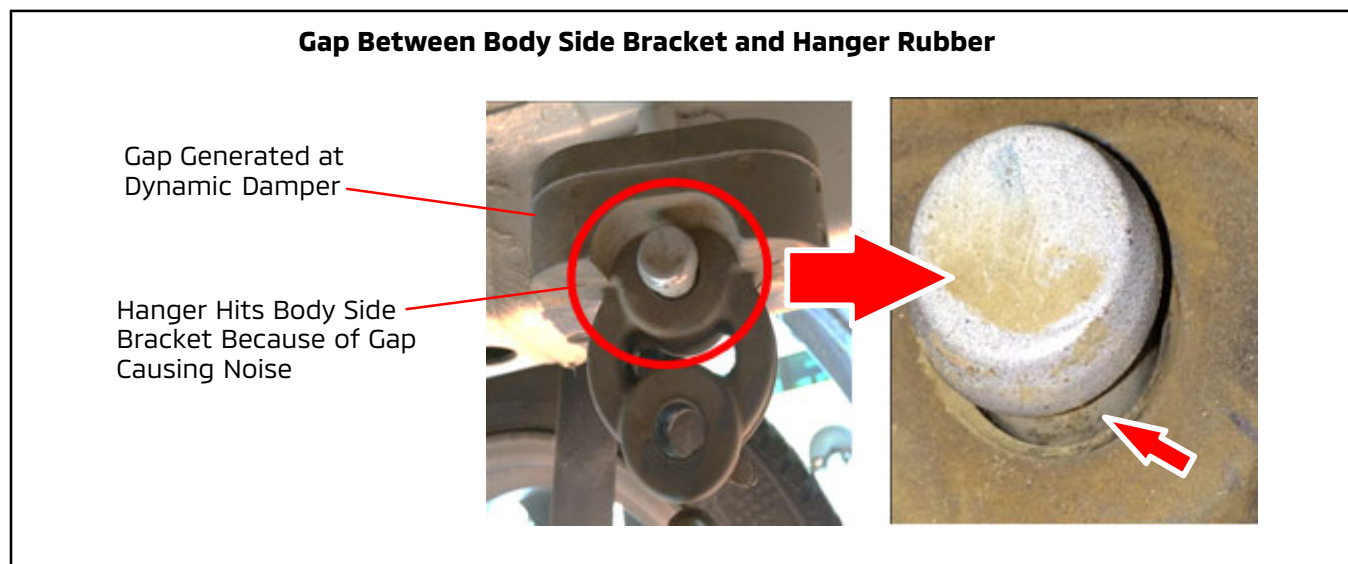
A customer may complain of an abnormal noise coming from the exhaust area while driving. This may occur due to vibration between the exhaust hanger and body side bracket. As the vibration intensifies, the gap at the damper increases in size and the hanger hits the bracket creating an abnormal noise.

This TSB instructs dealers to replace the two identified hanger rubber parts with new parts.

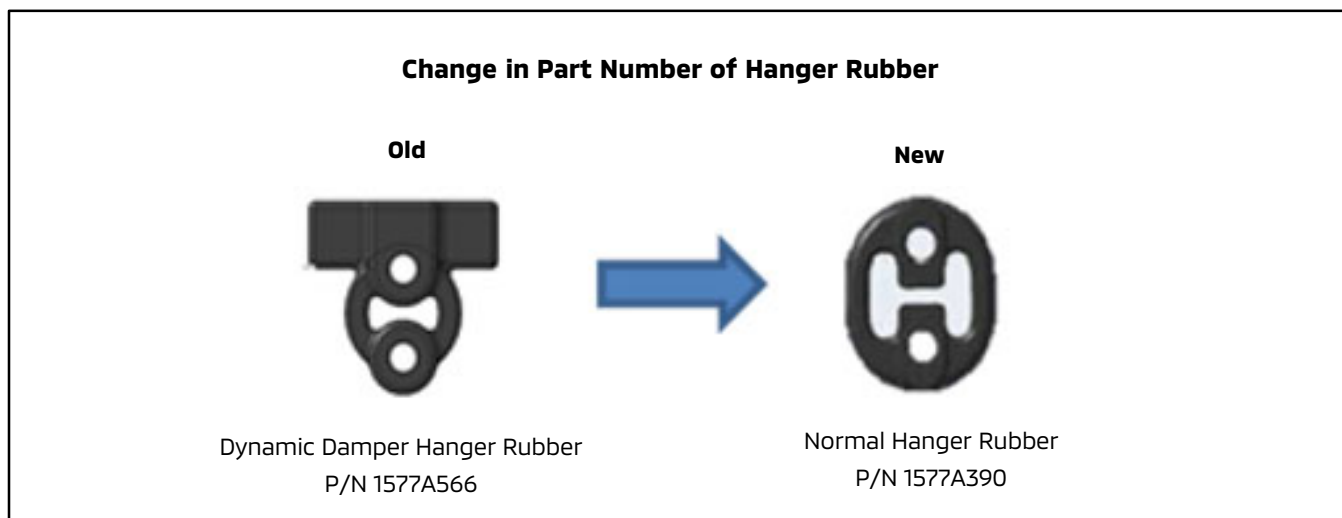
Replace the Exhaust Muffler Hanger with the new part number 1577A390 at position 2 and 3 as shown below.
