RAV4 HV – REFUELING PERFORMANCE 20TE04 & 20TE05 Quick Reference Guide

CSP 20TE04 Coverage - Fuel Tank & Fuel Sender Gauge

CSP 20TE05 Coverage - Fuel Sender Gauge*

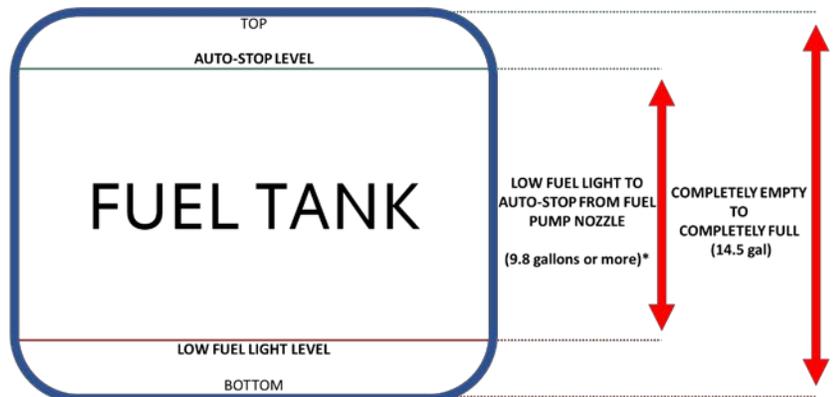
Refueling from Low Fuel Light to Auto Stop (Normal Operation)

(*) The refueling amount from low fuel light to auto-stop depends on a number of factors including normal fuel tank production variation, temperature, gas station pump variations, distance travelled since low fuel light illumination and other factors.

Note: Diagram is referenced in Owner Letter. Reference the FAQ within the Dealer Package on TIS: [20TE04](#) or [20TE05](#)
