| | GROUP | MODEL | | | | |
|---|---|---|--|--|--|--|
| | 218 | December 2020 | | | | |
| TECHNICAL SERVICE BULLETIN | | | | | | |
| CLOCKSPRING REPLACEMENT FOR | | | | | | |
| AIRBAG WARNING LIGHT ON – DTC B1346/B1481 | | | | | | |

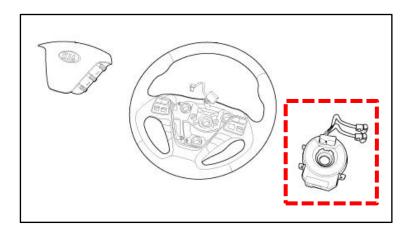
This bulletin provides information related to the replacement of the driver's airbag clock spring assembly on some 2012-2013MY Rio (UB) and 2014-2015MY Forte/Koup (YD) associated with the Warranty Extension Program (WTY017). If the Airbag Warning Light is ON with any of the DTC's below, follow the procedure outlined in this bulletin to resolve the issue.

B1346 - Driver Air Bag Resistance Too High (1st Stage) **B1481 -** Driver Air Bag Resistance Too High (2nd Stage)

Replace the Clock Spring by referring to the "Restraint → Air Bag Module → Driver Air bag (DAB) Module and Clock Spring → Repair procedures" chapter in the applicable Shop Manual on KGIS.
