SERVICE BULLETIN

APPLICABILITY: 2013-20MY Crosstrek
 2010-20MY Forester
 2009-20MY WRX & WRX STI
 2013-20MY BRZ

SUBJECT: Wheel Lug Nuts- Design Change

NUMBER: 05-79-20
DATE: 12/15/20

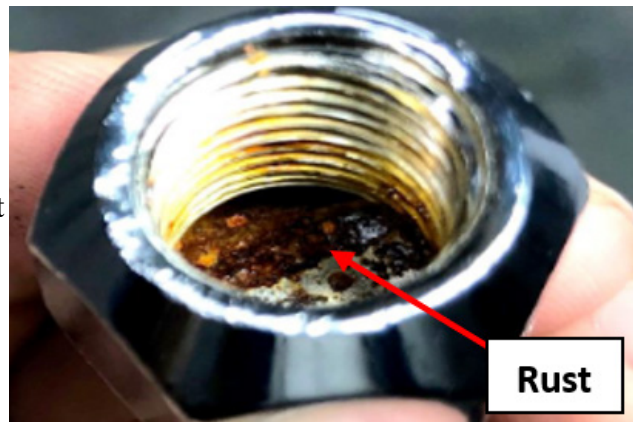
This Service Information Bulletin announces a change made to the wheel lug nuts on the models listed above. The change is in response to a number of reports describing rust inside of the nut shown here in the example photo. An anti-rust treatment coating is now applied during the manufacturing process to prevent rust from developing.

The new WHEEL NUT part number is **28171AJ000**.

NOTE: Any orders placed for the old part number 28171AG000 will be automatically switched to the new 28171AJ000 part number.
