# Technical Service Bulletin

## 20 Fuel line noises between 1000-2000 rpm

20 20 32 2061778/1 December 18, 2020.

Model(s)	Year	VIN Range	Vehicle-Specific Equipment
TT	2019 - 2021	All	2.0TFSI

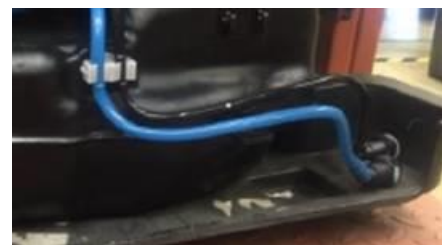
- The rattling noise from the fuel lines can be duplicated.
- The fuel supply line (between fuel pump and connector in the area of the inner sill) is detached at the fuel tank.

The TT fuel supply lines can vibrate against the fuel tank in certain cases. This phenomenon occurs when the two fuel lines begin to resonate between 1000-2000 engine rpm and rattle against one another or the tank.

*Figure 1. Lines in the tank.*

Apply the clip WHT 007 935 and apply it centrally between the two fuel lines (Figures 1- 2).

Make sure there is now sufficient spacing between the fuel lines.

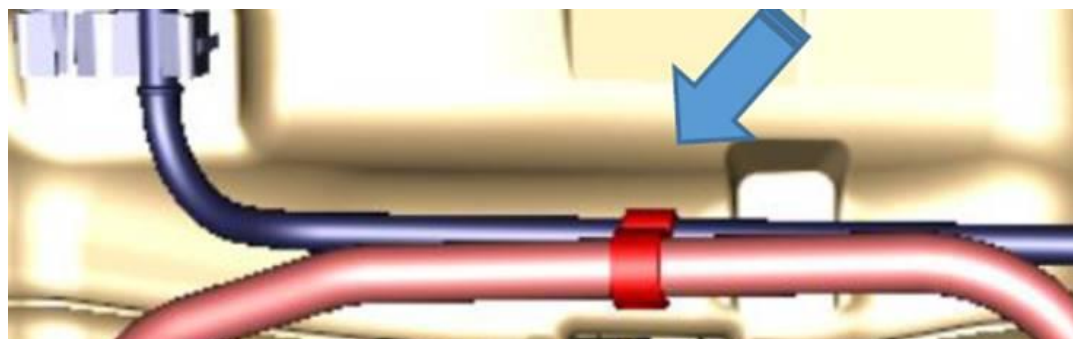
**Figure 2.** Where the clip should be applied.
