JLRTB02059NAS1

**TECHNICAL BULLETIN**

Incorrect Operation of Climate Control Air Distribution

MODEL:	MODEL YEAR:	VIN:	ASSEMBLY PLANT:
Discovery (LR)	2020	413208-434784	Nitra (Slovakia)
Defender (LE)	2020	000252-000954	Nitra (Slovakia)

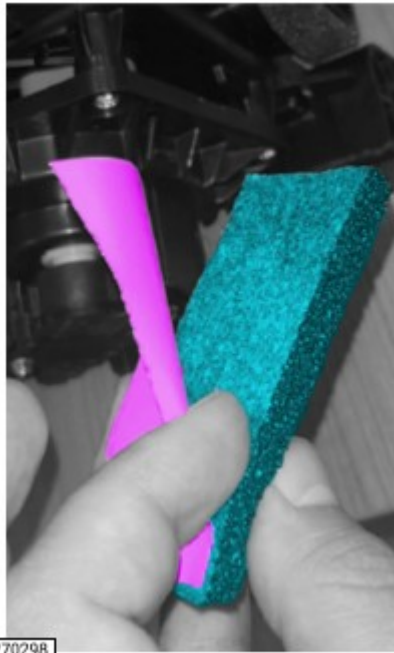
9.

Remove the protective backing from 1 adhesive foam pad.

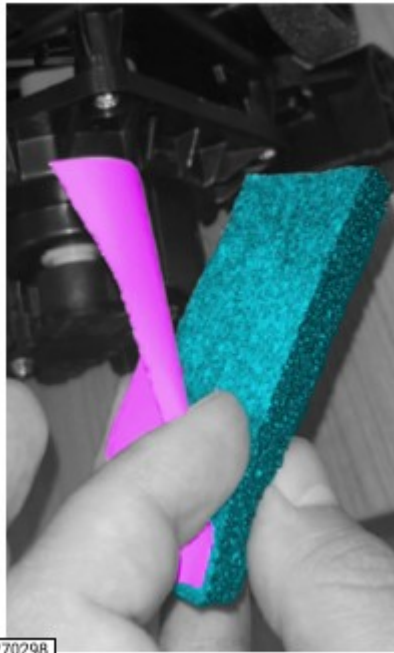
E27029B

Remove the protective backing from the other adhesive foam pad.

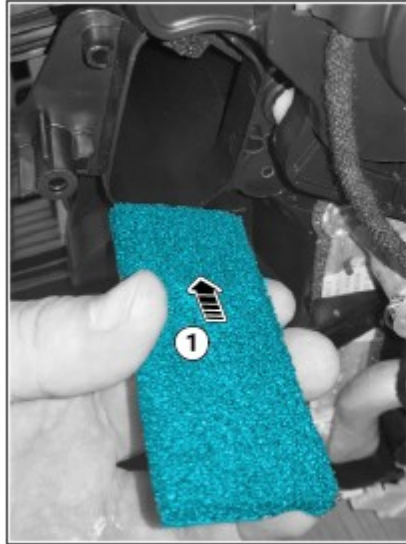
E270300

Make sure the adhesive side of the foam pad is pointing down

Install the adhesive foam pad into the right foot duct outlet.

- **1.** Fully insert the adhesive foam pad until it is flush with the outside edge of the duct outlet.
- **2.** Align the edge of the adhesive foam pad with the edge of the duct outlet.
- **3.** Apply firm pressure across the whole adhesive foam pad to secure it to the bottom of the duct outlet.
