# **Special Parts Collection – USA** Code: 69BD

#### Special Parts Collection - Head Curtain Airbag

Audi is conducting a special parts collection program involving the head curtain airbags from selected 2016 model year Audi Q5 vehicles.

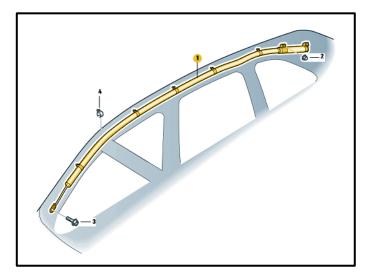
- Replace left and/or right head curtain airbag.
  - o Criteria 01 = right
  - Criteria 02 = left

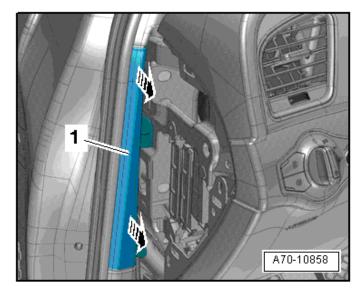
#### Remove gap covers:

- Remove the gap cover <1> from the A-pillar trim and the sill trim <arrow>.
- Remove the gap cover upward from the clips on the A-pillar.

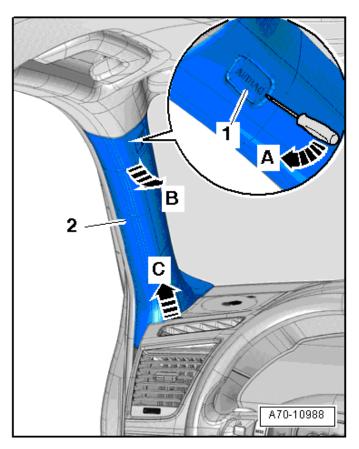
#### Remove A-pillar trim:

- Pry out the expanding cap <1> with the "airbag" symbol about 5 mm with a screwdriver <arrow A>.
- The trim is removed from the A-pillar in direction of <arrow B> in different ways depending on which clips are installed in the vehicle.
- If clips with a hook are installed, the trim needs to be pulled just a few millimeters until the hooks engage.
- The clips will then be removed from the A-pillar when the trim is pulled upward in direction of <arrow C>.
- Carefully unclip the A-pillar trim <2> beginning at the top using a -80-200- <arrow B>.
- Push the A-pillar trim upward and remove it <arrow C>.
- Replace damaged clips.

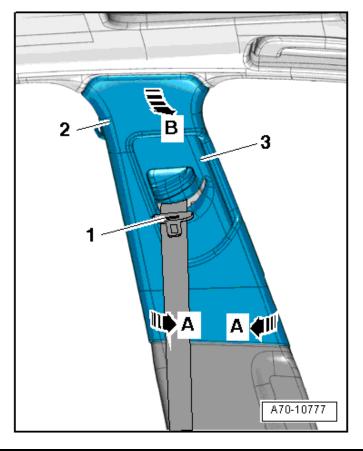
#### Remove upper B-pillar trim:

- Press belt height adjuster button and bring height adjuster slide into lowest position.
- Unclip the upper B-pillar trim <2> in direction of <arrows A> by inserting the -3409- into the lower edge of the trim.
- Remove the upper B-pillar trim from the bracket on the body in direction of <arrow B> by moving the trim toward the inside and pulling it downward at the same time.
- Lower the upper B-pillar trim down in the passenger compartment and protect it from damage.

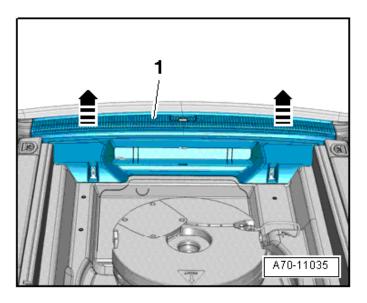
#### Remove lock carrier trim:

- Remove the rear luggage compartment floor.
- Unclip the rear lid end trim panel <1> using the -80-200- diagonally upward in direction of <arrows>.
- Carefully remove the rear lid end trim panel upward and disconnect the connector for the rear lid closed sensor Rear Lid -Closed-Sensor 1 -G525-/Rear Lid -Closed- Sensor 2 -G526-.

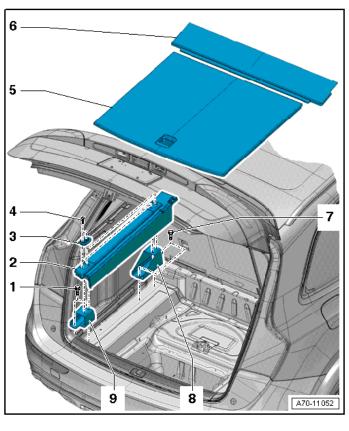
#### Remove gap cover:

- Remove bolts <4>.
- Remove tie downs <3>.
- Remove gap cover <2>.

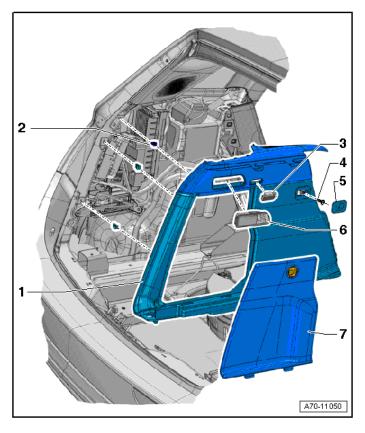
#### Remove luggage compartment side panel:

- Remove backrest release <6>.
  - Hold the release lever pulled and remove the screw behind the lever.
  - Unclip the cable from the lever.
- Pry out luggage compartment lamp <3> with the -3409- and disconnect it.
- Pry off coat hook <5> with the -3409-.
- Remove bolt <4>.
- Pry the luggage compartment trim away from the body using the -80-200-.

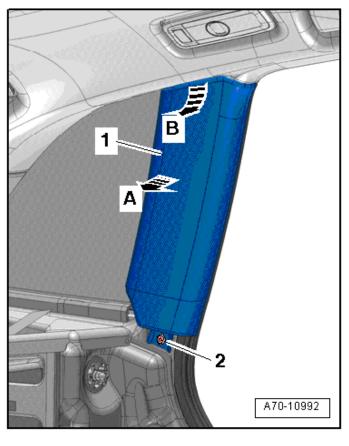
#### Remove C-pillar trim:

- Remove the expanding clip <2>.
- Unclip the C-pillar trim panel <1> using the -80-200- in direction of <arrow A>.
- Pull the C-pillar trim downward in direction of <arrow B> and remove.

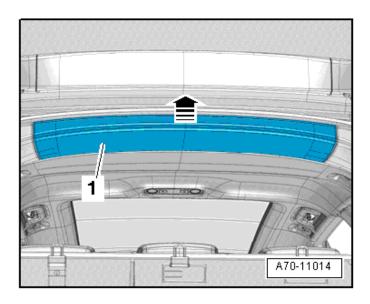
#### Remove roof end panel trim:

Carefully unclip the rear roof panel trim <1> in the center off the roof frame using the -80-200in direction of <arrow>.

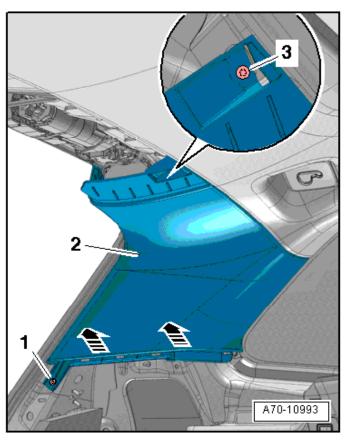
#### Remove D-pillar trim:

- Remove the expanding clips <1> and <3>.
- Remove the D-pillar trim <2> from the body <arrows> using the -80-200-.
- Versions with a speaker: Disconnect the connector.

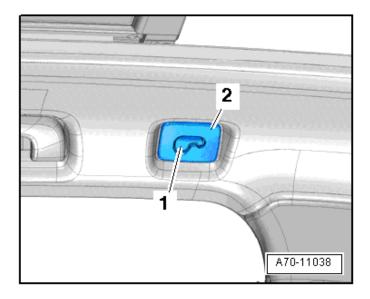
#### Remove screen separator mounts:

Press the cover <1> toward the inside and remove the screws on the screen separator mount <2>.

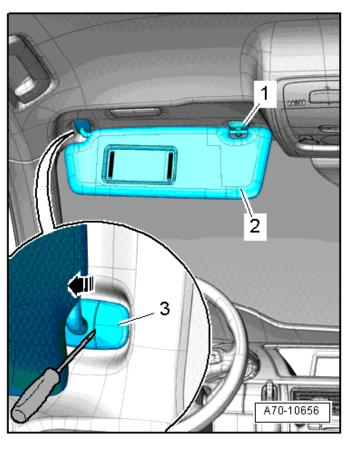
#### Remove sunvisors:

- Disengage the sun visor <1> in the center of the vehicle from the sun visor center bracket <2>.
- Unclip the expanding cap <3> using a screwdriver.
- Tilt the sun visor bracket down <arrow> and remove it.
- Versions with lighting: Disconnect the electrical connector and remove the sun visor.

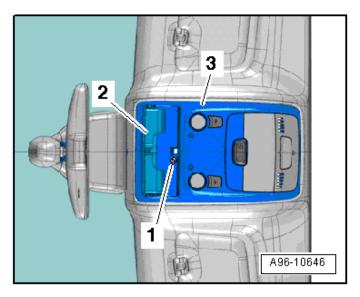
#### Remove front reading lamp:

- Open the eyeglass compartment <2>.
- Remove the bolt <1>.
- Pivot the front interior lamp/reading lamp <3> downward and remove it from the roof trim panel.
- Disconnect the connectors.

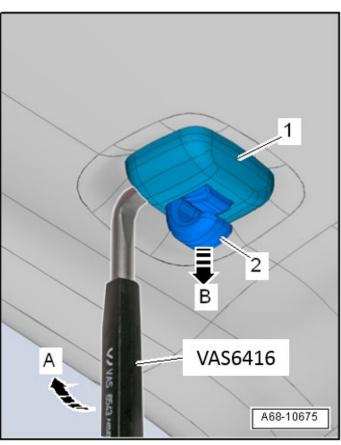
#### Remove sun visor center supports:

Unclip the sun visor center support cover <1> by sliding the -VAS6416- only about 1 mm under the cap in the direction of <arrow A>.

If the -VAS6416- is inserted farther, it will be located under the sun visor. It is not possible then to pry out the expanding cap.

- Remove sun visor center support <2> in the direction of <arrow B>.
- Remove both sun visor center support covers.

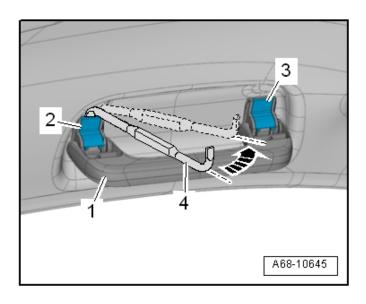
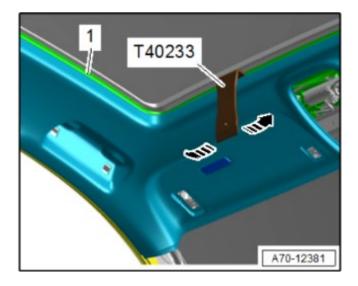
#### Remove all four grab handles:

- There is a risk of destroying the roof grab handle if the silicone brake and spring fall out. Replacement of the grab handle due to improper removal will not be covered under this action.
- Only unclip the expanding caps <2 and 3> up to their lock position. Do not remove them completely.
  - Place the angled screwdriver <4> in the gap behind the clips <2>.
  - Pivot the angled screwdriver in the direction of <arrow>, until the clips slide audibly into the rest position.
  - Repeat the procedure on clip <3>.
  - Remove the roof grab handle <1> from the body opening.
  - Leave the expanding caps in the rest position in the roof grab handle.

- Open the sun shade.
- To avoid dirtying the headliner, clean the -T40233-.
- Push the -T40233- between the frame <1> for the sliding sunroof and the headliner.
- Loosen the headliner using the -T40233from the sliding sunroof frame all the way around <arrows>, as shown.

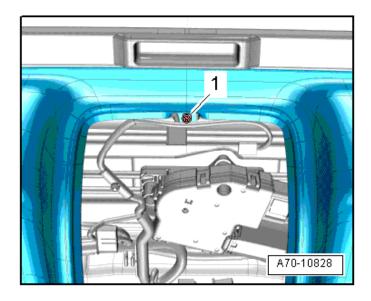
Remove the bolt <1> in the front interior/reading light roof opening.

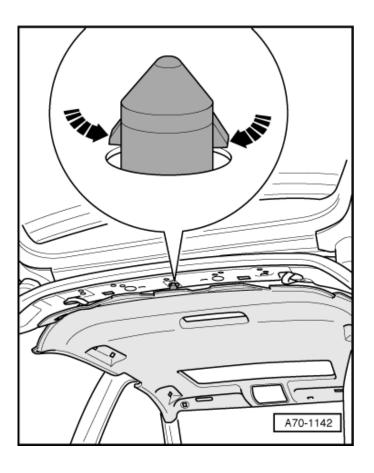
#### Remove headliner:

The headliner bends easily.

Two technicians are needed to loosen the last connections and to remove the headliner.

Release the clips in direction of <arrows> on the rear centering clip with a small screwdriver.

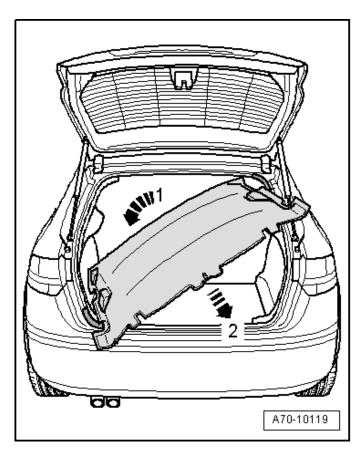
- Lower the headliner on the left side of the vehicle in direction of <arrow 1>.
- Remove the headliner through the opening for the rear lid in direction of <arrow 2>.

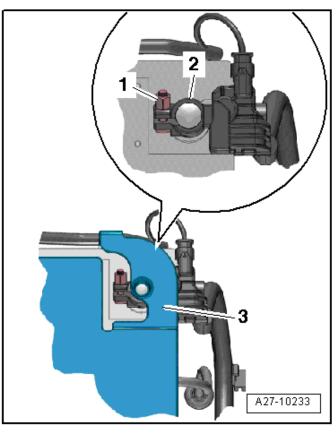
#### Disconnect the battery:

Accident risk. When working on pyrotechnic components (such as airbags and belt tensioners), the battery must be disconnected with the ignition switched **ON**.

- Turn the ignition ON.
- Access the battery.
- Open the cover <3> over the battery negative terminal.
- Loosen the nut <1>.
- Remove and isolate the battery ground cable terminal from the battery pole.

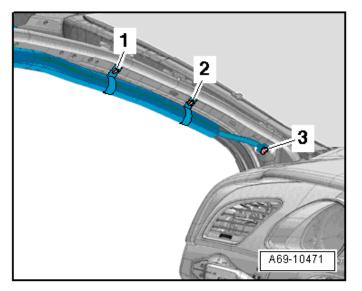
#### Remove the head curtain airbag:

- Criteria 01 remove <u>right</u> side head curtain airbag.
- Criteria 02 remove <u>left</u> side head curtain airbag.
- Remove head curtain airbag bolt <3> on the Apillar.
- Remove the head curtain airbag from the clips <1> and <2>.

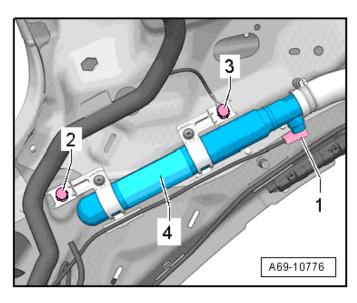
- Release connector lock and disconnect connector <1>.
- Remove cap nuts <2> and <3>.

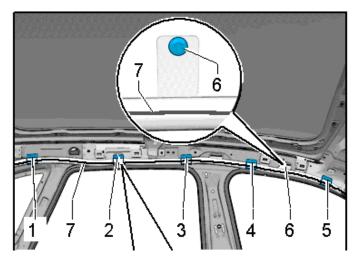
• Detach the clip <6>.

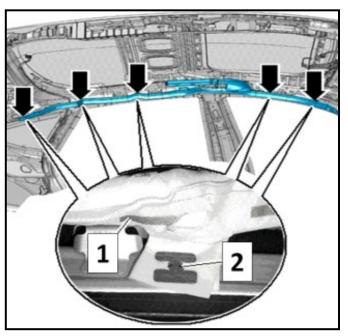
- Unclip the head curtain airbag clips from the body using -VAS211001-.
  - Fold airbag material <1> up to access clips <2>.
  - Guide the plier tips into the openings while holding the pliers open, press the clip catches for the head curtain airbag together and remove the clip.

The clips <2> will become damaged during removal.

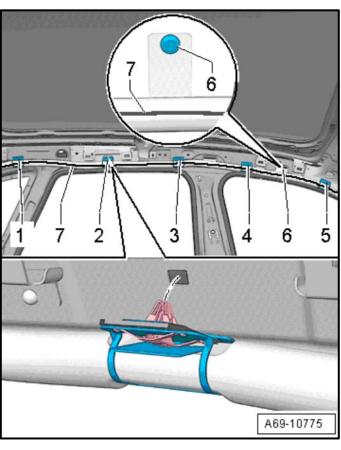
#### Install new head curtain airbag:

- Ensure the black strip <7> is visible along the entire length of the head curtain airbag.
- Ensure the head curtain airbag is not twisted.
- Clip the side curtain airbag retaining tab clips
   through 5> onto the body.
- Clip the clips <6> onto the body.

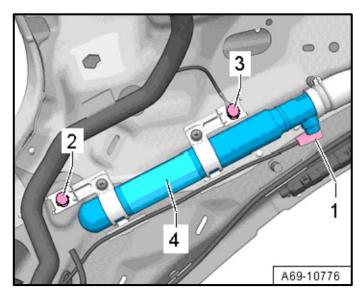
- Engage the head curtain airbag <4> on the bolt and tighten the cap nuts <2> and <3> by hand.
- Torque the cap nuts <2> and <3> to 9 Nm.
- Connect and lock connector <1>.

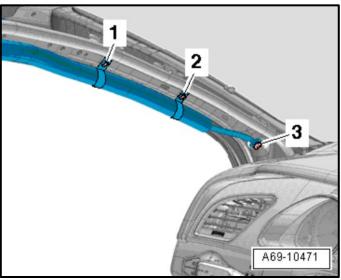
- Secure the head curtain airbag with the clips <1> and <2>.
- Attach the tensioning strap and torque new bolt <3> to 3.5 Nm.

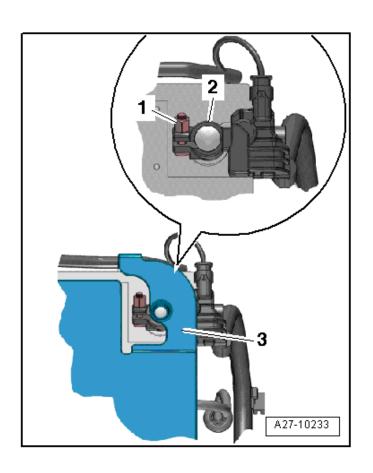
Ignition must be **ON** when connecting battery. If pyrotechnic components (e.g. airbag, belt tensioner) are not repaired correctly, they may deploy unintentionally after connecting battery. There must not be anyone inside the vehicle when connecting the battery.

- Disconnect the connector <2> from the Battery Monitoring Control Module -J367- <3>.
- Attach the battery ground cable clamp by hand to the battery negative terminal and torque the nut <1> to 6 Nm.
- Reconnect the connector to the Battery Monitoring Control Module -J367-.
- Re-install the luggage compartment floor.
- Cycle the ignition off and back on.
- Set clock to local time.
- Activate the power window regulator onetouch up/down function.
- Check the DTC memories of all the control units and erase under-voltage faults if necessary.

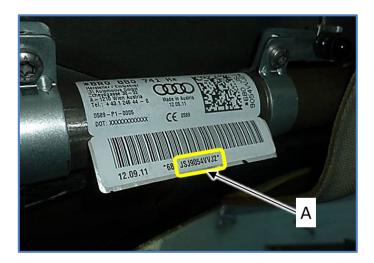
#### Document vehicle and airbag information:

- Document the following on a piece of paper and attach (tape) it to the removed airbag before repackaging it for return:
  - o VIN#
  - Vehicle mileage
  - Airbag module number <A>
