Technical product information

Topic	Rear Shock absorber leaking (Left or Right)
Market area	Bentley: worldwide (2WBE)
Brand	Bentley
Transaction No.	2061743/1
Level	EH
Status	Approval
Release date

New Continental GT - New Continental GTC - New Flying Spur

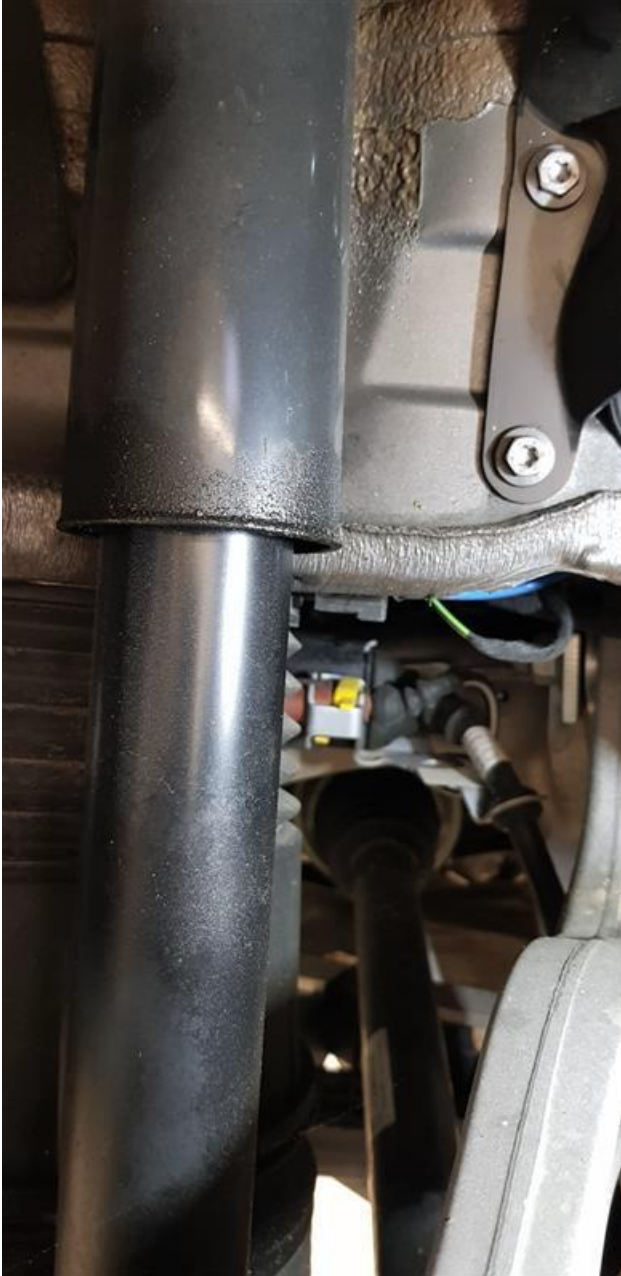
Figure 1

Oil leak evident from the rear shock absorber/s (Left and/or Right)

Should oil be leaking from the left or right rear shock absorber as shown in Figures 1 - 2 and 3, the operative should refer to the Measure section of this TPI

- 1) Carry out an inspection of the right and left hand shock absorbers
 - Should an oil leak be evident
- 2) Open a Non technical/For information only DISSquery
 - Attach photos of the leaking shock absorber/s to the open DISSquery
 - Submit the DISSquery
- 3) Replace the leaking shock absorber/s - Refer to Rep.Gr 42
