Service Bulletin

Bulletin No.: 19-NA-128

Subject: Limited Vehicle Speed, Malfunction Indicator Lamp (MIL) Illuminated - DTC P07A7

Brand:	Model:	Model Year:		VIN:		Engine:	Transmission:
		from	to	from	to		
Cadillac	CT6 Plug-in	2016	2018	—	—	2.0L (LTG)	Automatic-Hybrid Electric (MRD)

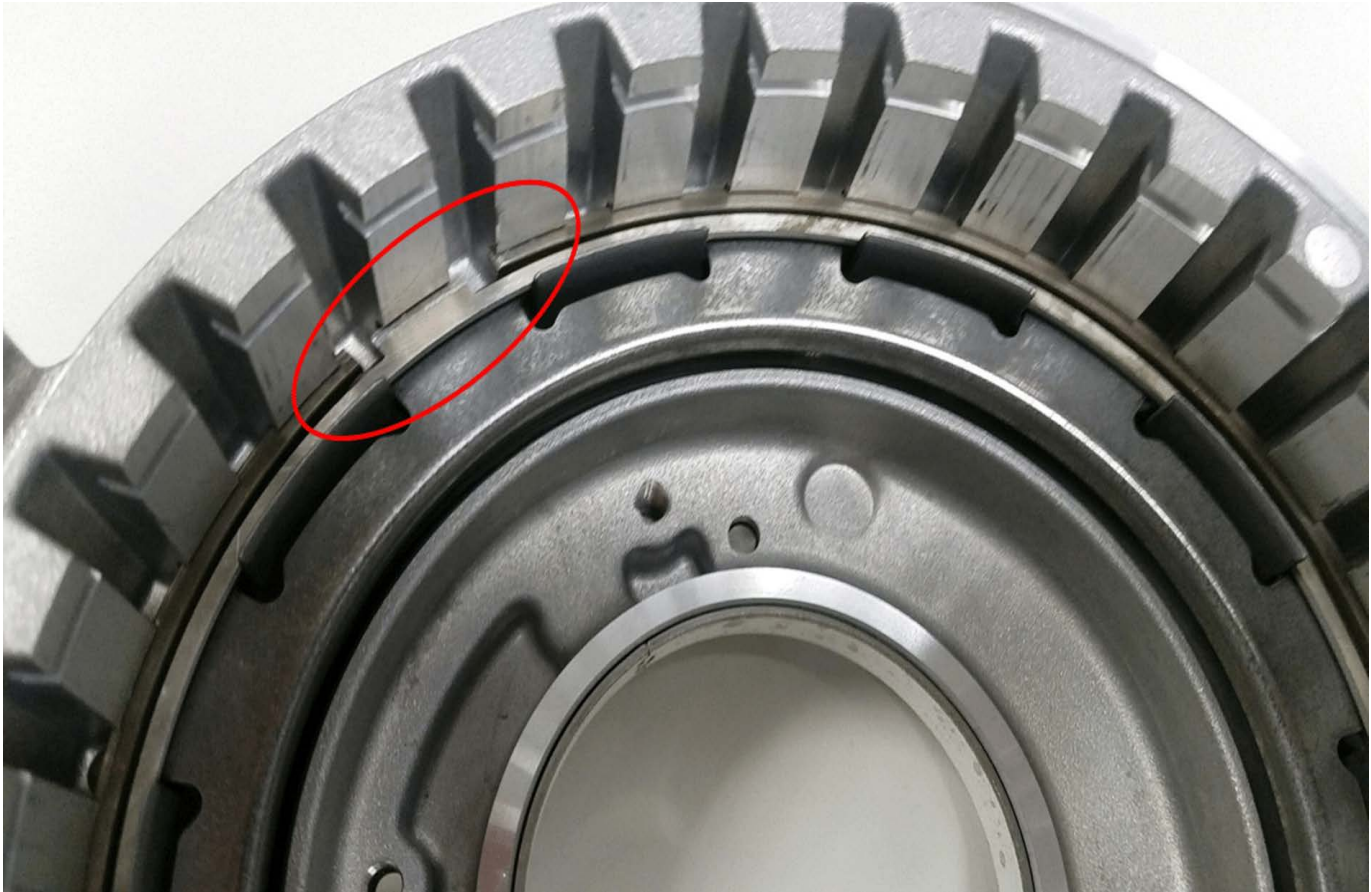
5224585

Cause	
	<p>5224678</p> <p>This condition may be caused by the 1-3 clutch return spring ring (1) that has come out of its groove, causing the Variable 1-4 and 1-3 Clutch Piston Return Spring Plate to contact (2) the variable clutch plate assembly.</p>

Important: During assembly, position the 1-3 clutch return spring ring, as shown in the above picture, to aid in retainer installation.

Correction	<p>Note: The addition of this C3 snap ring retainer will correct the condition and allow for repair, in lieu of transmission replacement.</p> <p>Engineering has designed a snap ring retainer that will stop the snap ring from rotating, which keeps it securely in its designed groove.</p> <p>⇒ The C3 clutch assembly must be disassembled, replacing both the clutch pack and the snap ring as well as adding the new snap ring retainer.</p>
-------------------	--
