# Special Coverage Adjustment

## N192291600 Drive Motor Cooling Blower

Release Date: August 2020

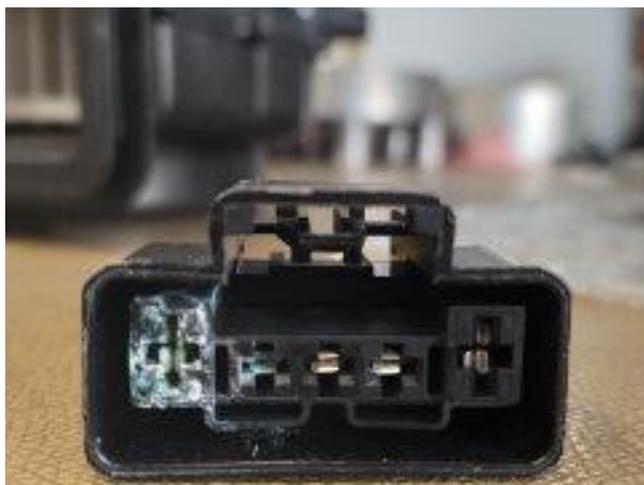
5618476

3. While replacing the drive motor generator battery cooling blower, check the body side electrical connector for corrosion. If corrosion is found, replace the body wiring harness connector kit refer to *Repairing Connector Terminals (Terminated Lead Repair)* in SI.
4. If Moisture is found in the rear compartment, verify that recall number N192210570 has been performed (if applicable).
5. Clear any stored DTC information.
