S.A.T.	260 MV
area	n°

Service Bulletin

Subject: **Fusecase cover**

Product: **Brutale 1000 Serie Oro - RR - Rush**
from vin ... LV000011 to vin ... MV000546

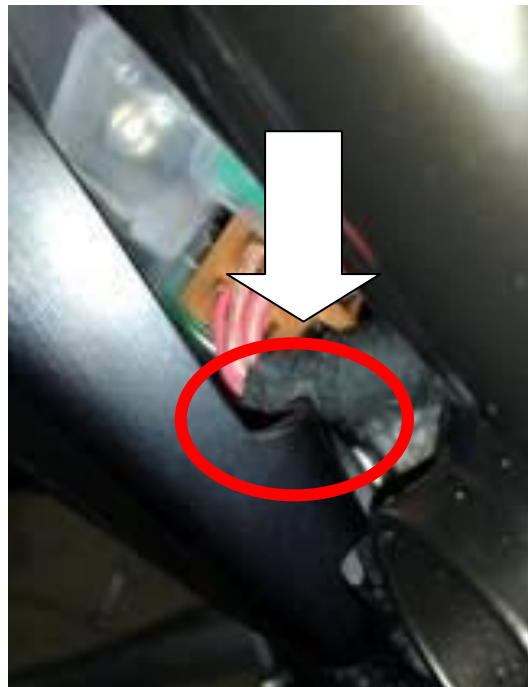
If the passage of the wire is not correct, the aluminum cover could damage or crush the wiring of the starter relay connector:

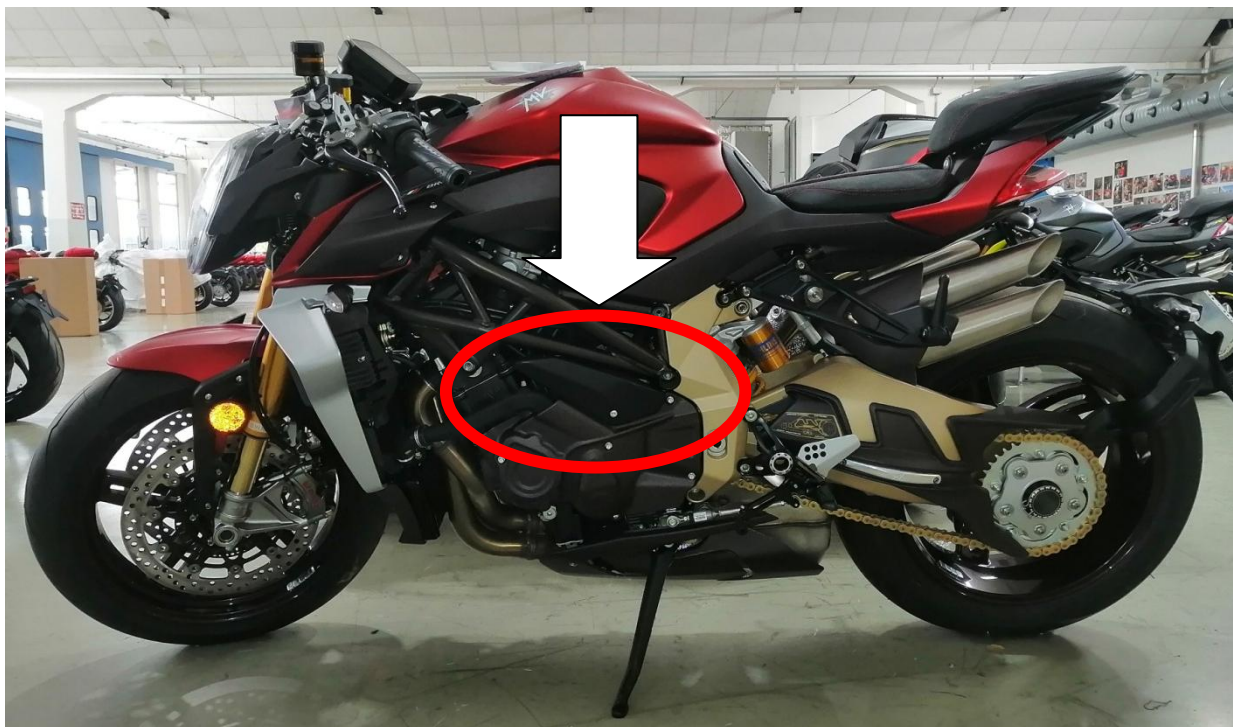
Position of the cover (on both B4 and Rush models):

It will be possible to identify the motorcycles that needs to be updated by removing the aluminum cover on the left side of the bike, using a 4mm Allen key and acting on the quick release screw, and checking the points indicated below;

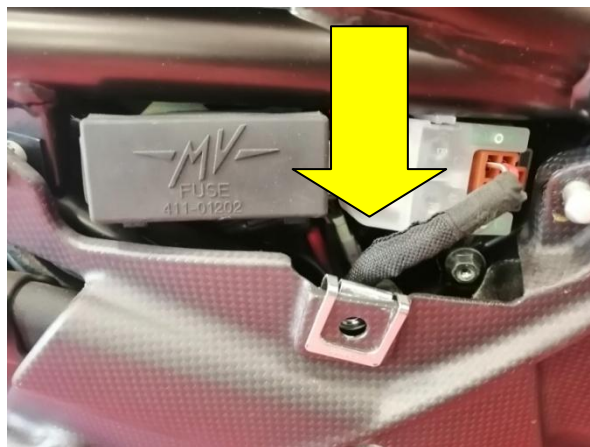
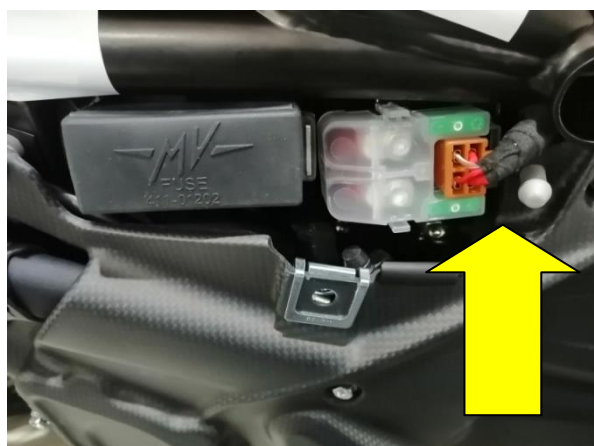
Main relay cable routing:

On the motorbike it is possible to find 4 assembly variants with different actions to be taken according to the configuration found on the vehicle. It is possible to proceed with only one action to be taken:

CABLE ROUTING	RUBBER PADS	ACTION TO BE TAKEN
1	COMPLIANT	COMPLIANT	NO ACTION REQUIRED
2	COMPLIANT	NOT PRESENT	POINT A
3	NON-COMPLIANT	NOT PRESENT	POINT B
4	NON-COMPLIANT	COMPLIANT	POINT C

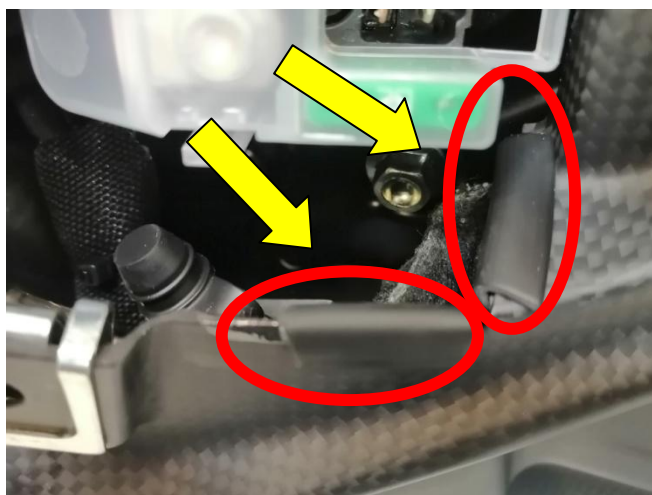
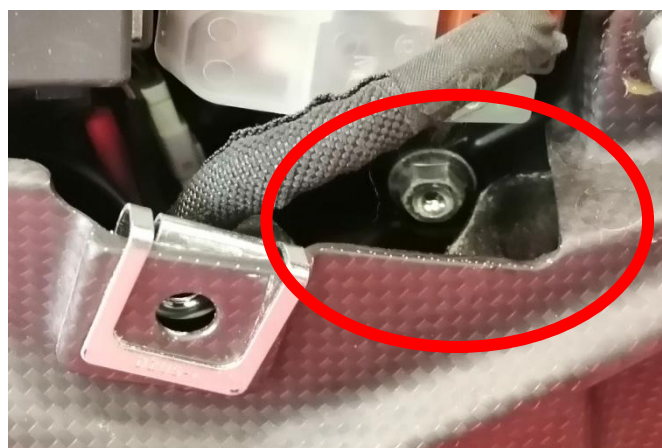
The same problem could occur following the absence of protective rubber pads on the edge of the sound-absorbing panel.

Presence of protective rubber pads on the sound-absorbing panel:
