Diesel Exhaust Fluid (DEF) Contamination In Fuel System, Inspection And Repair; Engine Misfire, No-Start, Uneven Operation, Multiple Injector Codes, Fuel Pressure Codes - US17 And Newer (Common Rail Fuel System)

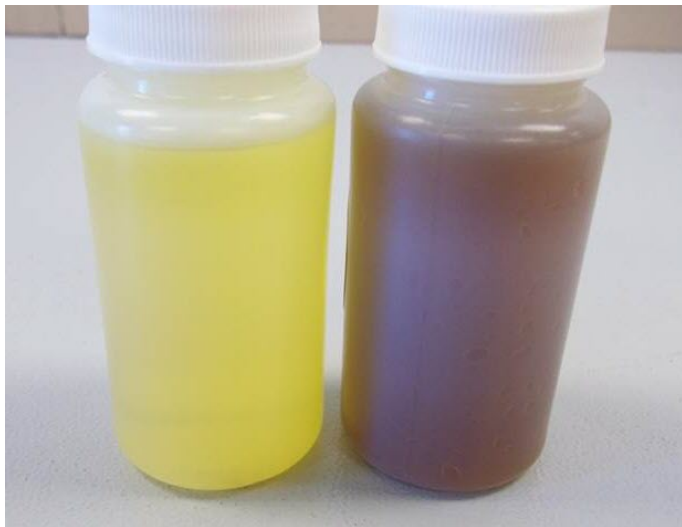
- The depth the sample is taken from is important. Both of the samples in the picture below were taken from the same tank. A sample taken from the middle or top of the tank (left) may not show an issue, when a sample taken from the bottom of the tank (right) does.

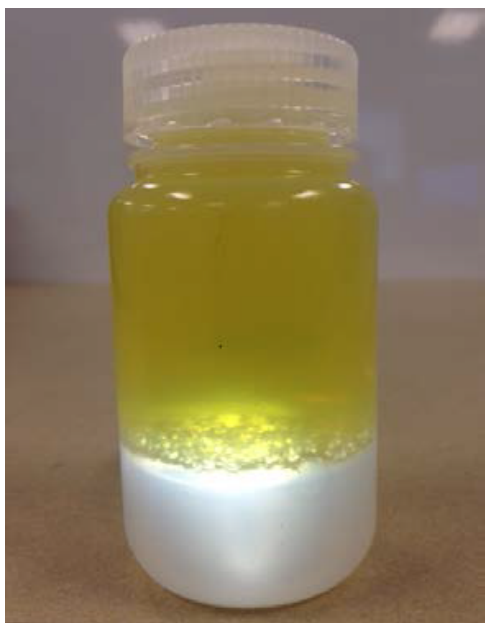
3. Allow the sample to settle. In many cases there will be a visible separation of DEF and fuel as shown below:

- Shining a light through the sample can help highlight the separation, as seen

the photo.

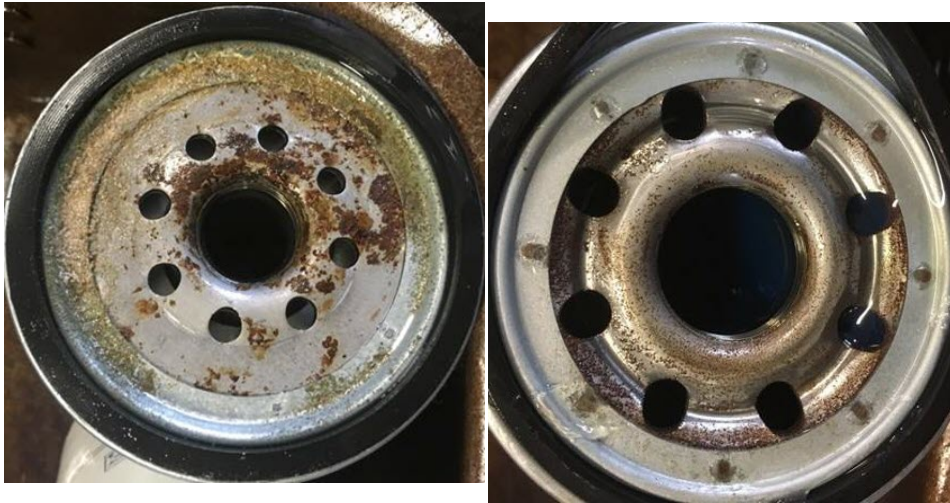
1. Remove both fuel filters from the housing.
2. Check for the presence of crystal buildup or corrosion on the filter face as seen below:

Crystal buildup and corrosion/rust present on primary filter

Corrosion/rust on secondary filter

- If the filters are allowed to dry, white crystal residue may be observed on the filter face.

- The fuel tanks need to be completely drained and thoroughly flushed with water. The presence of pitting on the inside of the tank may require tank replacement. The tank will need to be inspected following cleaning.
- The complete fuel system will need to be thoroughly flushed.
- The system should be dried as thoroughly as possible prior to reassembly.

- Fuel Injectors and sleeves
- Fuel supply pump
- Fuel Filter base
- High pressure fuel supply tubes
- Fuel rail
- Fuel rail pressure sensor
- Fuel rail pressure relief valve
- Fuel return line (from cylinder head to filter housing) assembly
- Aftertreatment Hydrocarbon Injector (AHI) Module
- AHI nozzle
- AHI fuel/air supply line (line between AHI module and nozzle)
- Any other fittings where corrosion or clogging is observed.

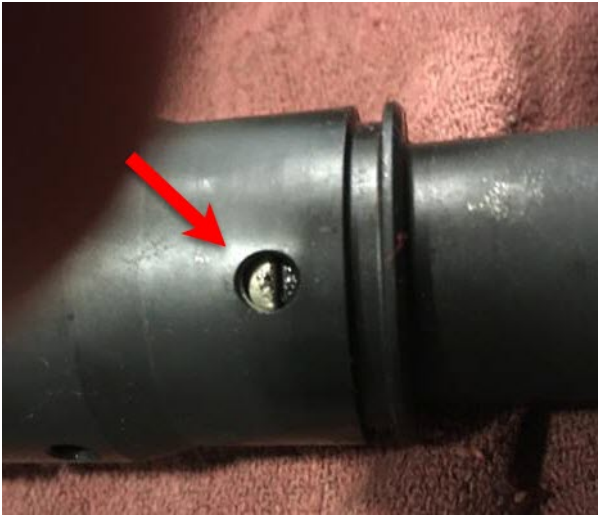
The low pressure fuel port in the side of the injector may show presence of pitting or crystal deposits as shown below:

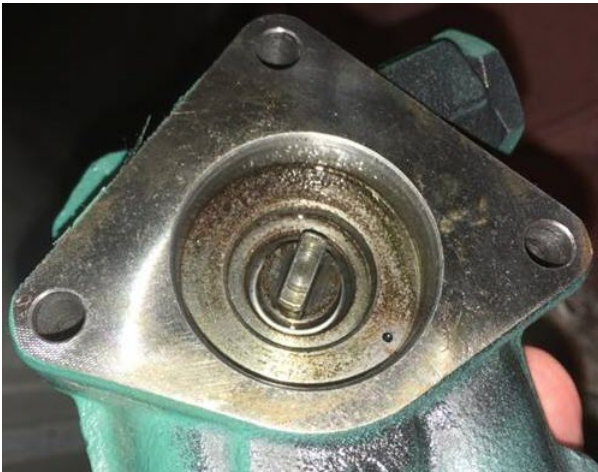
Corrosion and crystal buildup may be observed in the fuel supply pump as shown below:
