# Technical Service Bulletin

<b>Subject:</b> <b>OIL SEEPAGE / LEAKAGE FROM REAR SHOCK ABSORBERS</b>	<b>Bulletin No.:</b> 02-001/21
	<b>Last Issued:</b> 01/20/2021

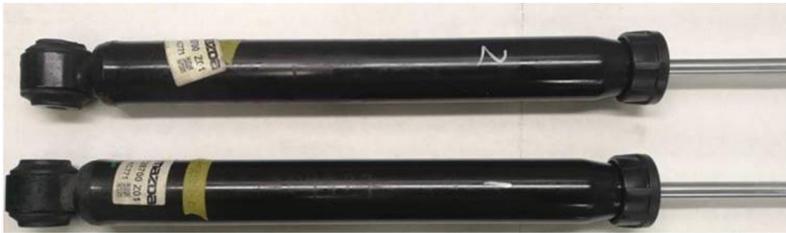
- The original part number can be found on the shock absorber label (as shown below).
- If the parts label has fallen off of the shock absorber, refer to the GEPC to determine the correct part number for the subject vehicle.

5. Verify the subject vehicle is equipped with the rear shock absorber(s) listed in the "**Old Part Number**" column in the Parts Information table below.
