## iABS Sensor Visual Inspection Illustration

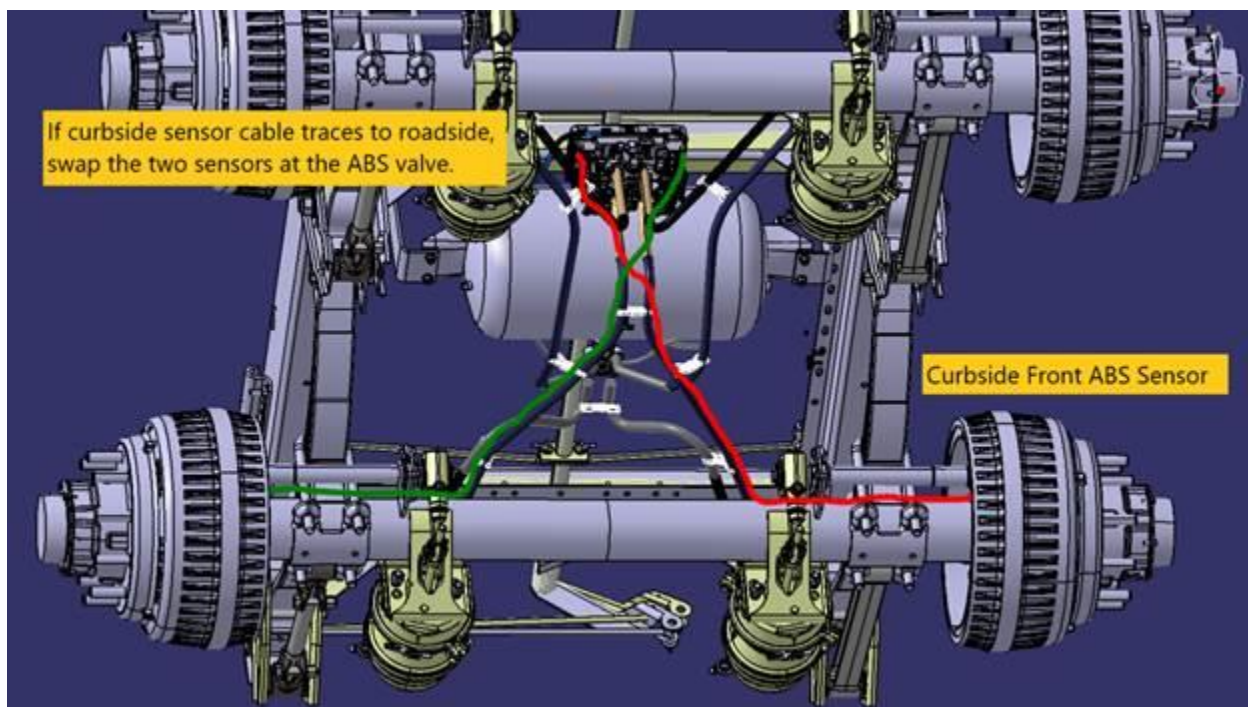
The view below shows what it would like if the sensor cables are installed incorrectly. The sensor cables should not cross side to side.
