HYUNDAI Technical Service Bulletin	GROUP Engine Mechanical	NUMBER 21-EM-001H
	DATE JANUARY 2021	MODEL(S) Elantra (MD / UD), Elantra GT (GD), Elantra Coupe (JK)
SUBJECT: NU ENGINE CYLINDER BLOCK INSPECTION & REPLACEMENT

Description: This bulletin describes the procedure to inspect an engine exhibiting noise between the cylinder block and piston due to possible scuffing on one or more cylinder walls. Follow the procedure outlined in this bulletin to inspect and replace the short engine assembly if scuffing is observed.

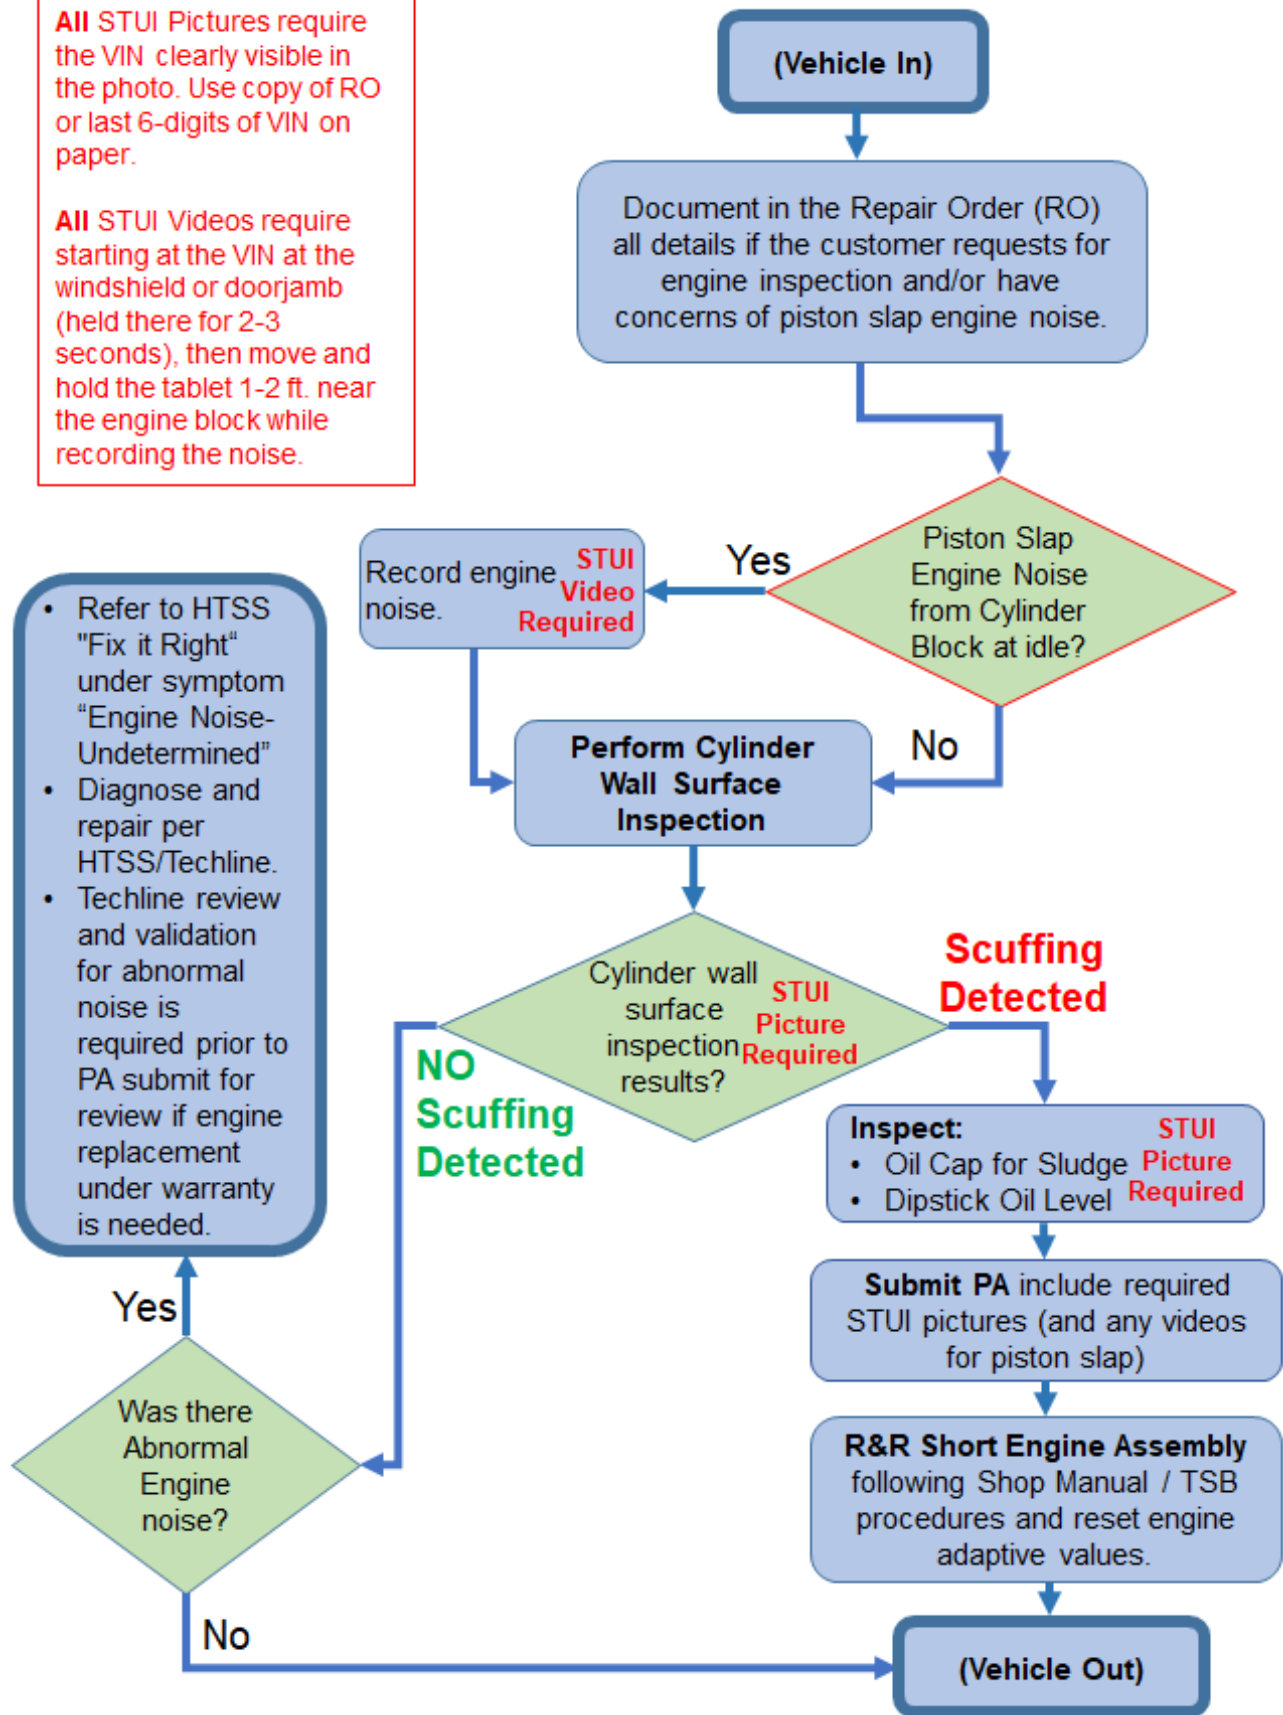
Service Procedure Flowchart:

All STUI Pictures require the VIN clearly visible in the photo. Use copy of RO or last 6-digits of VIN on paper.

All STUI Videos require starting at the VIN at the windshield or doorjamb (held there for 2-3 seconds), then move and hold the tablet 1-2 ft. near the engine block while recording the noise.

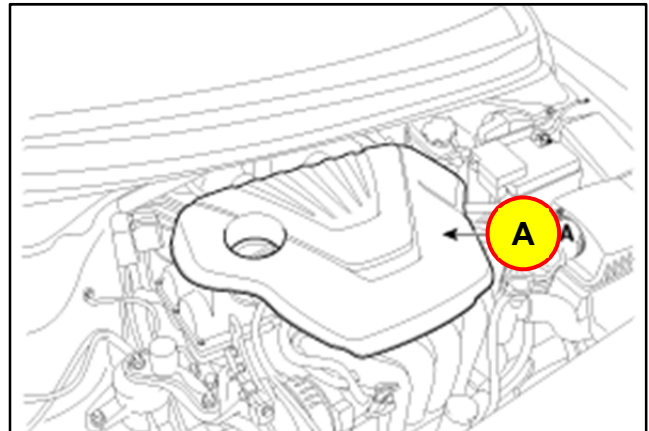
Remove the engine cover (A).

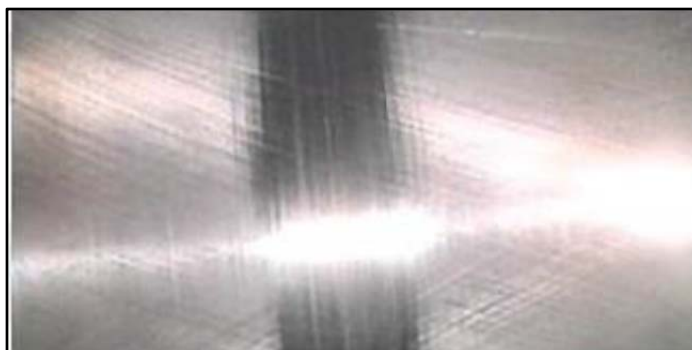
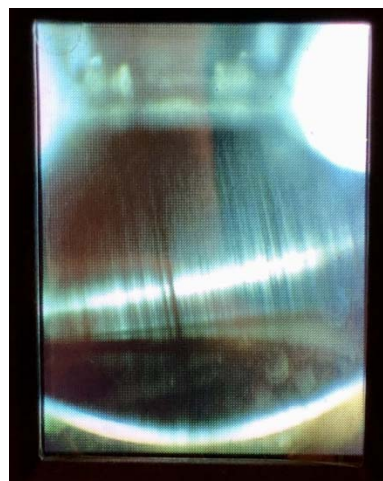
4. Inspect the cylinder walls for signs of vertical scuffing pattern (refer to the reference pictures as shown on the right for scuffing examples).

NOTE: Some borescope units may display the vertical scuffing differently (not up/down). Be sure to position the borescope display accordingly to show the vertical scuffing correctly per below for the STUI pictures.

➤ **If scuffing is identified**, use STUI to take a picture of the borescope display of each identified cylinder wall surface if scuffing is found.

Submit PA with STUI pictures to replace the short engine assembly.
