Technical Service Bulletin

69 Airbag/PODS warning light on, DTCs B102229, B12251B and/or B102202 are stored in the airbag module

69 21 62 2061030/2 February 23, 2021. Supersedes Technical Service Bulletin Group 69 number 20-61 dated December 9, 2020 for reasons listed below.

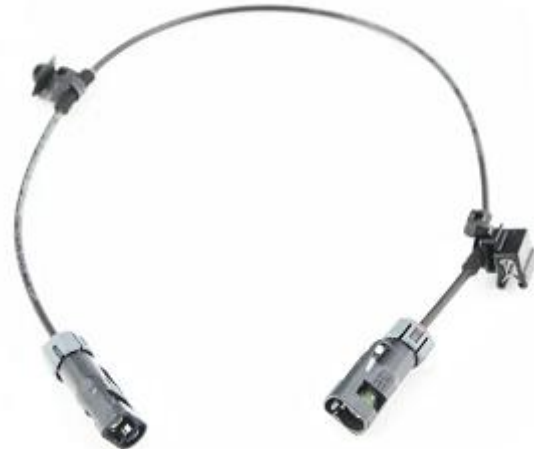
PODS Repair Kits do not require the 69Z4 campaign harness (8P0.972.785) (Figure 1).

Figure 1. 69Z4 campaign harness obsolete after PODS Repair Kit installation.

3. If Safety Campaign 69Z4 has already been completed or is not applicable, proceed to install a PODS Repair Kit (PODS sensor mat and PODS module) as outlined in the repair manual in Elsa.

Do not modify the PODS Repair Kits as this could result in repeat repairs.
