# Technical product information

<b>Topic</b>	DTC's C10BCF6 - 160000 and/or C12E2F2 with symptom code 59744 stored in address 0003 - Parking brake warning in DIP
<b>Market area</b>	Bentley: worldwide (2WBE)
<b>Brand</b>	Bentley
<b>Transaction No.</b>	2062104/1
<b>Level</b>	EH
<b>Status</b>	Approval
<b>Release date</b>

DTC's C10BCF6 - 160000 and/or C12E2F2 with symptom code 59744 stored in address 0003 - Parking brake warning in DIP

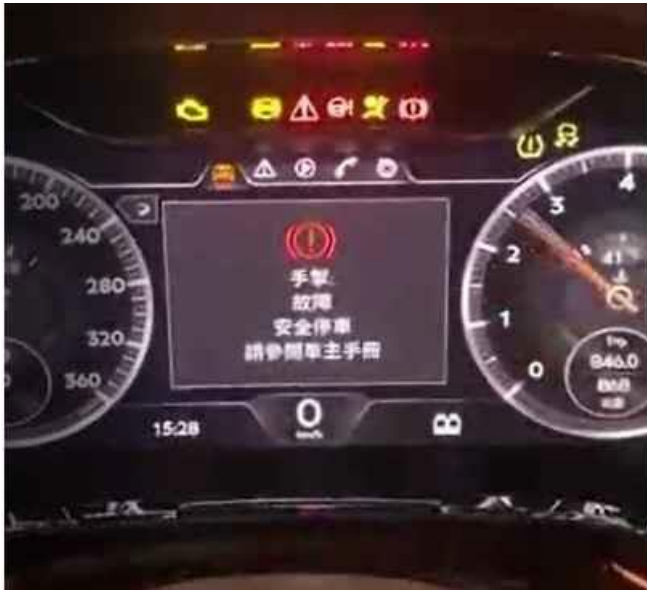
Figure 1

Parking brake warning light evident within the DIP (See example shown in Figure 1)

1) Carry out an inspection of the rear (Electronic Parking Brake EPB) actuators and system

2) Referring to the applicable wiring diagram - Conduct an inspection and check the electrical integrity of the (EPB) connections and wiring to the relevant/applicable actuator (Right and or Left hand side)

3) In the event that no other issues have been found - Replace the defective actuator - Rep. Gr 46
