Technical product information

Topic	New Continental GT - Boot open/close function inoperative
Market area	Russische Föderation (5RU),Australia E04 Bentley rest Asia and Australia (6E04),China 796 VW Import Comp. Ltd (Vico), Beijing (6796),Germany E02 Bentley rest Europe (6E02),Japan E03 Bentley Japan (6E03),Korea, (South) E08 Bentley South Korea (6E08),United Arab Emirates E06 Bentley Middle East and Africa (6E06),United Kingdom E01 Bentley UK (6E01),United States E05 Bentley USA and rest America (6E05)
Brand	Bentley
Transaction No.	2060652/3
Level	EH
Status	Approval
Release date

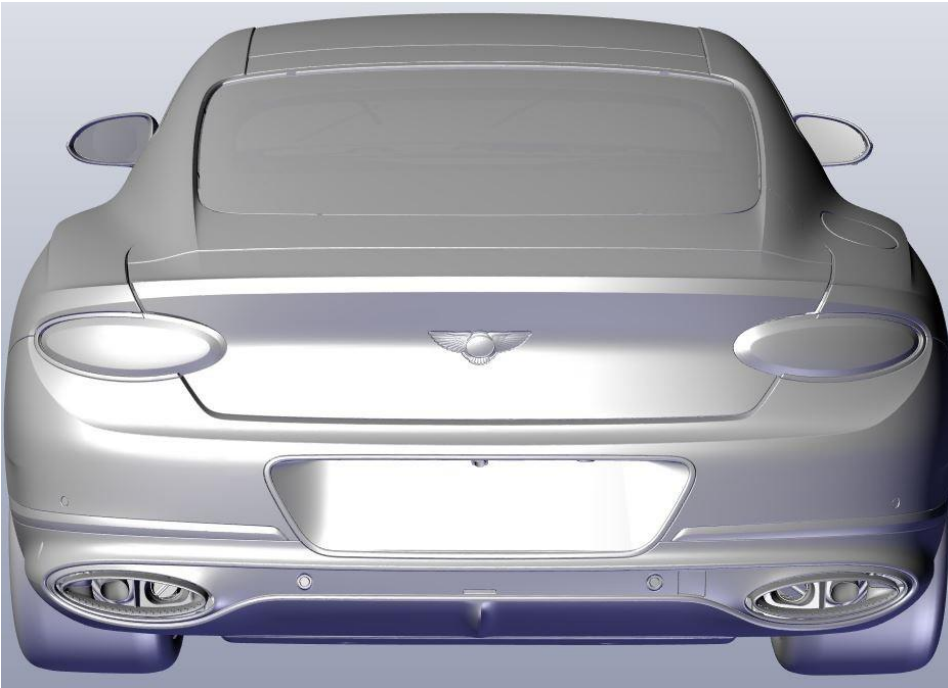
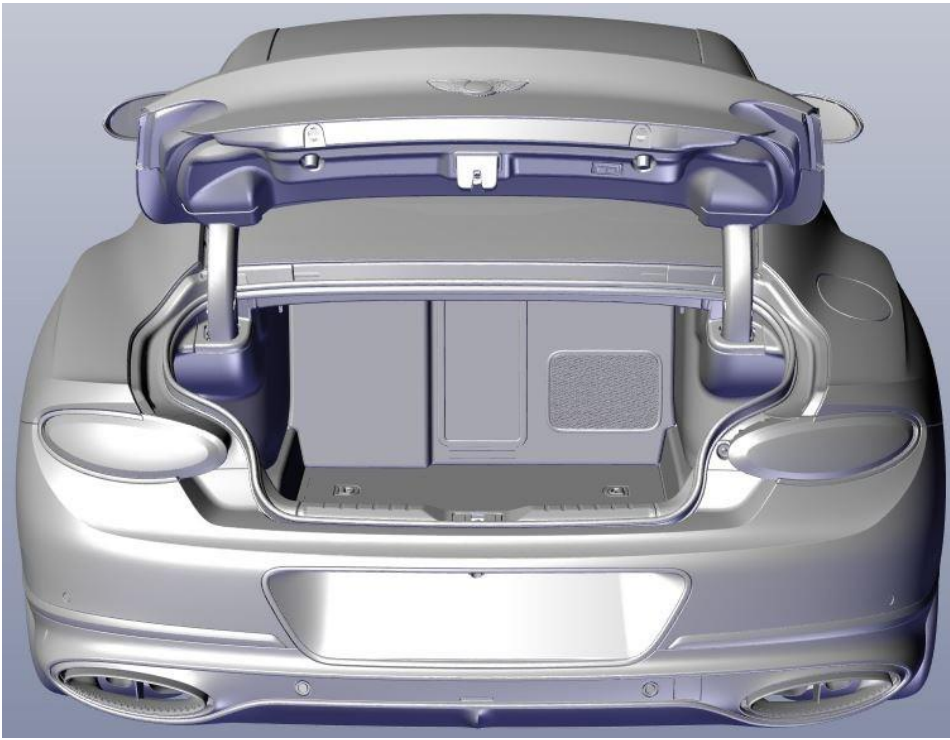
▪
If any area of the visual inspection is NOK please highlight on the images below
