SPYDER RT 2020-21 Saddle Bags Hard To Open - 138444

Some MY20-21 RT rear saddle bag lever can be hard to pull to open the saddle bag due to water intrusion in the latch cables.

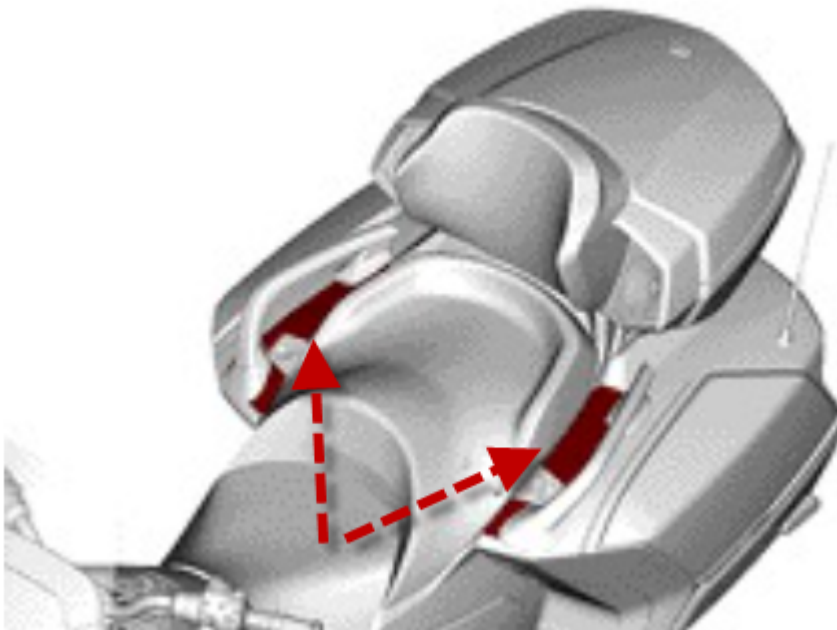
- Remove access covers 708303754, 708303755

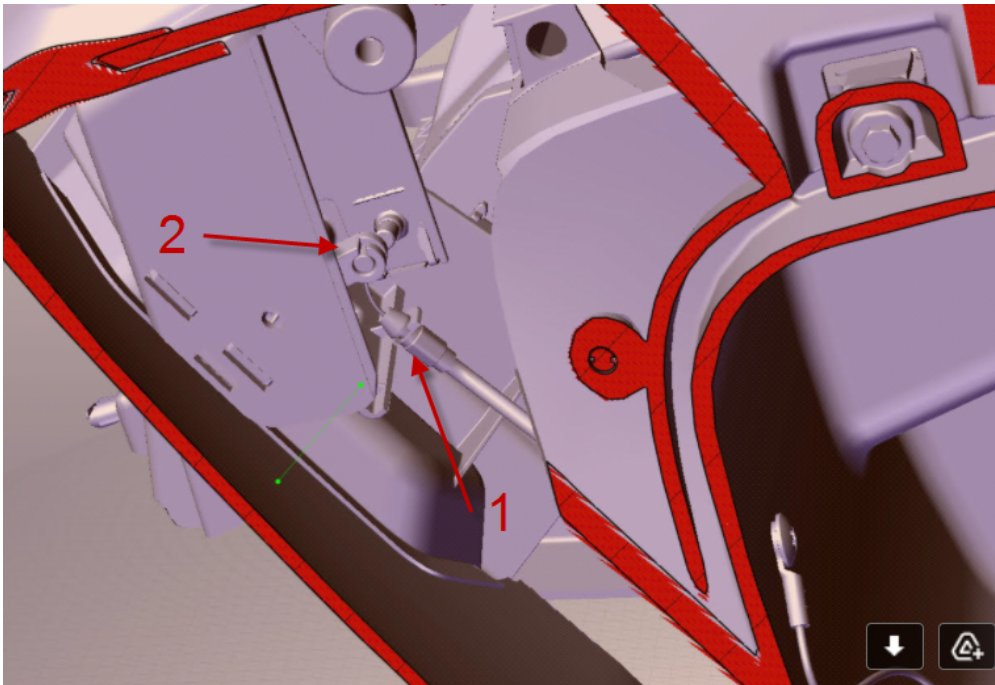
- From underneath (see video attached), grab and follow the cable.
 1. Pull the cable outward to unhook it from the plastic bracket.
 2. Then, lift the cable upwards and take the lead head out of the half-moon

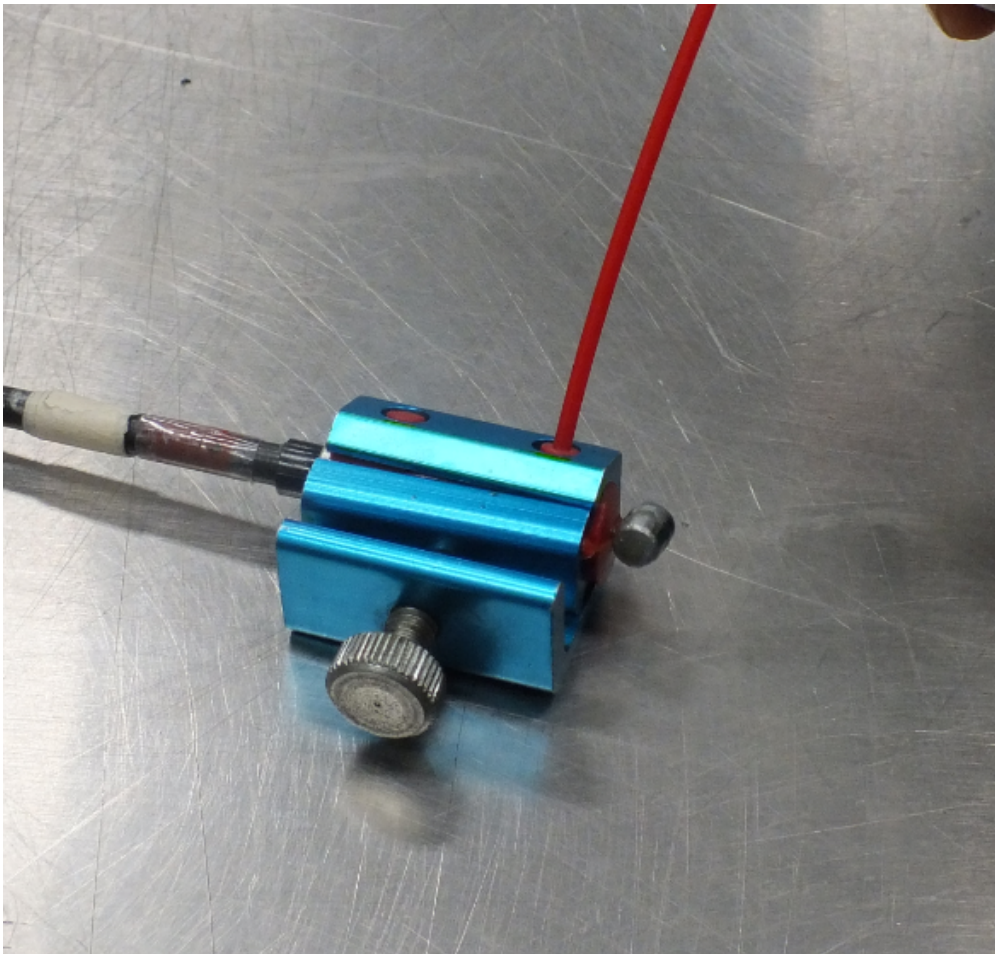
- Use BRP cable lubrication tool 529035738

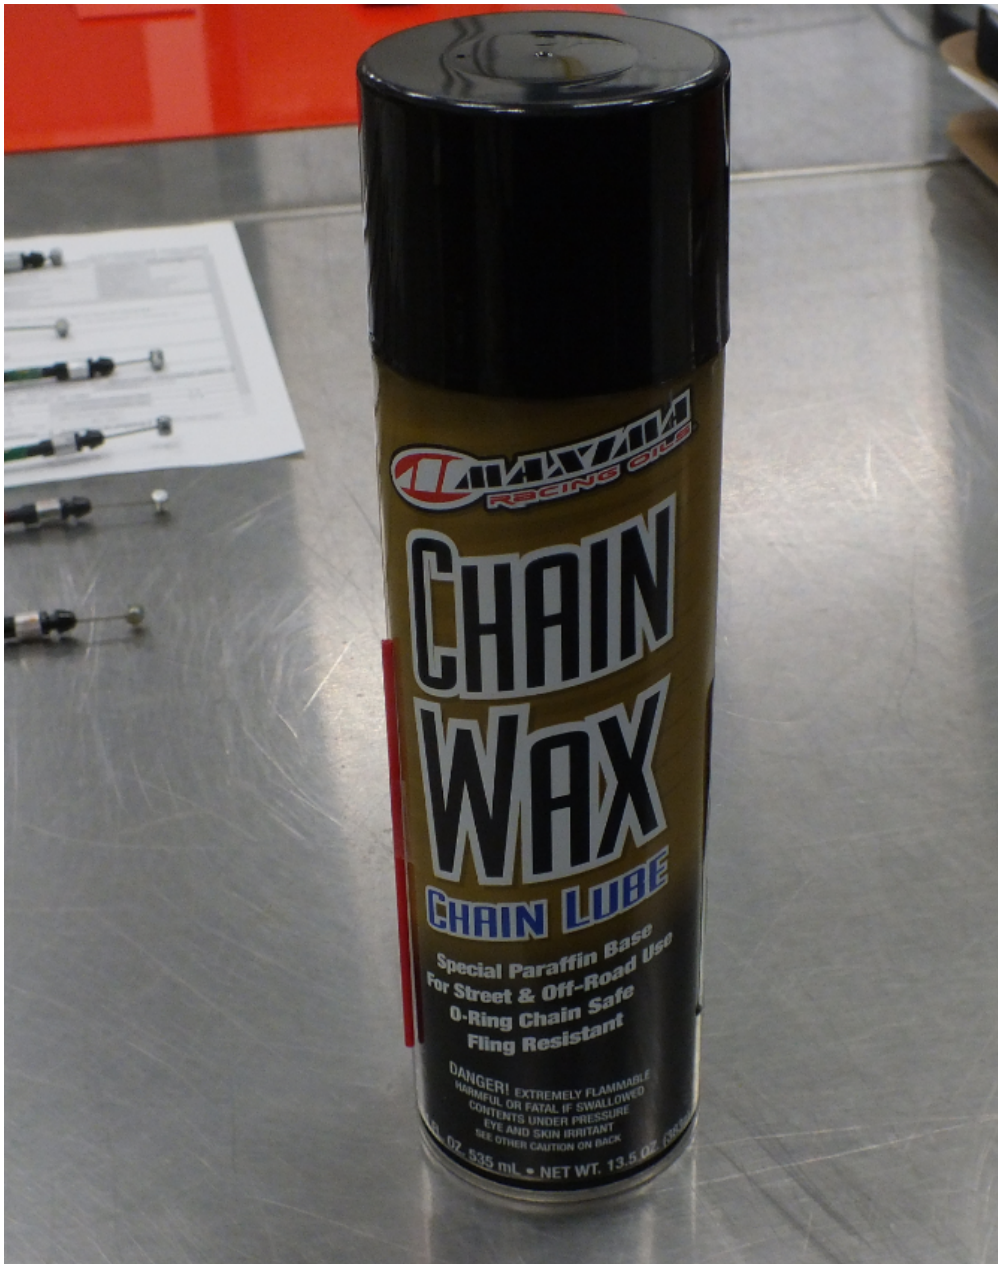
- Spray Chain Wax product in the tool orifice until you see the product dripping out of the cable other ends where the access covers are removed. This product can easily be found from any local supply shop or Amazon.
