## STAR ONLINE PUBLICATION

**Case Number:** S2108000043

**Symptom/Vehicle Issue:** Backup Camera has Black Screen with “Check Entire Surroundings” Message

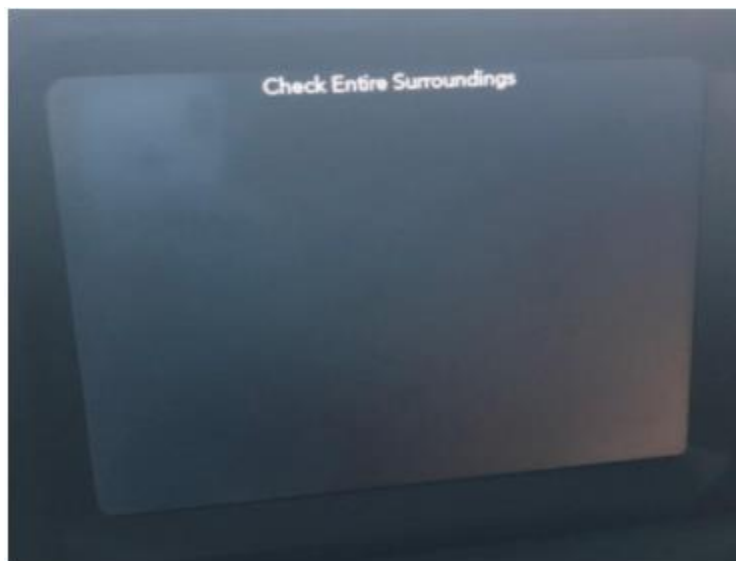
**Discussion:** This issue may occur when the customer switches to reverse immediately after starting the vehicle, Ignition run position. This may create a camera initialization timing conflict that may induce a black screen.

**Do not replace radio or camera for this concern. An ignition key cycle will reset the screen. A momentary delay/hesitation approximately one second when transitioning to Reverse mode after vehicle Ignition is turned to the run position will allow proper initialization. A software update is scheduled for release by the 2<sup>nd</sup> Qtr 2021.**
