XC40 support charger/jump start - access positions

REF NO: TJ 35420.2.0	ISSUING DEPARTMENT: Technical Service	CAR MARKET: United States and Canada	
PARTNER: 3 US 7510 Volvo Car USA		ISSUE DATE: 2021-01-27	STATUS DATE: 2021-02-05
FUNC GROUP: 3110	FUNC DESC: Battery	Page 1 of 4

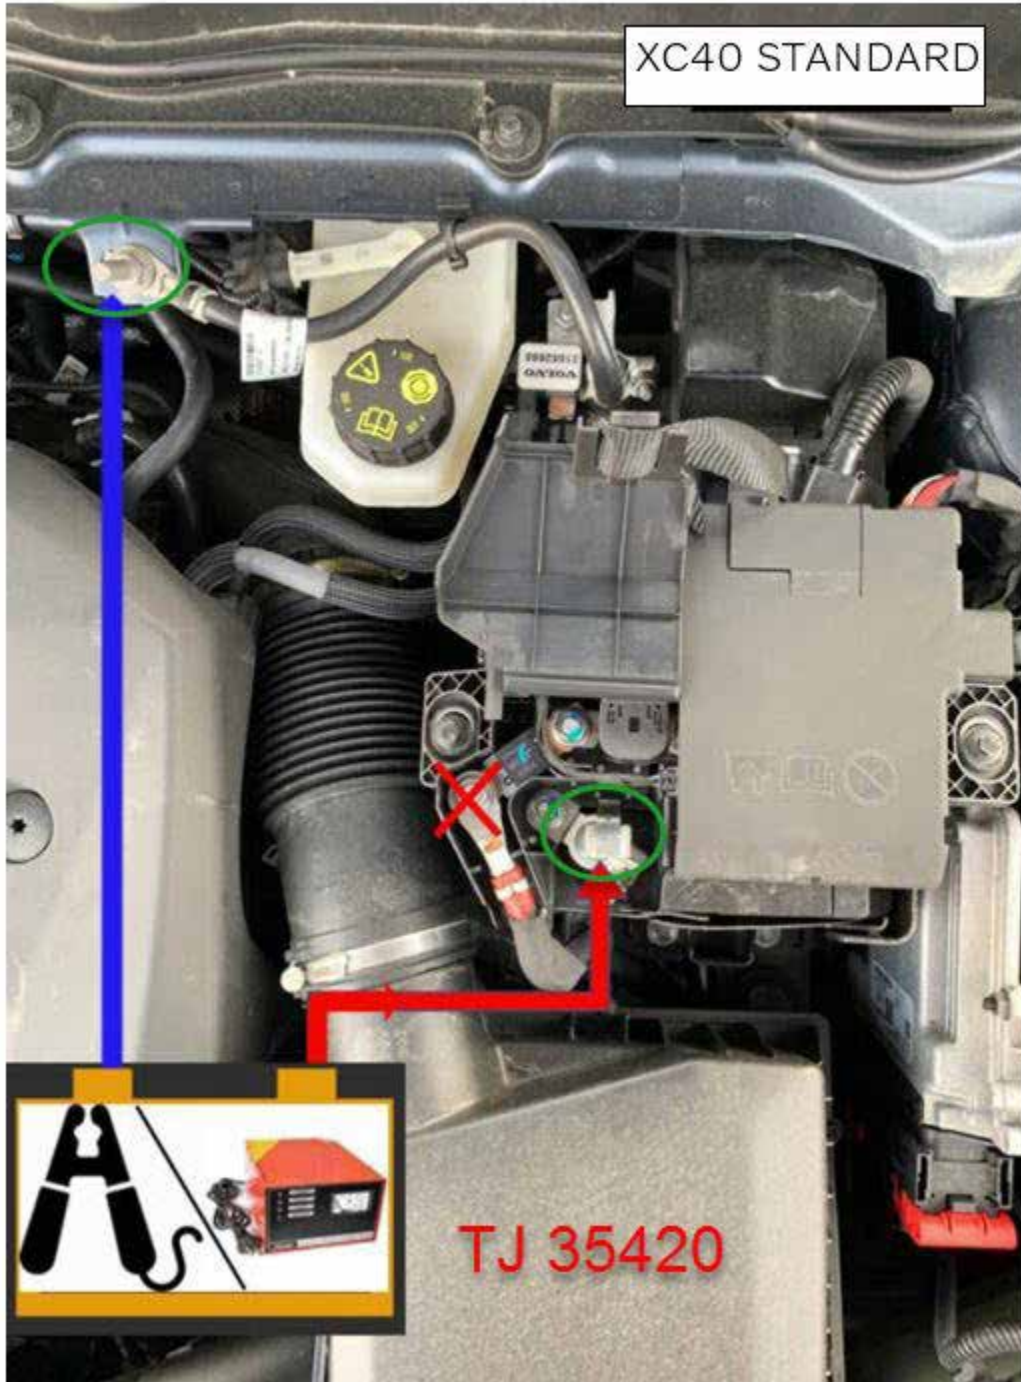
XC40 STANDARD

To ensure correct connection of the support charger during software download or when jump-starting, please follow the instructions under service.

Please follow the instructions in the attachments depending on variant for proper connection of a charger, maintainer, or jumper box/cable.
