# Technical Service Bulletin

## 60 Sunroof glass panel snap noise when opening to the vent position or reverses when closing from the vent position

60 21 51 2062135/1 March 16, 2021.

Model(s)	Year	VIN Range	Vehicle-Specific Equipment
Q5, SQ5	2019 - 2020	All	Not Applicable

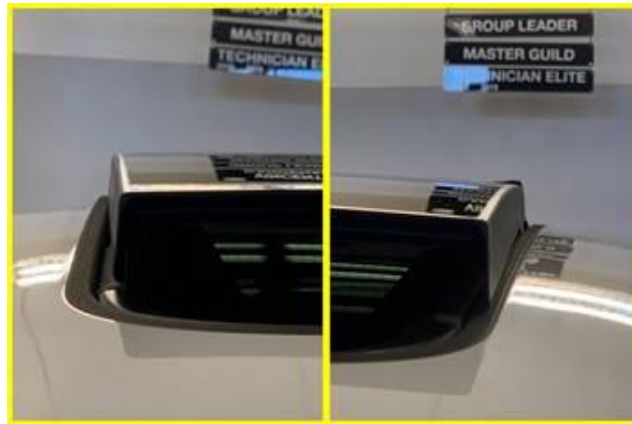
- When the front sunroof panel is opened the customer notices a 'pop' or 'snap' noise once the front glass panel leaves the panel space at the beginning of its opening sequence. Once opened the front glass panel may appear not parallel and incapable of re-entering the roof panel space effectively (Figure 1).

**Figure 1.** An opened sunroof glass panel in a 'twisted' state.

Should a confirmed case with the profile described in this TSB arrive at your dealer, make no repair or adjustment to the sunroof in any way. Determine whether the vehicle is customer owned, demonstrator, dealer inventory, dealer loaner or PDI.

If the vehicle can be held for analysis, order (if necessary) a sunroof opening perimeter seal **80A 877 459 A**. Do not replace the seal unless instructed to do so. If the complete analysis is performed a replacement sunroof opening perimeter seal will be necessary. The TAC consultant will then either arrange for an on-site analysis or provide repair direction.

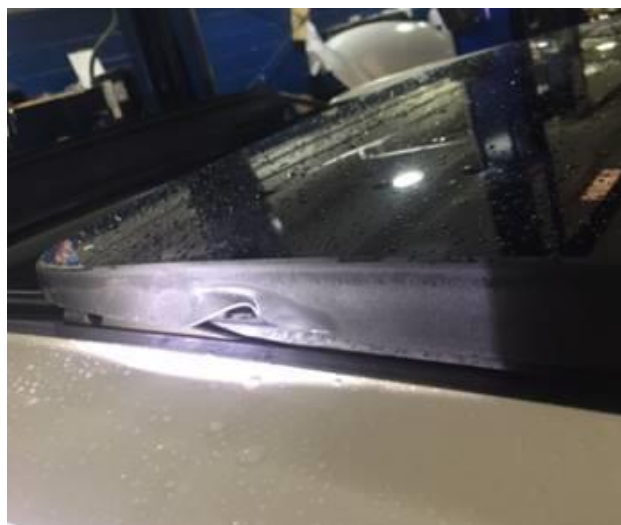
- A deformation in the rubber 'skirt' that surrounds the front and sides of the front sunroof glass panel may also be apparent. This deformation causes interference when the front panel fully closes and the skirt cannot properly engage the roof panel space. As a result, the sunroof panel may intermittently reverse direction when closing (Figure 2).

**Figure 2.** A distorted 'skirt' on the side of the sunroof glass panel.

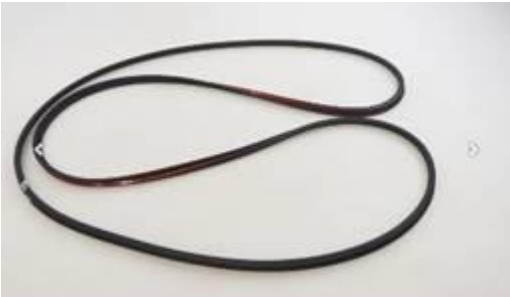
Gasket (adhesive), outer, for the perimeter of the sunroof opening	01
