Technical Service Bulletin

66 Grinding noise heard with steering wheel turned to full lock

66 21 70 2062700/1 March 25, 2021.

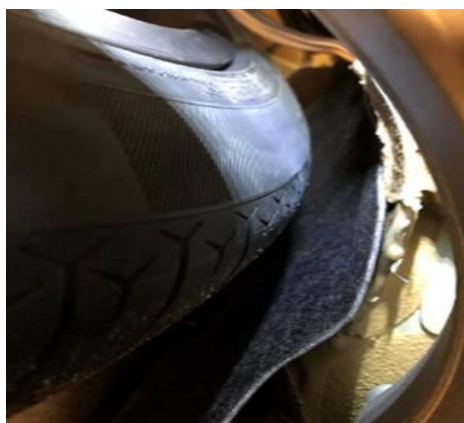
The front wheel housing liner backing can weaken and 'sag' into the path of a rotating front tire when the wheels are turned to full lock. The noise disappears when the steering angle is straightened (Figures 1 - 2).

Figure 1. Front tire making contact with the wheel housing liner.

If this symptom is duplicated and one or both front wheel housing liners are found to interfere with the tire causing the noise replace the front wheel housing liner(s) with part numbers:

- 4KE 821 171 C Left front wheel housing liner.

- 4KE 821 172 C Right front wheel housing liner.

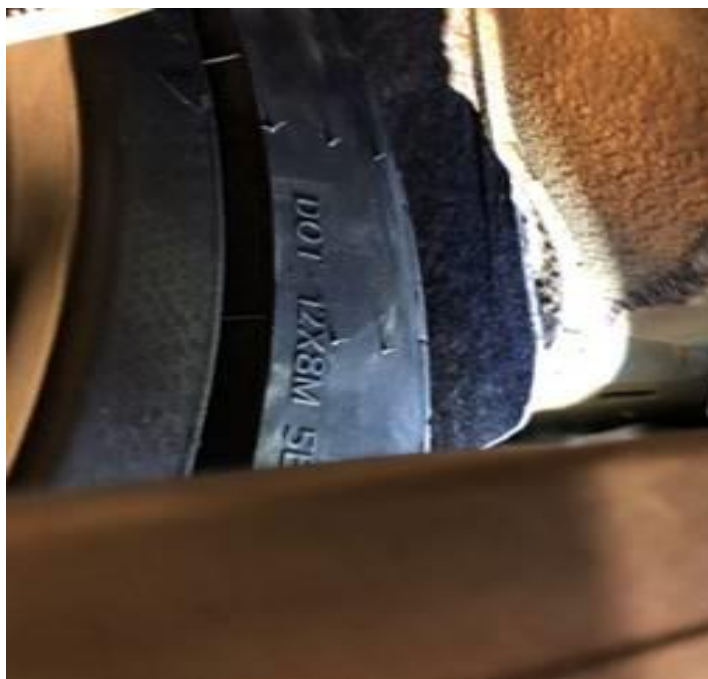
Figure 2. Front tire making contact with the wheel housing liner.
